RE: **Corrective Action Plan (CAP) Progress Report**
Rice Operating Company – BD SWD System
BD O-23-1 Junction Box (Vent) UL O, Sect 23, Township 21S, Range 37E
NMOCD Case Number 1R426-98

This Progress Report summarizes work completed to date by Rice Operating Company (ROC) at the BD O-23-1 vent junction box location (Figure 1). ROC has completed the soil restoration and vadose zone protection work elements specified in the Corrective Action Plan (CAP) for this project, as summarized below. The CAP was approved by the NMOCD on January 10, 2011.

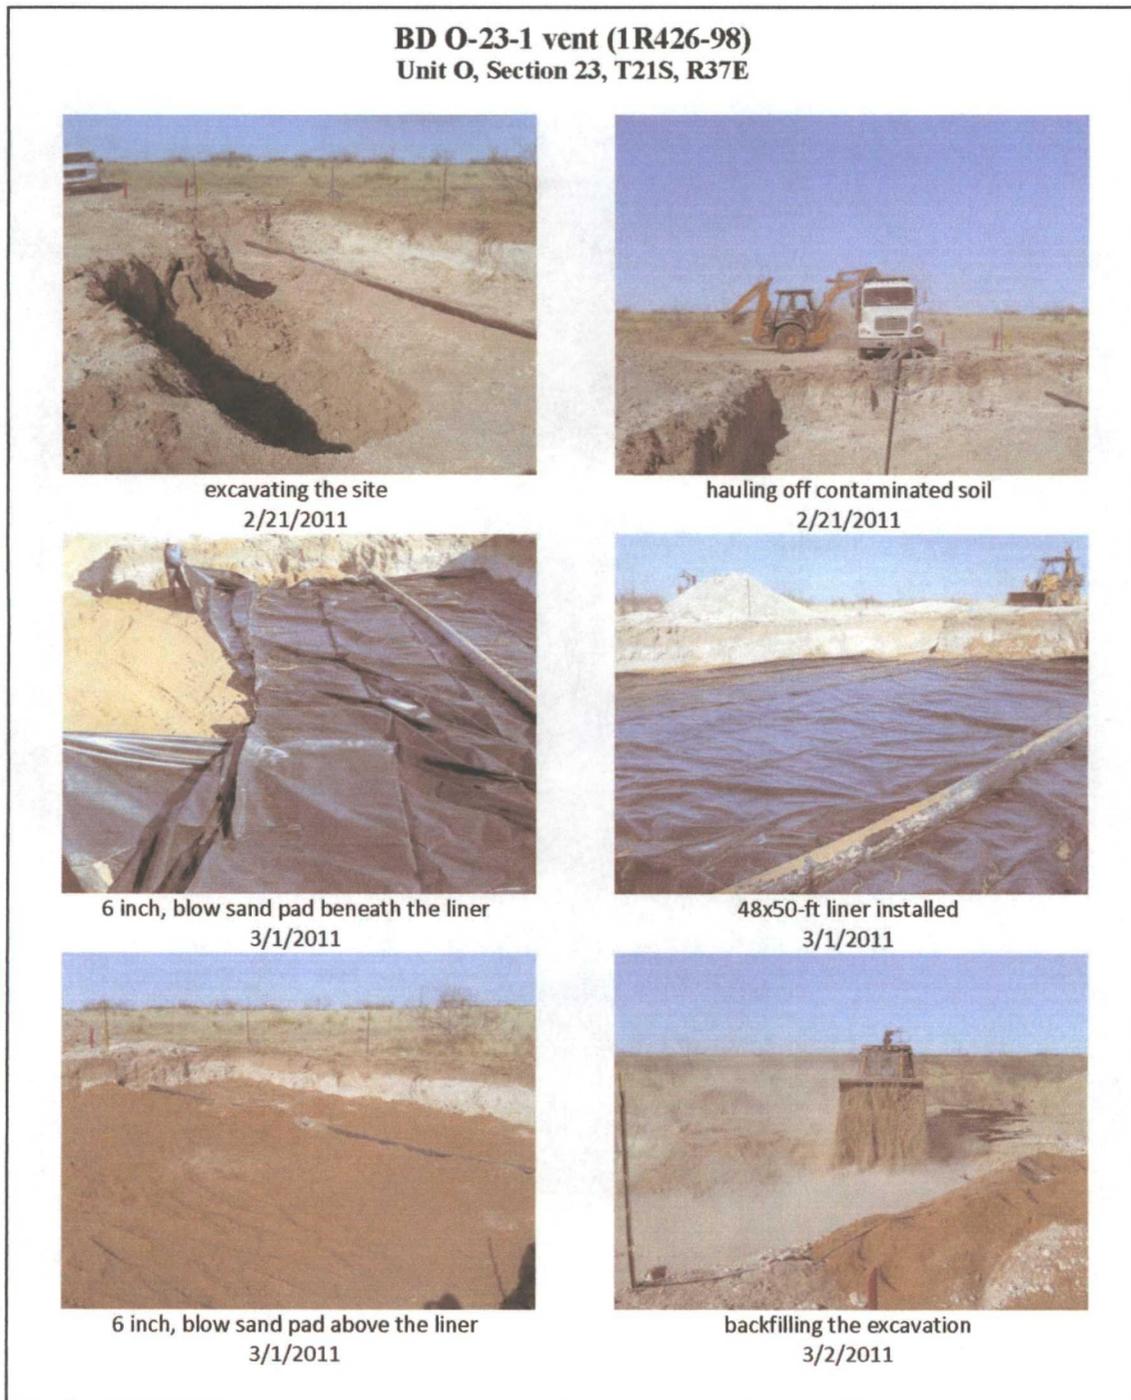
Figure 2a – Photographic chronology of soil removal, liner installation and soil restoration.

From February 18, 2011 through April 1, 2011, chloride impacted soils were removed across the area affected, approximately 48x50 ft, by past operations of the BD O-23-1 vent junction box, to a depth of 5 ft below ground surface (bgs). Six inches of clean blow sand (padding) were added to the bottom of the excavation and a 20 mil impermeable liner was carefully installed. An additional 6 inches of clean blow sand was padded on top of the liner before the excavated soil material was placed above it. An eight-point composite sample from the backfilled material tested 23.6 ppm (Figure 3; measured using a field PID meter) and 128 mg/kg for chlorides (Figure 4; by laboratory analysis). Clean, imported topsoil was amended with peanut hay and spread over the work area and the lease road was repaired using imported base coarse. The site was seeded using 10 pounds (lbs) of pecos district mix and 10 lbs of triticales seed (Figure 5) and silt fencing was installed to preclude wildlife during seedling growth.

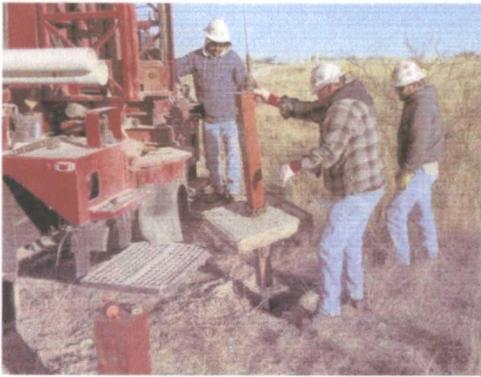
MW-1 being removed, facing north
1/21/2011

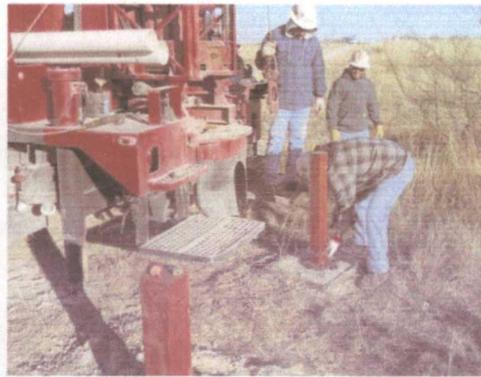
preparing to remove MW-1, facing north
1/21/2011

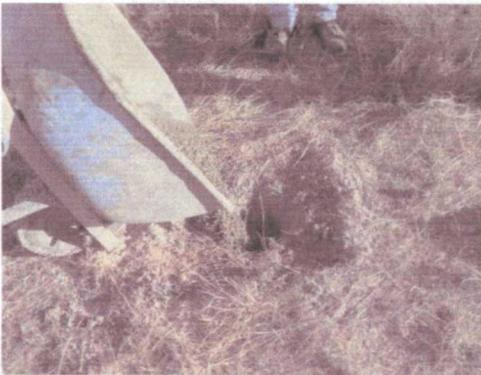
plugging MW-1 with concrete/bentonite slurry
1/21/2011

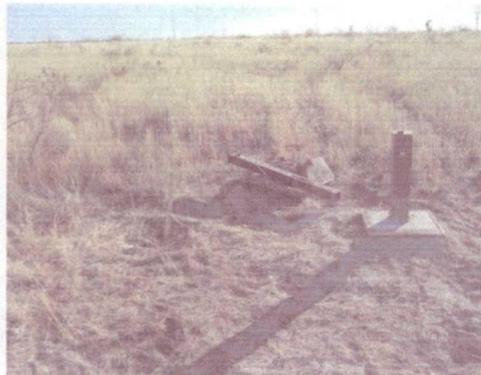
MW-1 plugging complete, facing east
1/21/2011

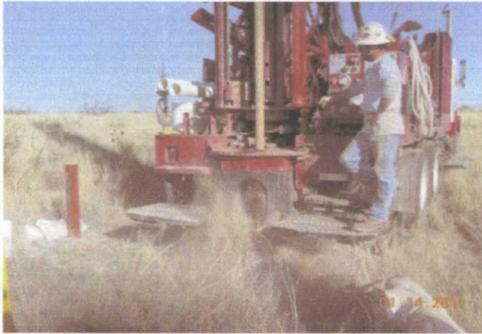
drilling MW-1R (facing east)

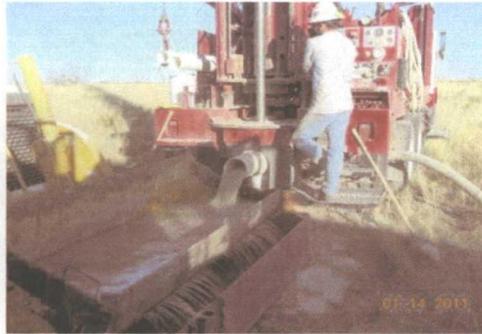
mudding in the well (facing east)

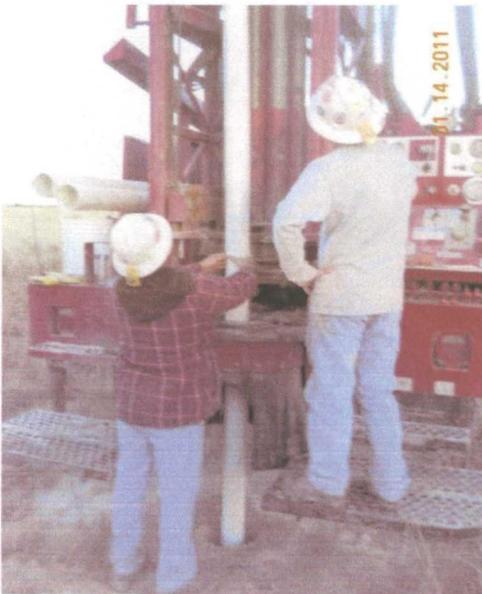
setting the casing (facing east)

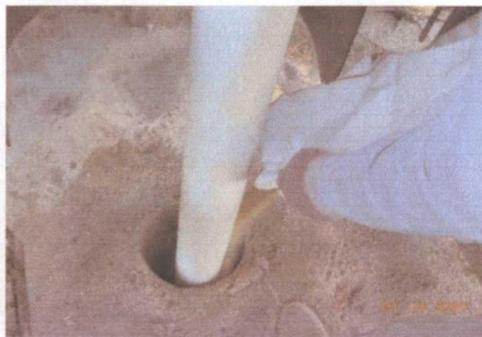
sanding the well in

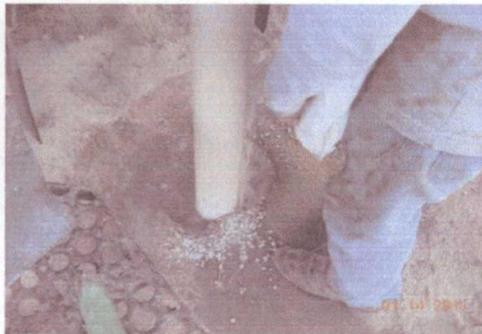
sealing the well in with bentonite (facing south)

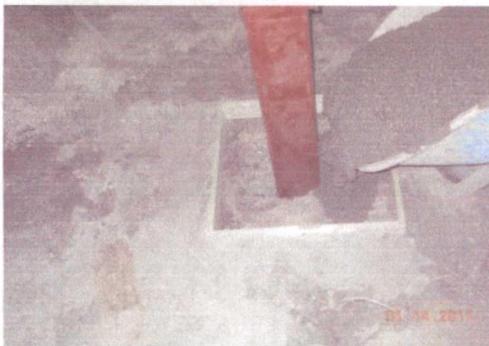
concreting the well in (facing south)

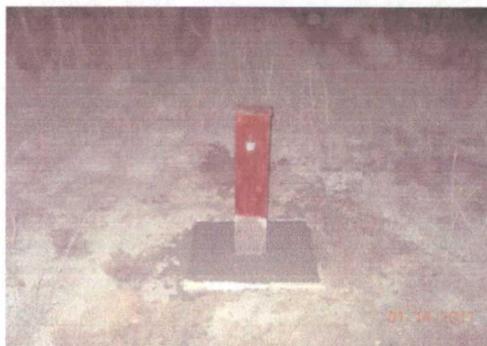
MW-1R complete (facing east)

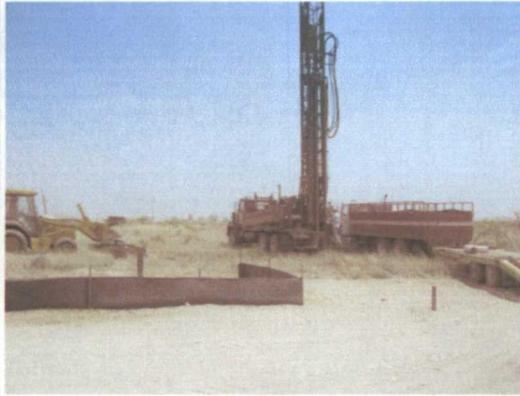
Drilling RW-2 (facing south-east)

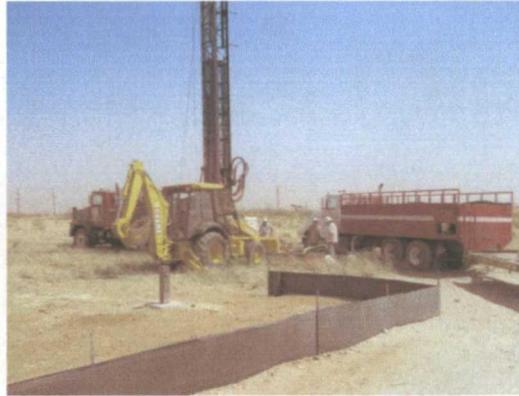
Drilling RW-2 with mud rotary (facing south-east)

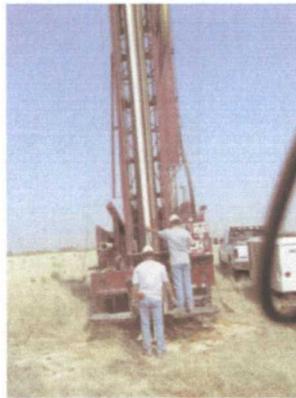
Inserting the casing into the hole

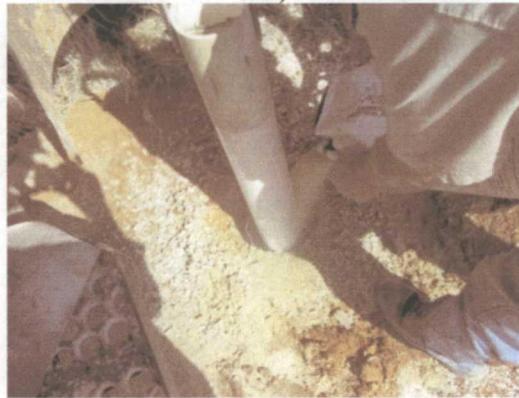
Adding the sand pack

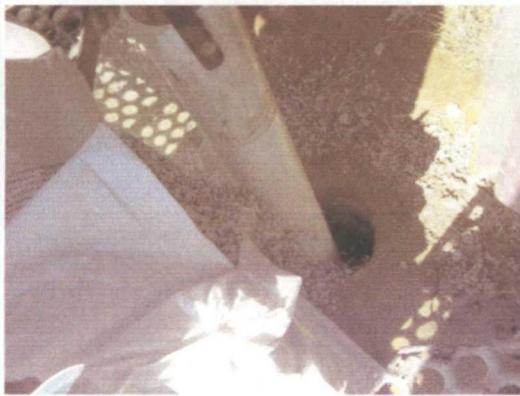
Adding the bentonite seal

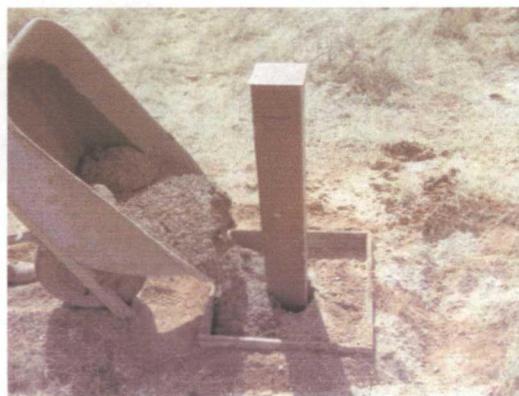
Pouring the concrete for the base
