# INITIAL C-141 AND REMEDIATION WORK PLAN

## Report Type: Work Plan

**Re: Work Plan for the COG Operating LLC., Hercules Federal Com #1,  
Unit E, Section 15, Township 15 South, Range 31 East, Chaves  
County, New Mexico.**

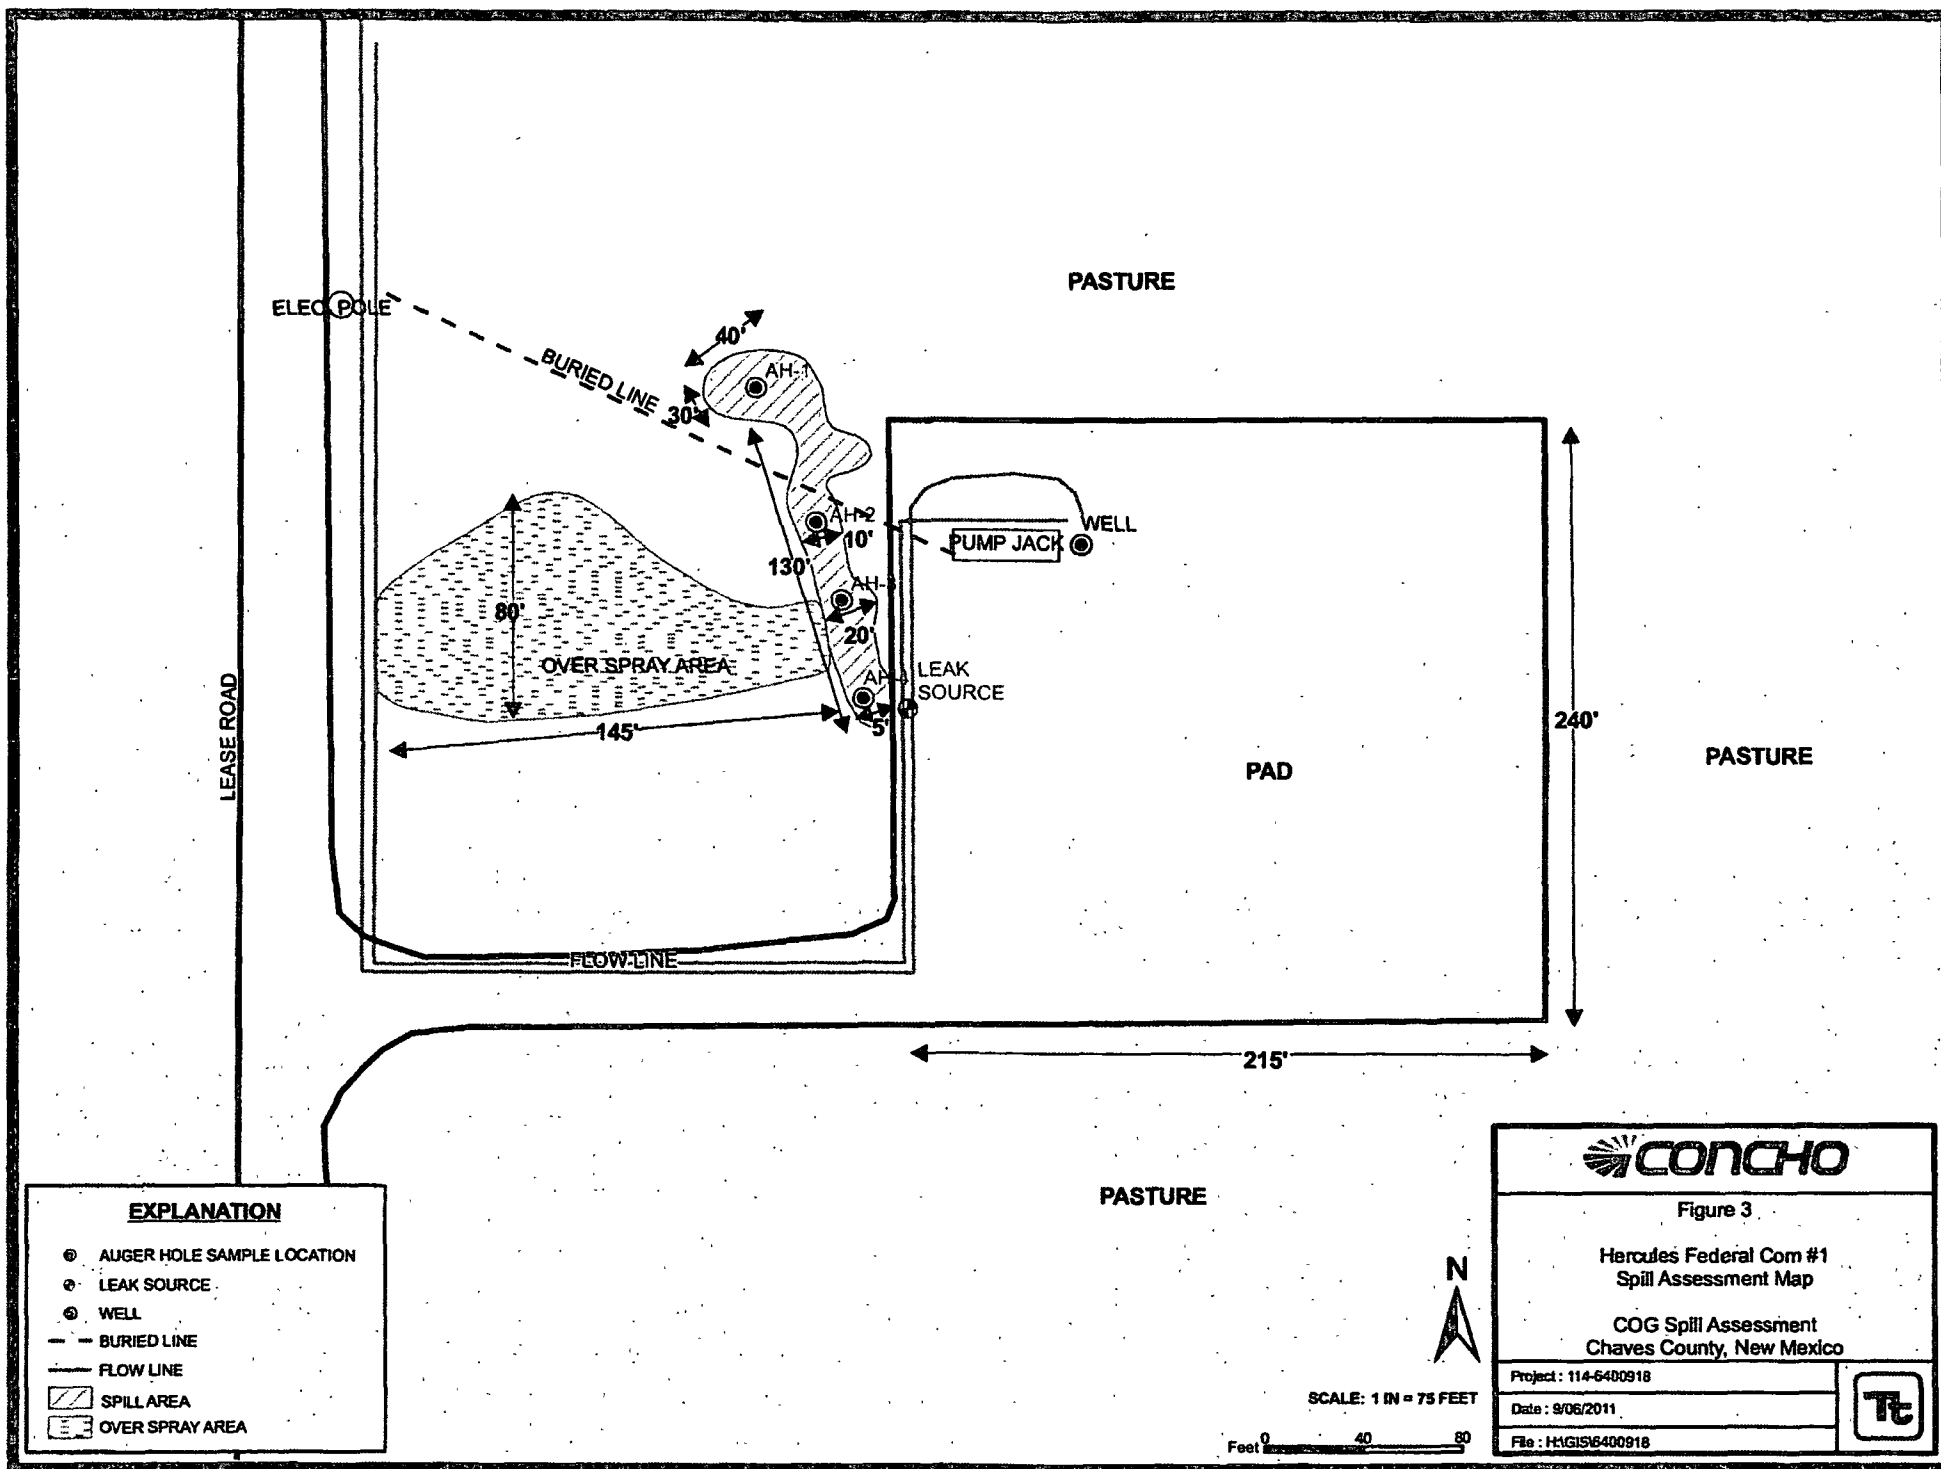
Referring to Table 1, all of the samples were below the TPH and BTEX RRAL, with the exception of AH-4. Auger hole (AH-4) showed a TPH of 9,585 mg/kg at 0-0.5' and not vertically defined, due to the dense formation. AH-1, AH-3 and AH-4 showed chloride concentrations of 1,600 mg/kg (0-0.5'), 2,120 mg/kg (0-1') and 1,670 mg/kg (0-0.5'), respectively. AH-1 did show a significant decline to <200 mg/kg at 1-1.5', but the remaining auger holes were not vertically defined.

COG proposes to remove impacted material as highlighted (green) in Table 1. The areas of AH-1, AH-3 and AH-4 will be excavated to a depth of approximately 1.0' to 2.0' below surface. Once excavated, backhoe trenches will be installed in the areas of AH-3 and AH-4 to evaluate the excavation bottom and further define the chloride impact, if necessary. In addition, a confirmation sample for TPH will be collected from the area of AH-4. Once excavated to the appropriate depths, the excavations will be backfilled with clean soil.

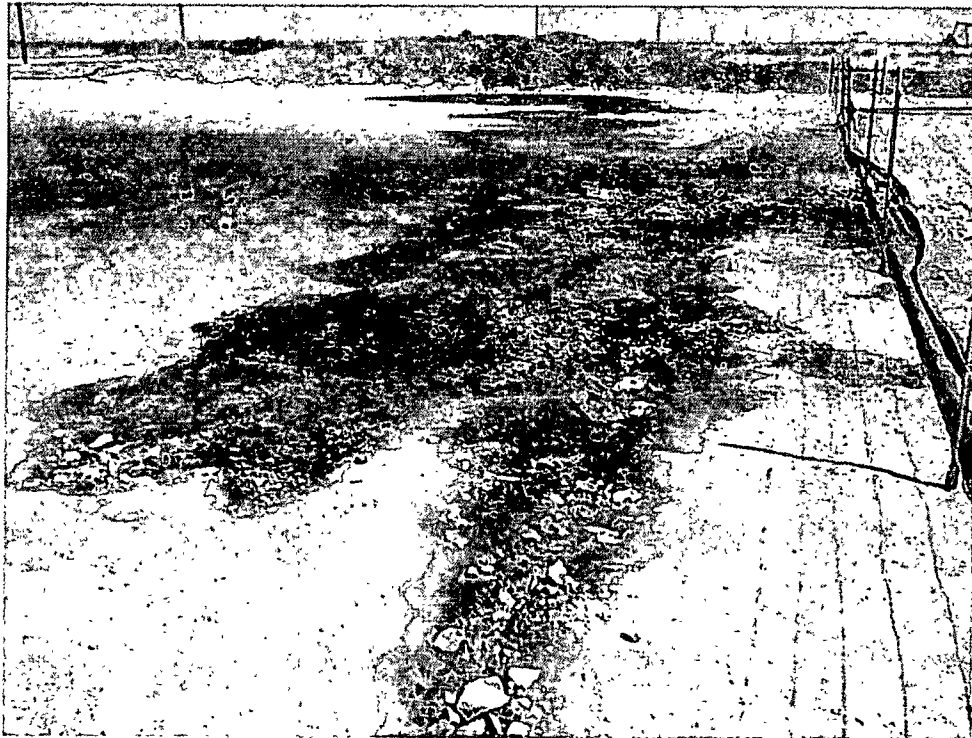
View North – AH-4, 3, 2, 1

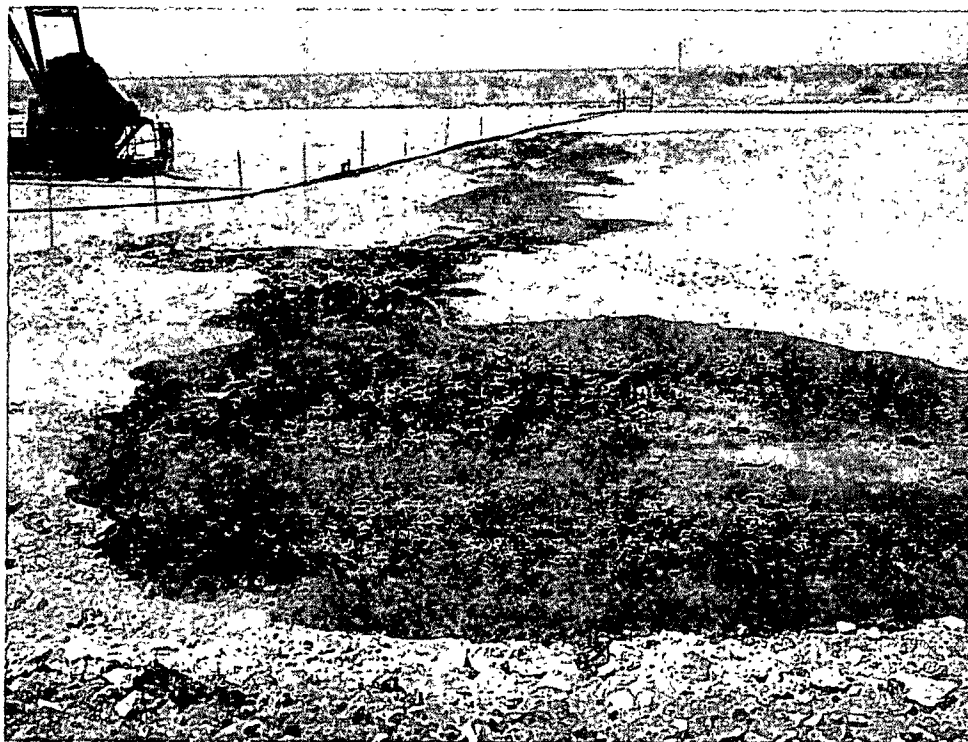
View South – AH-1, 2, 3, 4
