## Rice Environmental Consulting & Safety

**RE: CAP Report and Termination Request  
Rice Operating Company – EME SWD System  
EME K-35 (1R427-01): UL/K sec. 35 T20S R36E**

# EME K-35 (1R427-01)

Unit K, Section 35, T20S, R36E

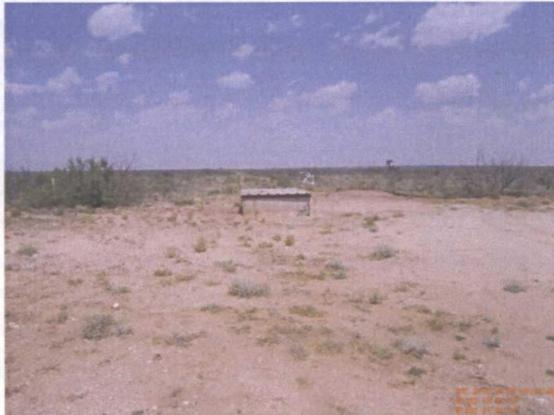
Site prior to scraping, facing east 6/28/2012

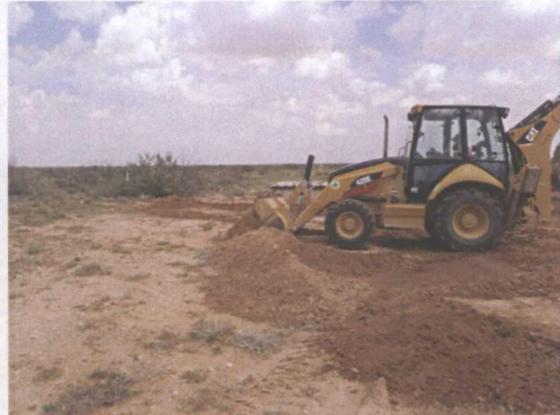
Scraping site, facing east 7/11/2012

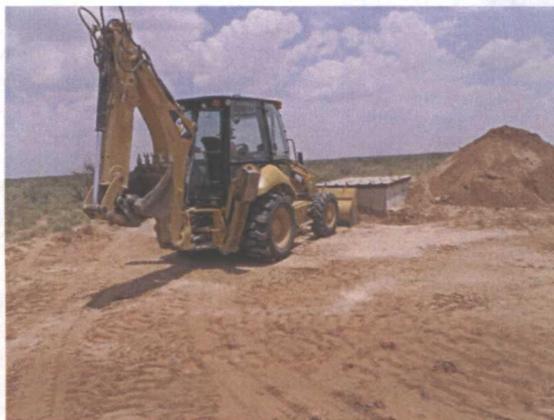
Scraping site, facing east 7/12/2012

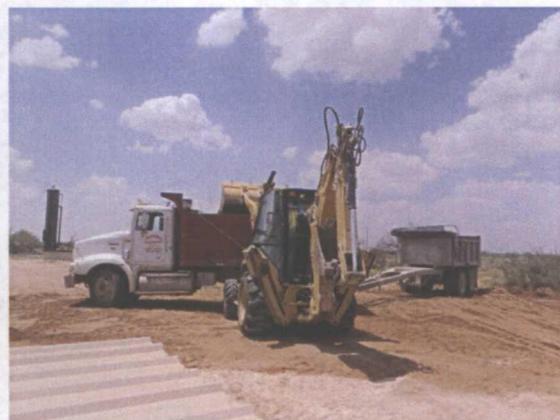
Exporting soil, facing west 8/17/2012

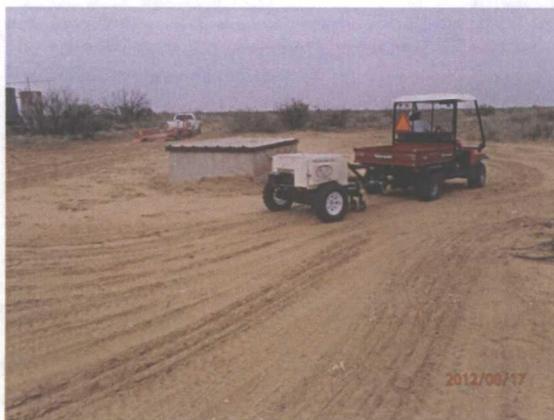
Seeding and tilling, facing west 8/17/2012

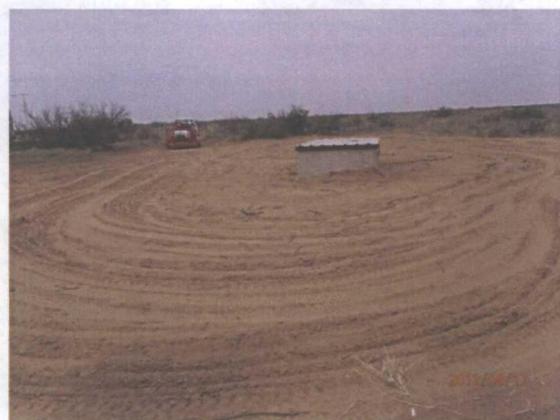
Site complete, facing west 8/17/2012
