Report Type: Work Plan

Site:	RJ Unit #134				
Company:	COG Operating LLC				
Section, Township and Range	Unit O	Sec. 27	T-17-S	R-29-E	
Lease Number:	API-30-015-34573				
County:	Eddy County				
GPS:	32.80056° N			104.05979° W	
Surface Owner:	Federal				
Mineral Owner:					
Directions:	Intersection of 529 and CR-217 travel west on 82 4.4 mi, turn left on CR-213 1.5 mi, turn right 0.2 mi, turn left 200' to location on left in right away. (Near Apache Well B440 Federal #6 well pad location)

Re: Work Plan for the COG Operating LLC., RJ Unit #134 Flowline, Unit O, Section 27, Township 17 South, Range 29 East, Eddy County, New Mexico.

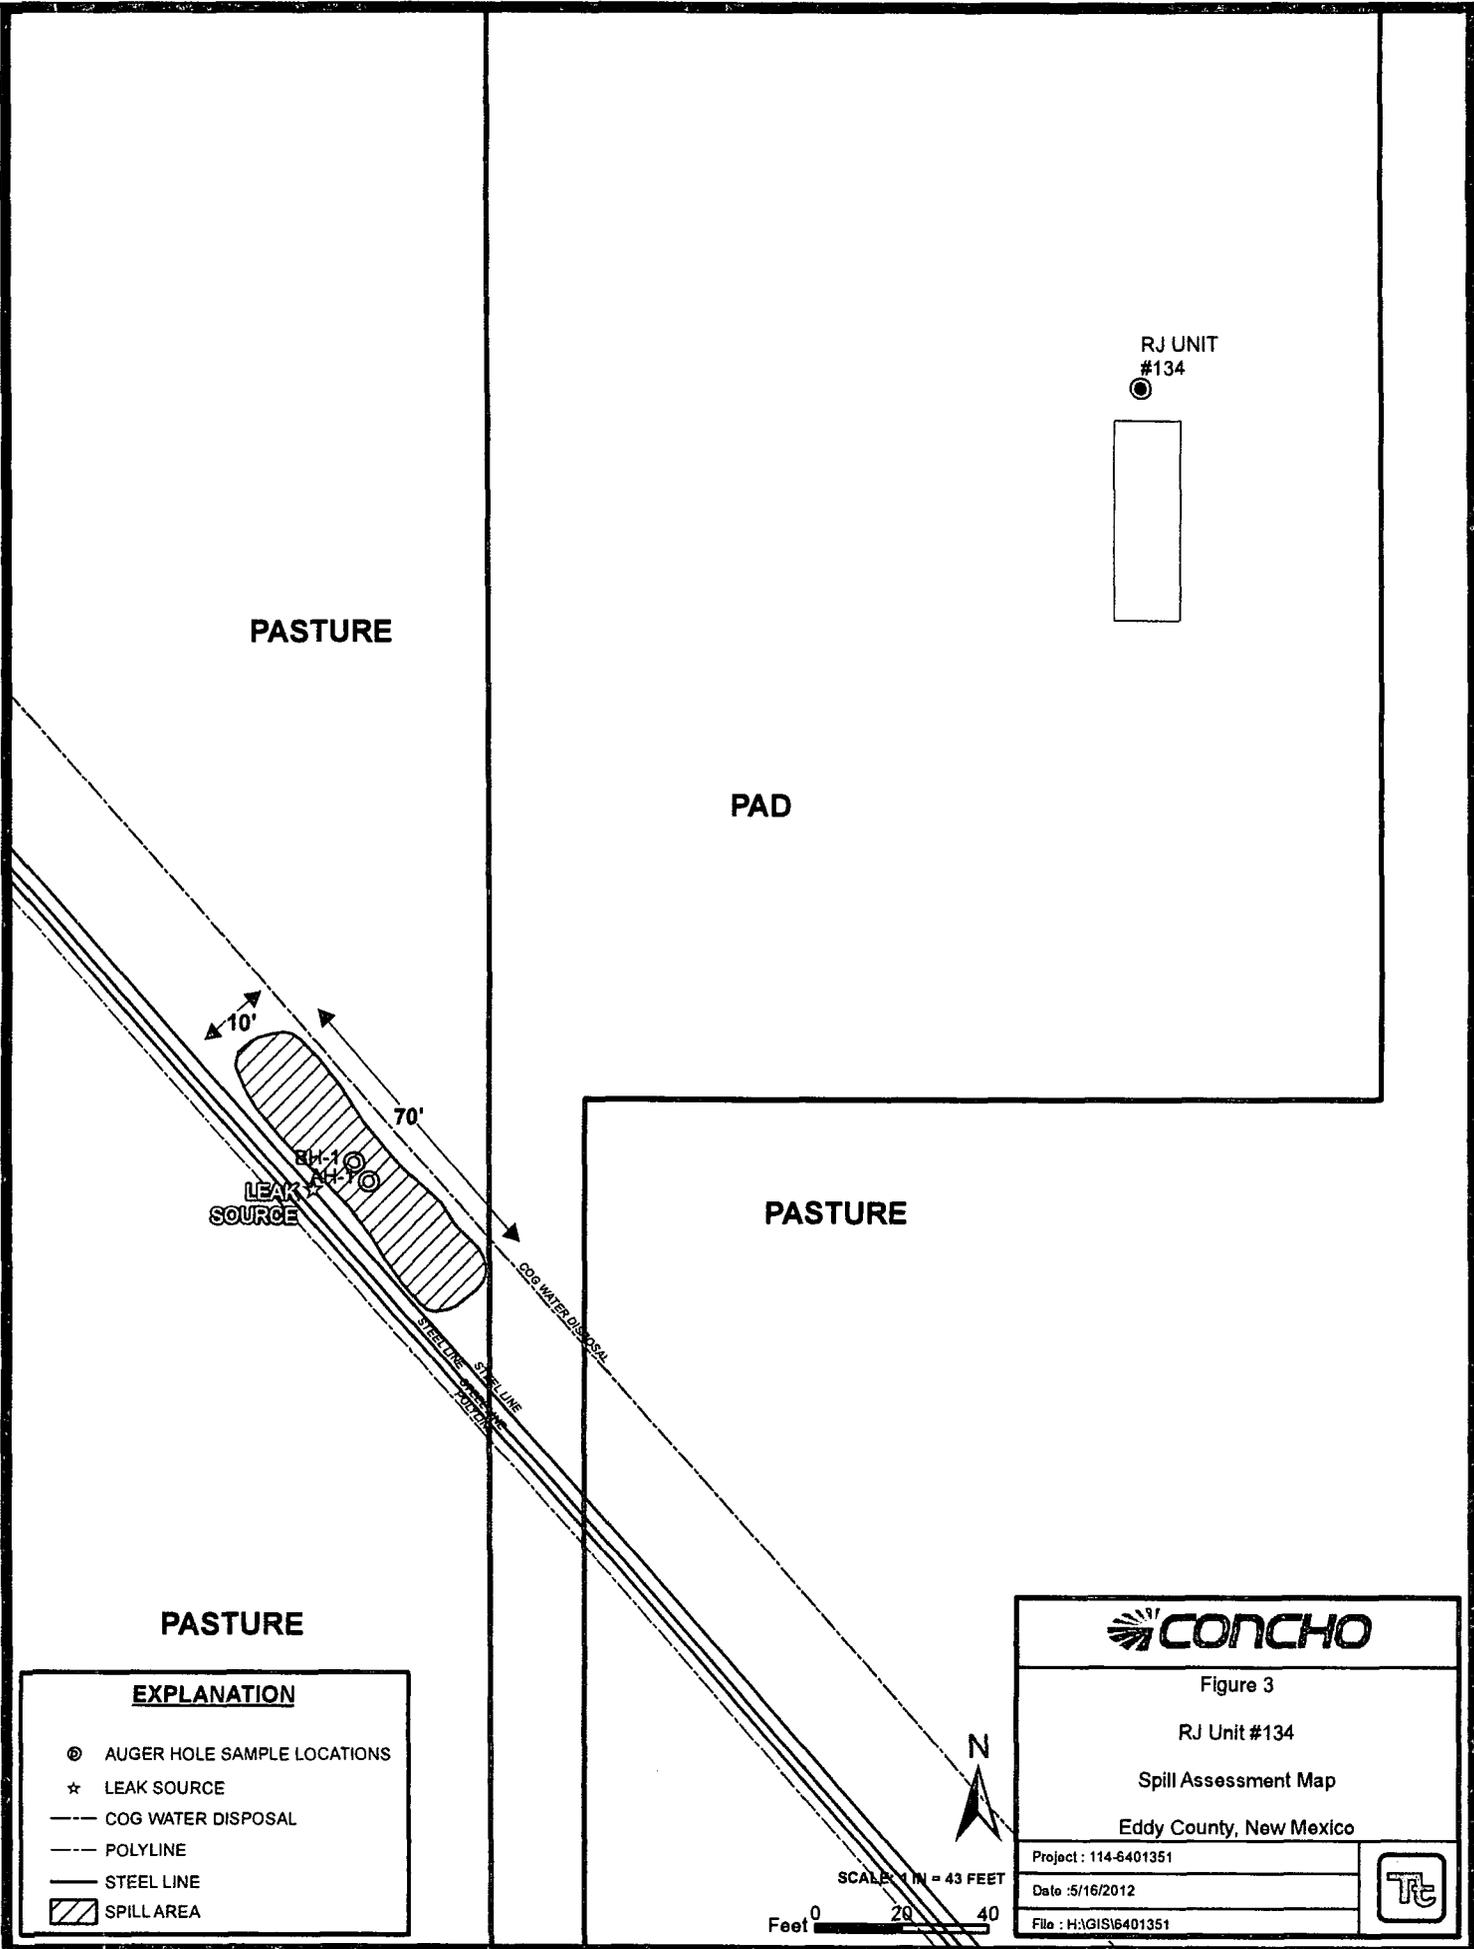
Figure 3

On March 28, 2011, Tetra Tech personnel inspected and sampled the spill area. One (1) auger hole (AH-1) was installed in the center of the spill area using a stainless steel hand auger to assess the impacted soils. Samples were collected to a depth of 9-9.5' below surface. Selected samples were analyzed for TPH analysis by EPA method 8015 modified, BTEX by EPA Method 8021B and chloride by EPA method 300.0. Copies of laboratory reports and chain-of-custody documentation are included in Appendix C. The sampling results are summarized in Table 1. The auger hole location is shown on Figure 3.
