Release Notification and Corrective Action

NAB15048401008
Name of Company: BOPCO, L.P. *#215099 - Cimarex* Contact: Tony Savoie
Address: 522 W. Mermod, Suite 704 Carlsbad, N.M. 88220 Telephone No. 575-887-7329
Facility Name: Hasta La Vista 1 DI Fed. COM #002Y. The Facility Type: Exploration and Production
spill is 1760 ft. SE of the well pad.

FIELD SPILL REPORT

LOCATION OF SPILL SITE: Hasta la Vista 1 DI Federal Com 002y (API-30-015-42705)

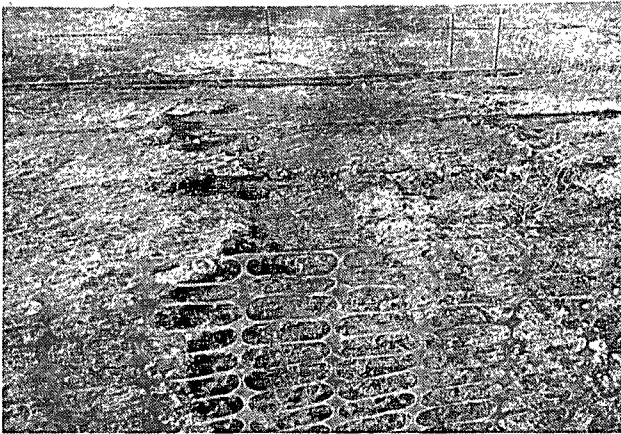
Describe Cause of Problem and Remedial Action Taken.* A hammer union became loose due to vibration and movement on the line. The union was re-tightened and the line was secured.

Flowline leak due to a hammer union working loose caused by line moving from pressure.

Contract gang repaired leaking union and vac truck recovered 1 bbl oil and 1 bbl produced water. Contract gang constructed orange excavation netting around contaminated soil and will check #1H & 2Y flowlines to insure there were no more possible leaks due to line movement
