Release Notification and Corrective Action

NAB1500354133		OPERATOR		<input checked="" type="checkbox"/> Initial Report	<input type="checkbox"/> Final Report
Name of Company: BOPCO, L.P.		Contact: Tony Savoie			
Address: 522 W. Mermod, Suite 704 Carlsbad, N.M. 88220		Telephone No. 575-887-7329			
Facility Name: Palmillo State #1		Facility Type: Exploration and Production			
Surface Owner: State of NM		Mineral Owner: State of NM		API No. 30-015-23164

## FIELD SPILL REPORT

LOCATION OF SPILL SITE: Palmillo State #1 Spill is 1286 ft. N.W. of well (API 30-015-23164)

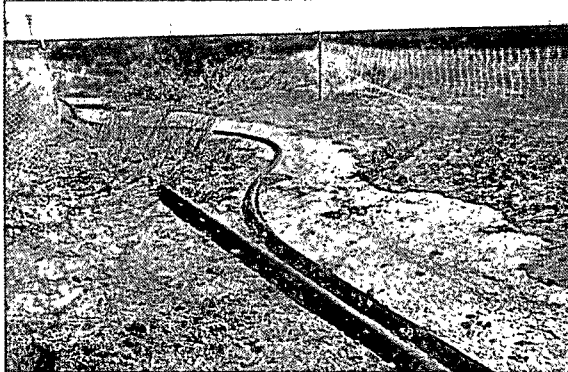
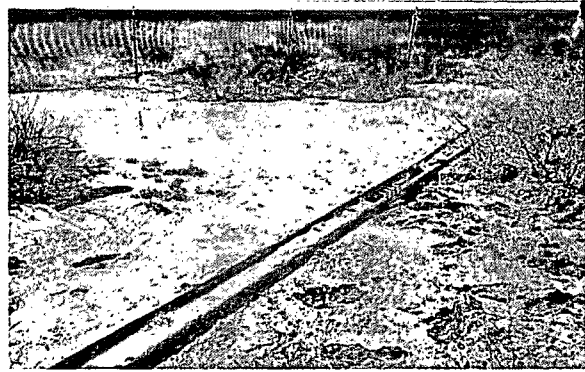
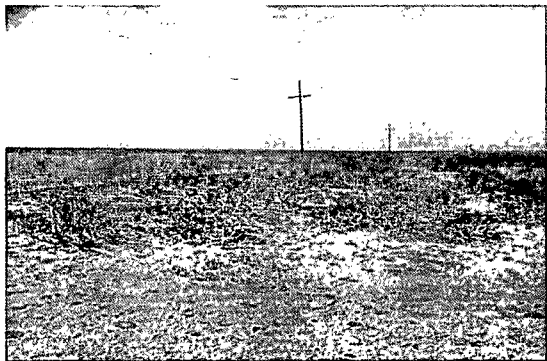
### PICTURE ATTACHMENT:

Release was due to corrosion in steel flowline. Product was congealed and there was no recovery.

Site was reviewed 2-24-15. The line had been clamped. The area was fenced off with orange construction barricade fencing. Leak site is directly underneath power lines and approximately 30' SE of a Kinder-Morgan buried gas line.
