Rele	ease Notific	atio	on and Co	rrective A	ction	1				
NAB 1506 929 643						OPERATOR Initial Report					Final Report		
Name of Co	mpany: B	OPĆO, L.P.	2/	00737		Contact: To							
Address: 522 W. Mermod, Suite 704 Carlsbad, N.M. 88220							Telephone No. 575-887-7329						
Facility Nar of the well l		5 The flow l	ine leak v	vas 1700 ft. sout	:h	Facility Typ	e: Exploration a	and Pro	oduction				
Surface Ow	ner: Feder	al		Mineral C	wner	: Federal			API No	. 30-015-2	7995_		
LOCATION OF RELEASE													
Unit Letter	Section	Township	Range	Feet from the	Nort	h/South Line	Feet from the	East/	West Line	County:			
F	6	23S	31E							Eddy			
				Latitude N 32.	33526	50 Longitud	e_W 103.81650	07					
				NAT	URI	E OF REL	EASE						
Type of Release: Produced water							Volume of Release: 13 bbls. Volume Recovered: 8 bbls						
Source of Release: 2 7/8" flow line							Date and Hour of Occurrence: Date and Hour of Discovery:

FIELD SPILL REPORT

LOCATION OF SPILL SITE: JRU 65 (API 30-015-27995) Spill is 1700 ft. south of the well

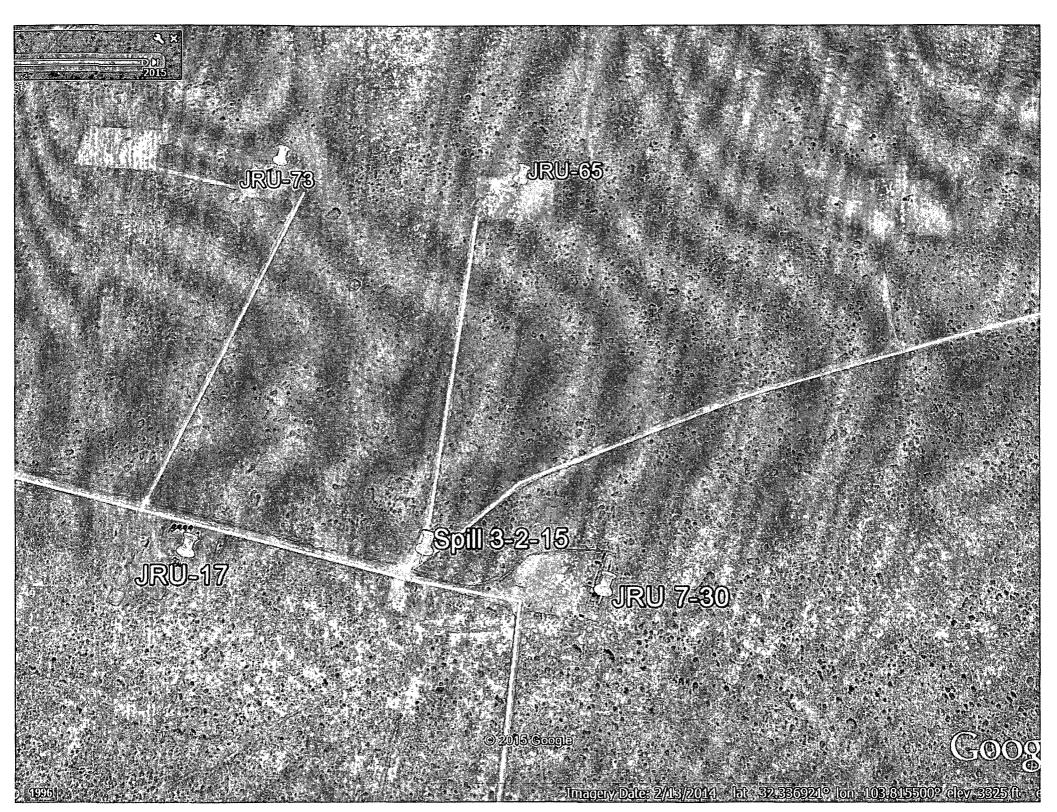
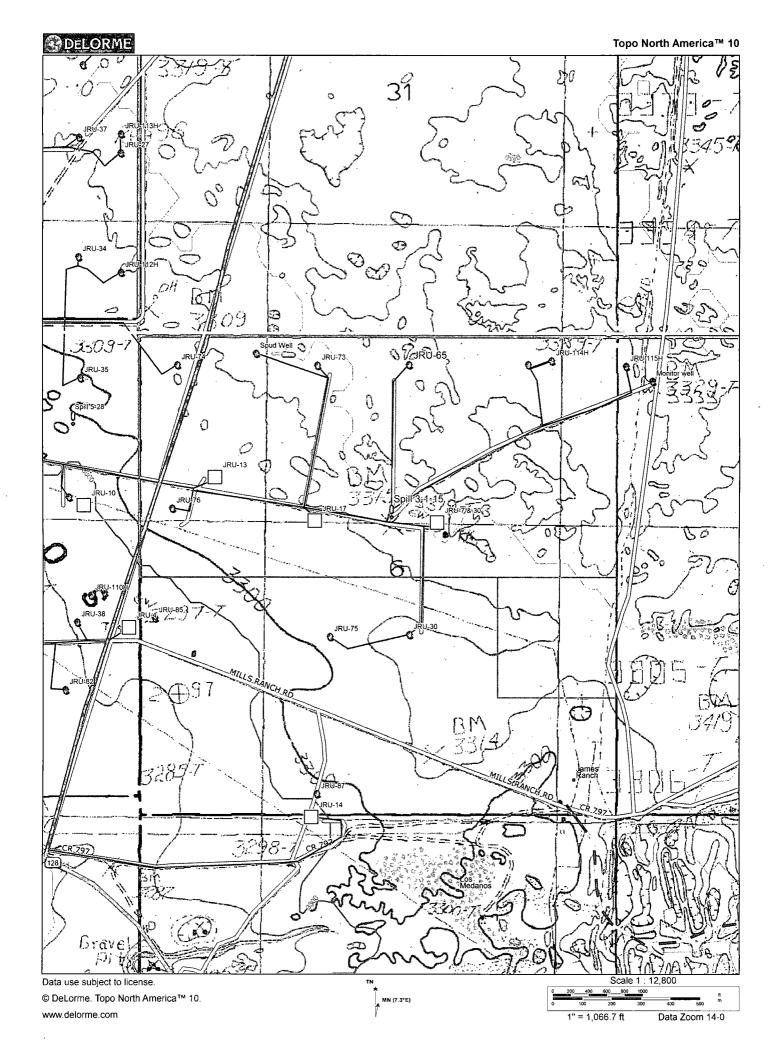
PICTURE ATTACHMENT:

Volume spilled:		BBIs Spilled	*BBIs Recovered	Net Spilled		BBIs Spilled	*BBIs Recovered	Net Spilled
On ground /or earth berm -	Oil:			0	Water:	13	8	5
Contained in impervious liner -	Oil:			0	Water:			0
Total:	Oil:	0	0	0	Water:	13	8	5

Flowline leak

Line was clamped
