**From:** shelby.g.pennington@exxonmobil.com  
**Sent:** Monday, July 19, 2010 9:02 AM  
**To:** Bratcher, Mike, EMNRD  
**Subject:** ADU #238  
**Attachments:** ADU #238 Samples.pdf

<p><b>Figure 6</b> Soil Boring Map ExxonMobil Avalon Delaware Unit #238</p>	<p>Eddy County, New Mexico NE 1/4 of the SW 1/4, Sec. 30, T20S, R28E N 32° 32' 41.21" W 104° 13' 15.65" Elevation: 3,299 feet amsl</p>	<p>DWG By: Jerry Smith July 2010</p>	<p>REVISED: 2010</p>	
	<p>0 60 120 Feet</p>	<p>120 SHEET 1 of 1</p>

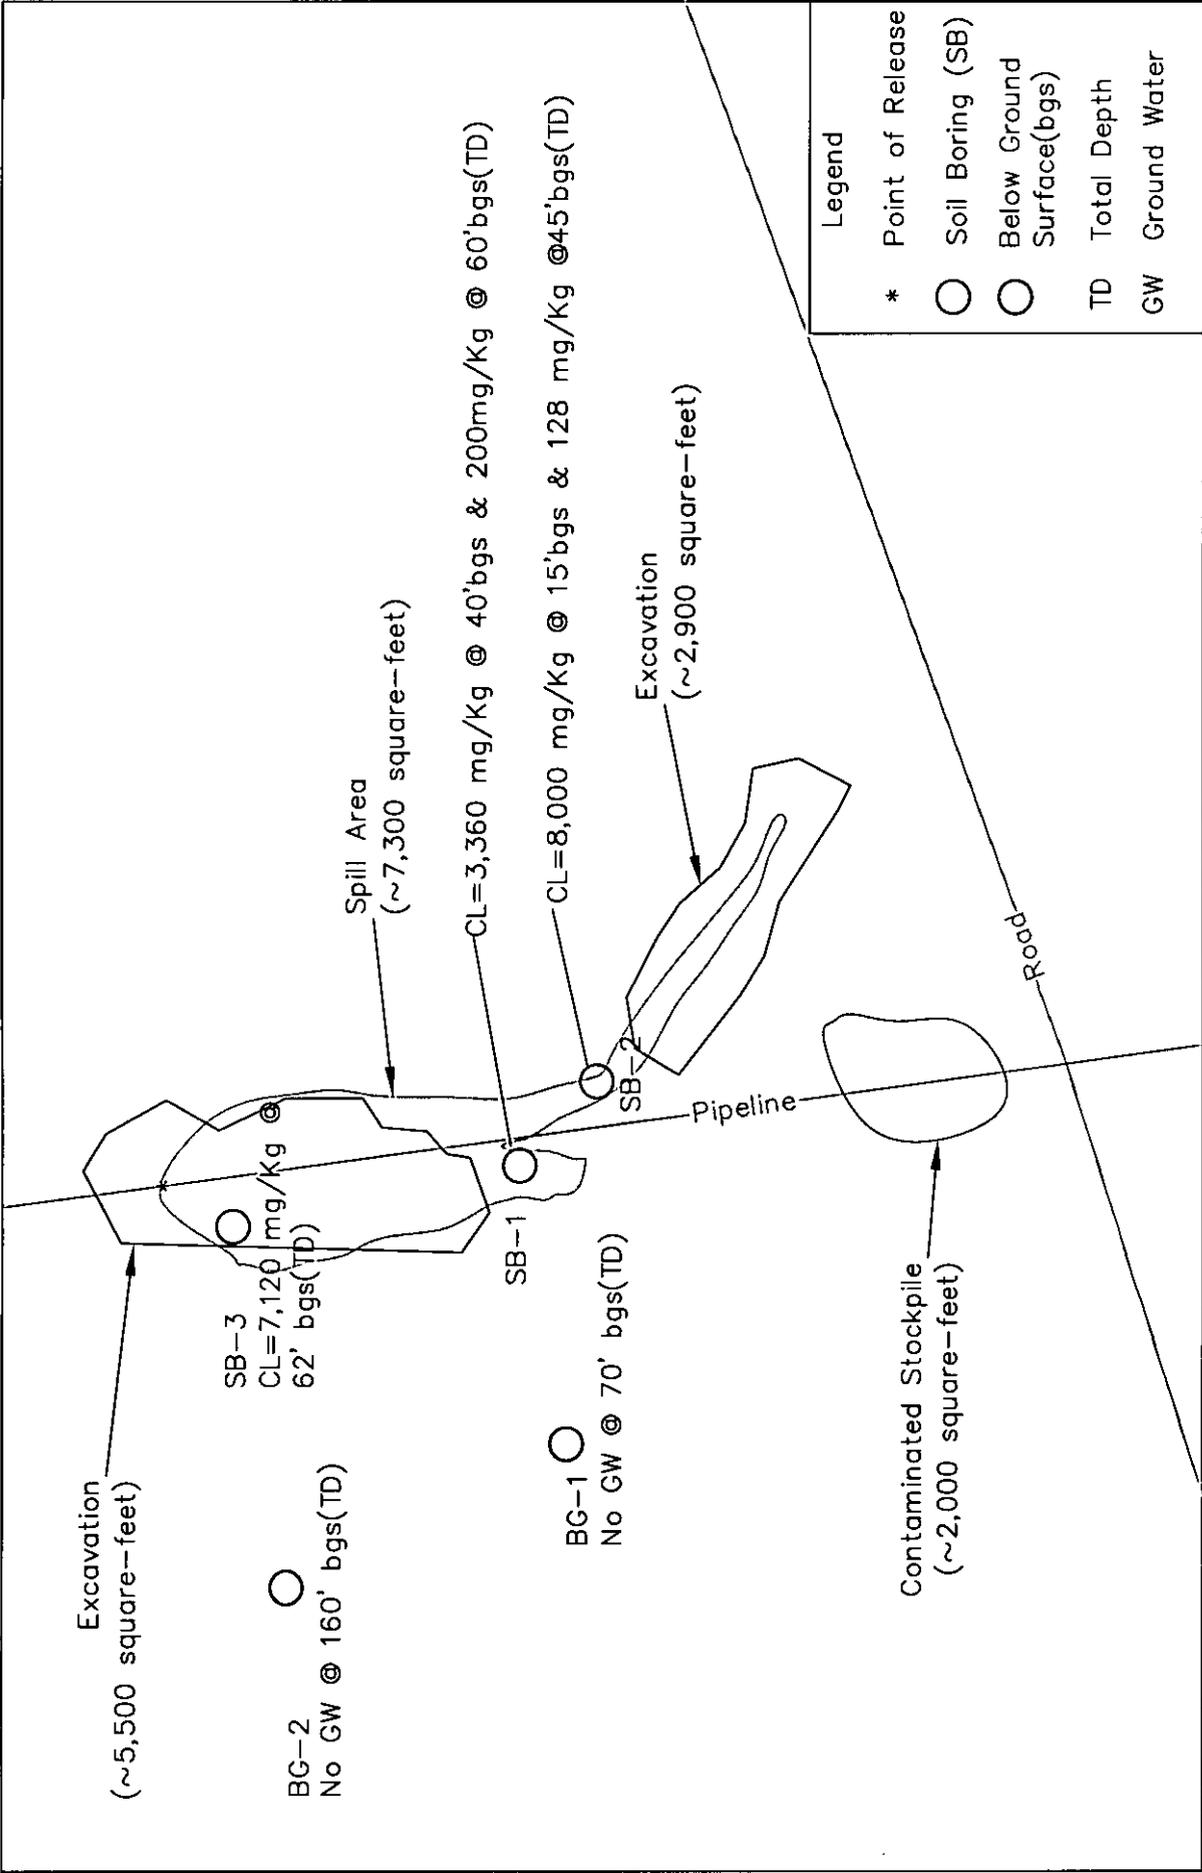
I have been in and out of the office for a while but need to get this spill closed out. We went and did a sample hole at the spill site to find the depth to groundwater. The rig went to a depth of 160 feet and we let it sit over night and checked it the next day. No sign of groundwater. There is still one boring that we have not delineated all the way due to previous concerns on the depth to ground water. SB-3 was delineated to a depth of 62 feet but chlorides are still at 7120. My question is, how would you like us to address this spill. At what depth or chloride level would you like us to excavate and install liner? Please give some feedback or thought. Thanks
