LINN OPERATING, INC.

Release Notification and Corrective Action

Remediation Summary Report Form

Site Name: Hale State #4

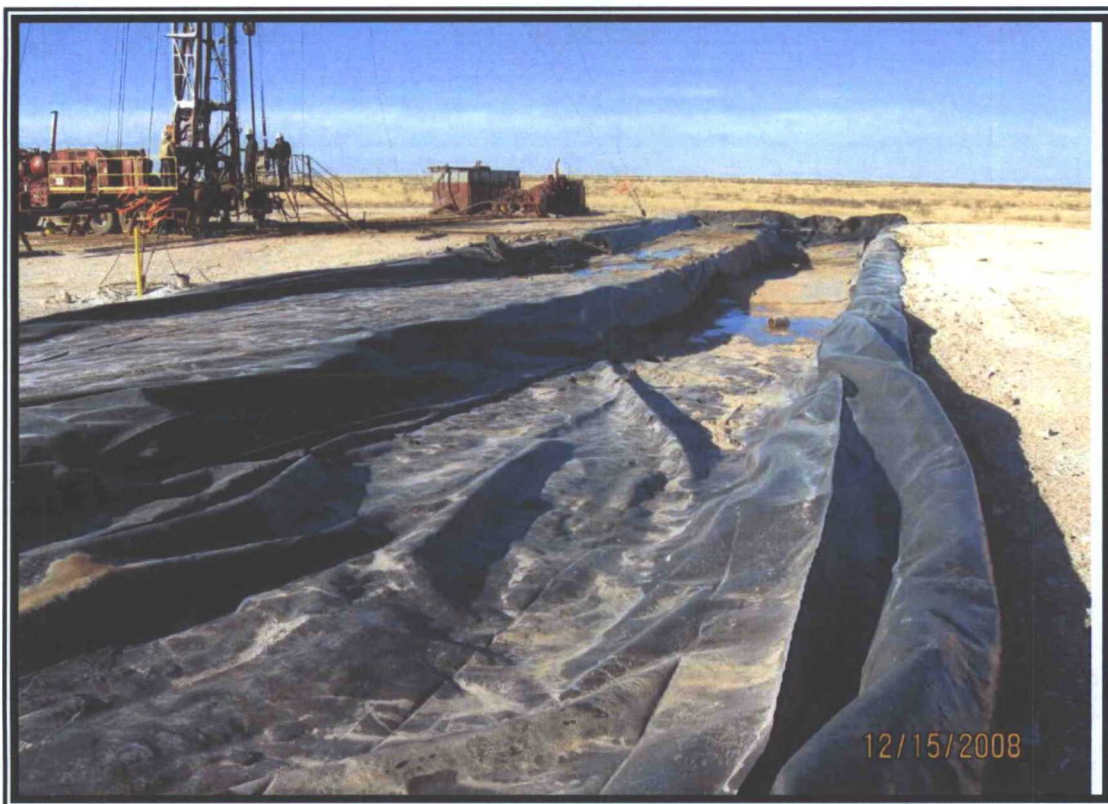
The Hale State #4 was drilled using a closed-loop mud system. The drilling contractor placed roll-off boxes in a two-tier trench to accumulate drill solids. After the rig was removed from the site, some drilling fluids and soil residuals were observed in the trenches. Visual inspection found several penetrations of the liner. After the liner was removed (see Photo #1), initial sampling found chloride levels ranging from 56,000 mg/kg (upper NE trench) to 1820 mg/kg (upper SW trench) and TPH levels ranged from 1,010 ppm (Upper C trench) to below action levels. The initial form C-141 was submitted to NMOCD on March 11, 2009.

#1 Initial View -- Upper and Lower Trenches

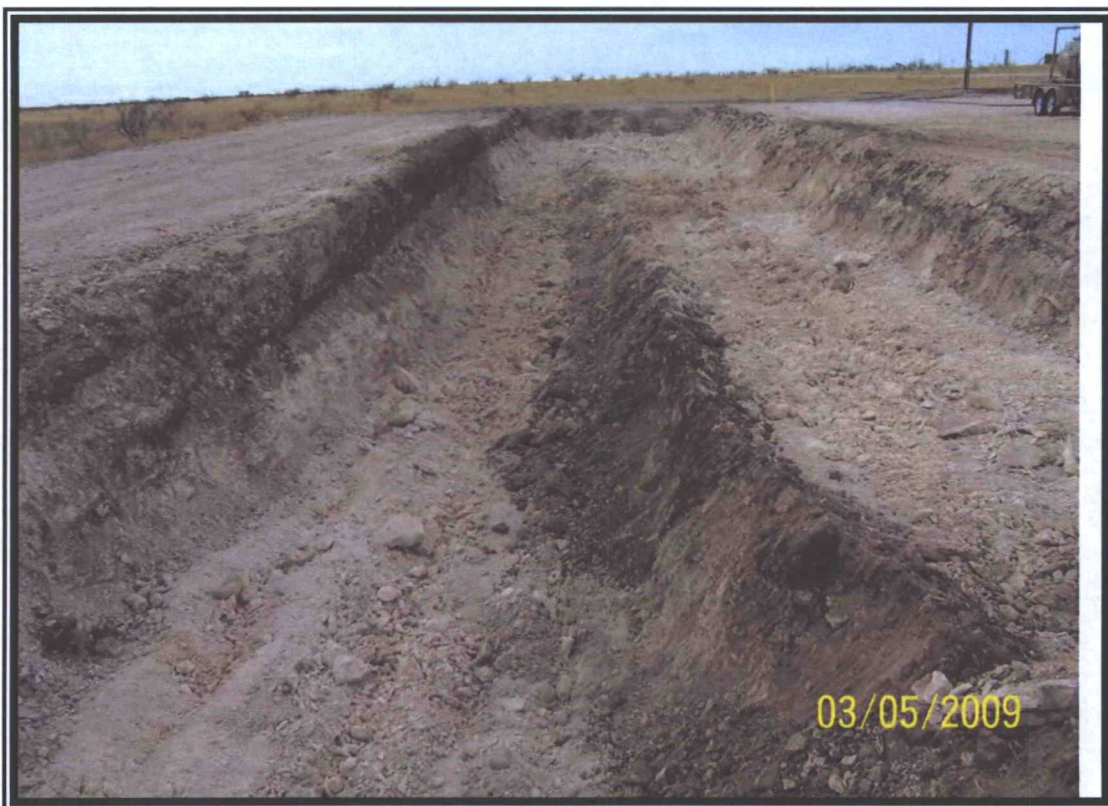
#2 Excavation in progress

About 1092 cubic yards of impacted soils were excavated and staged onto plastic prior to being manifested offsite. Soils were sampled at various depth intervals to evaluate the progress of the remediation (see Photo #2). Excavation was terminated when chloride concentrations were below action levels (see Photo #3). The excavation was backfilled with new soil that had been stockpiled at other sites. Soil was added in lifts and compacted to bring the excavation area to grade (see Photo #4). Final form C-141 has been prepared and is attached.

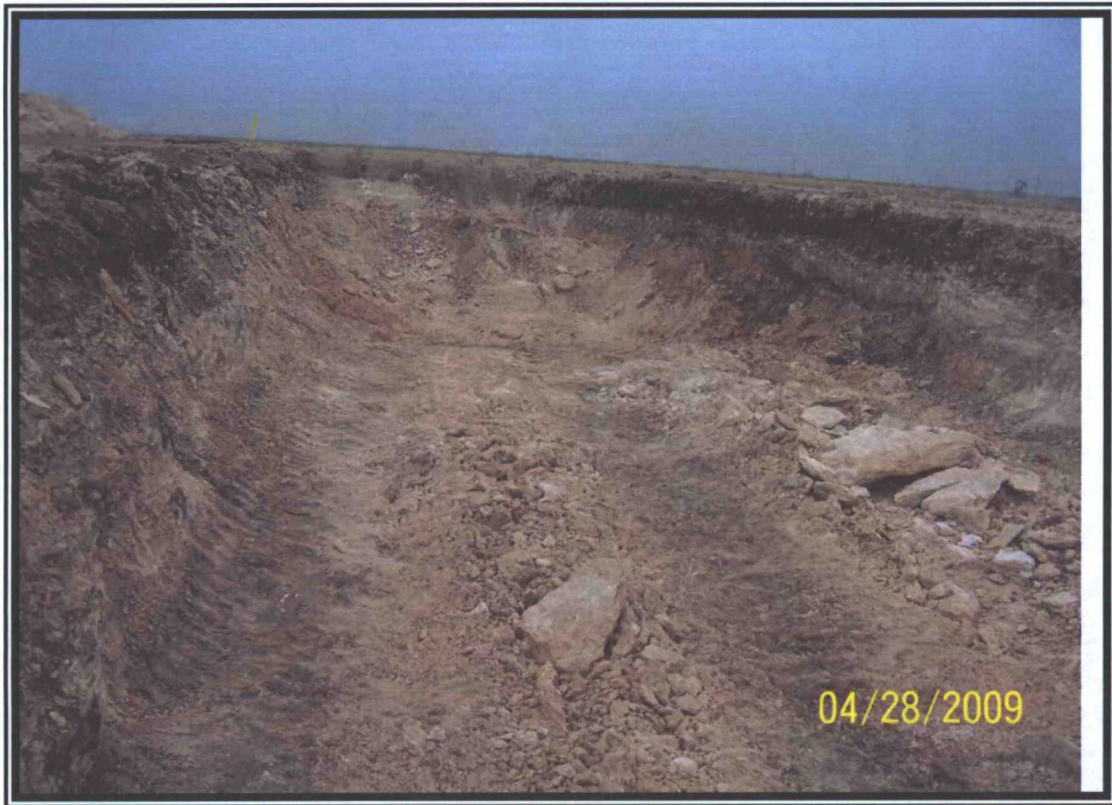
#3 Excavation completed

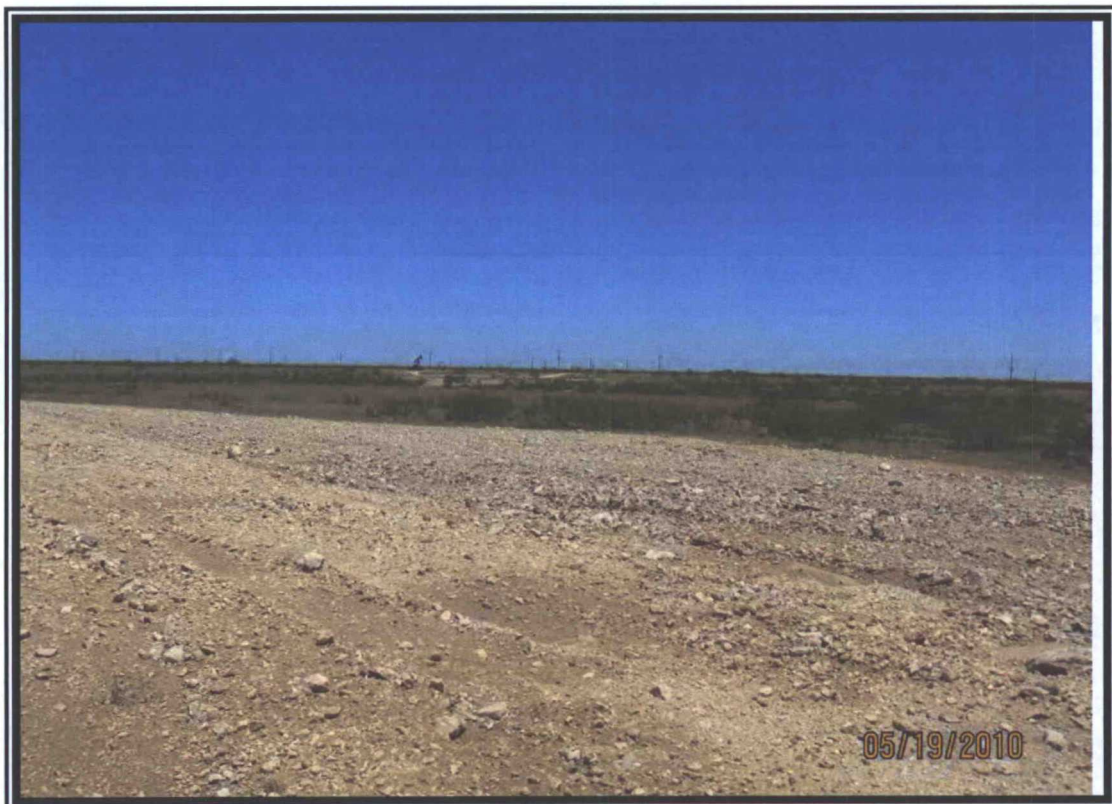
#4 Site After Backfilling.
