1RP-2610
NMSWD JENKINS STA. 13 N. LEAK
PROTOCOL 152

Release Notification and Corrective Action

**Remediation and Site Restoration Protocol
New Mexico Salt Water Disposal Jenkins Sta. 13 N. Leak
1RP - 2610**

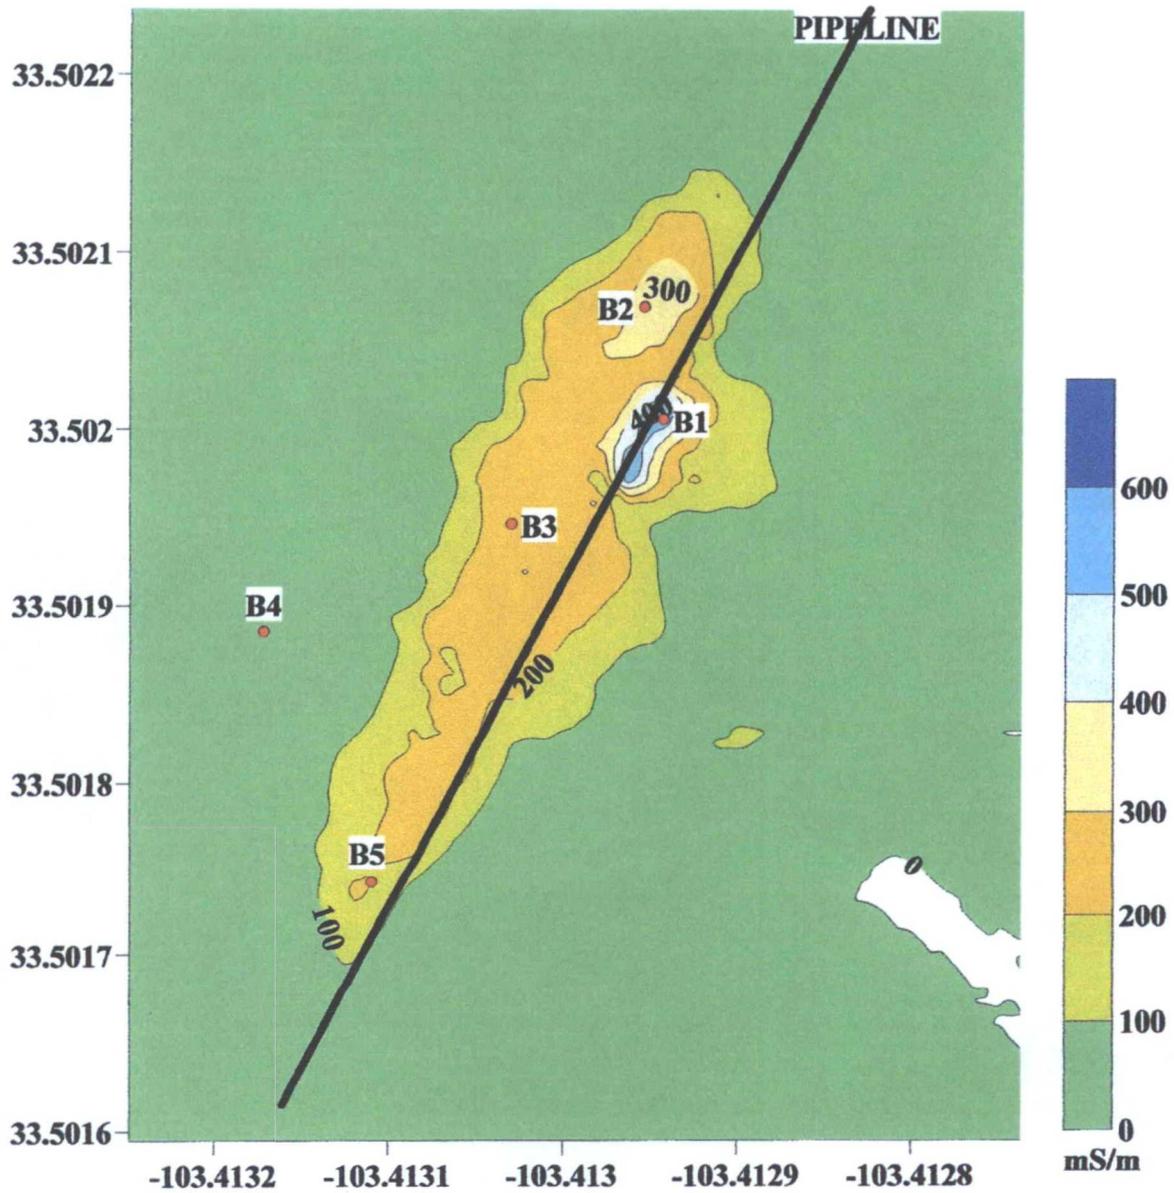
NMSWD JENKINS STA. 13 N. LEAK
UL/I SEC 25S - T9S - R34E
INACTIVE WINDMILL STOCK 1019' NE OF LEAK
EM38 SURVEY AREA 0.84 acre
