Re: Work plan approval letter
Keel B #39 Flowline leak sec. 6-17s-31e.

**Merit Energy
Keel B # 39 Flowline Leak
Work Plan
Section 6, Township 17S, Range 31E
Eddy County, New Mexico**

February 12, 2004

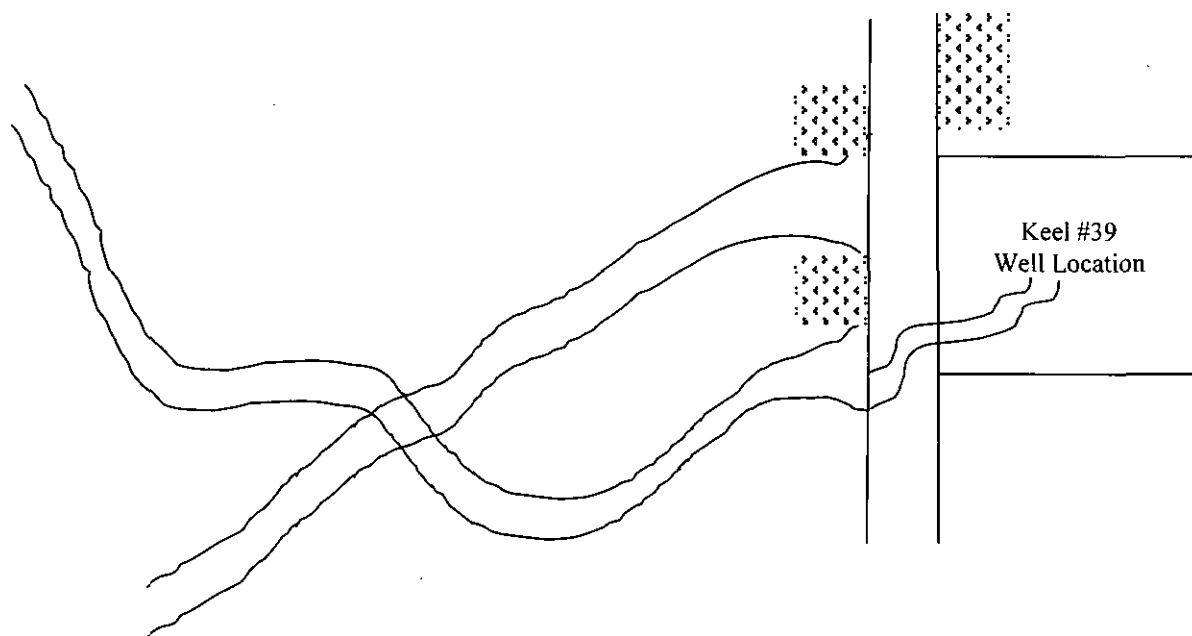
Figure 2
Site Plan

The suspected contaminant is produced water and crude oil which was being transported in the flowline. The release was basically contained in the arroyo and is only approximately 3 to 4 feet in width and approximately ¼ mile in length. The affected area is stained with hydrocarbon. (Site Plan)

The subject site is in the bottom of an arroyo. Any major excavation of this arroyo will cause more severe erosion in the area. As an alternative to total excavation and removal, SESI proposes to till the bottom of the arroyo with a small tractor. The pooling

areas will be excavated to bring all of the highly saturated soils to the surface where they will be tilled with the other soil in the bottom of the arroyo. Upon completion of the tilling, the bottom of the arroyo will be sprayed with Micro Blaze and allowed to naturally attenuate.

SESI also proposes that the area, which was contaminated by a slight spray from the leak, be left in place, sprayed with Micro Blaze and allowed to naturally attenuate.
