To: Christine Alderman, Bob Jennings, Terry Ainsworth
From: Bob Allen
Subject: Cimarex Cottonwood Draw 22 Federal Com #1

**Cimarex Energy Company
Cottonwood Draw 22 Federal Com #1
Delineation Report-2 and Work Plan**

Eddy County, New Mexico

June 15, 2012

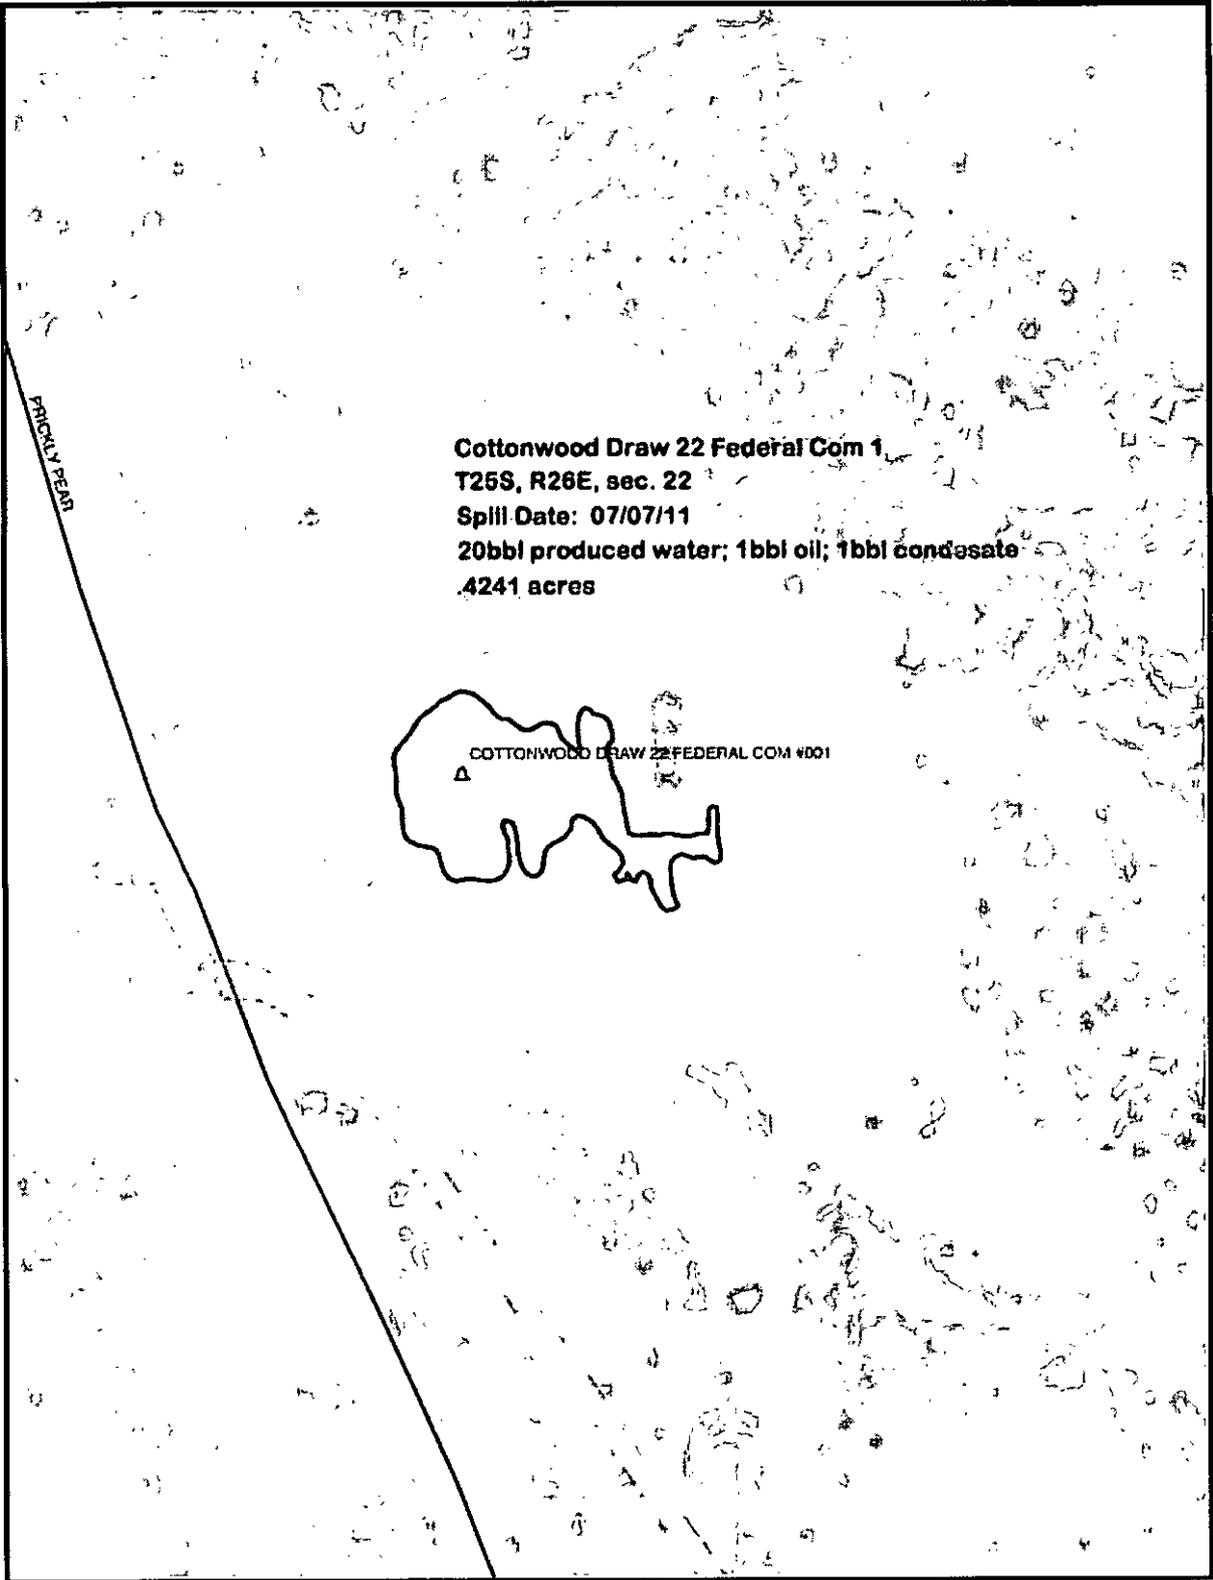
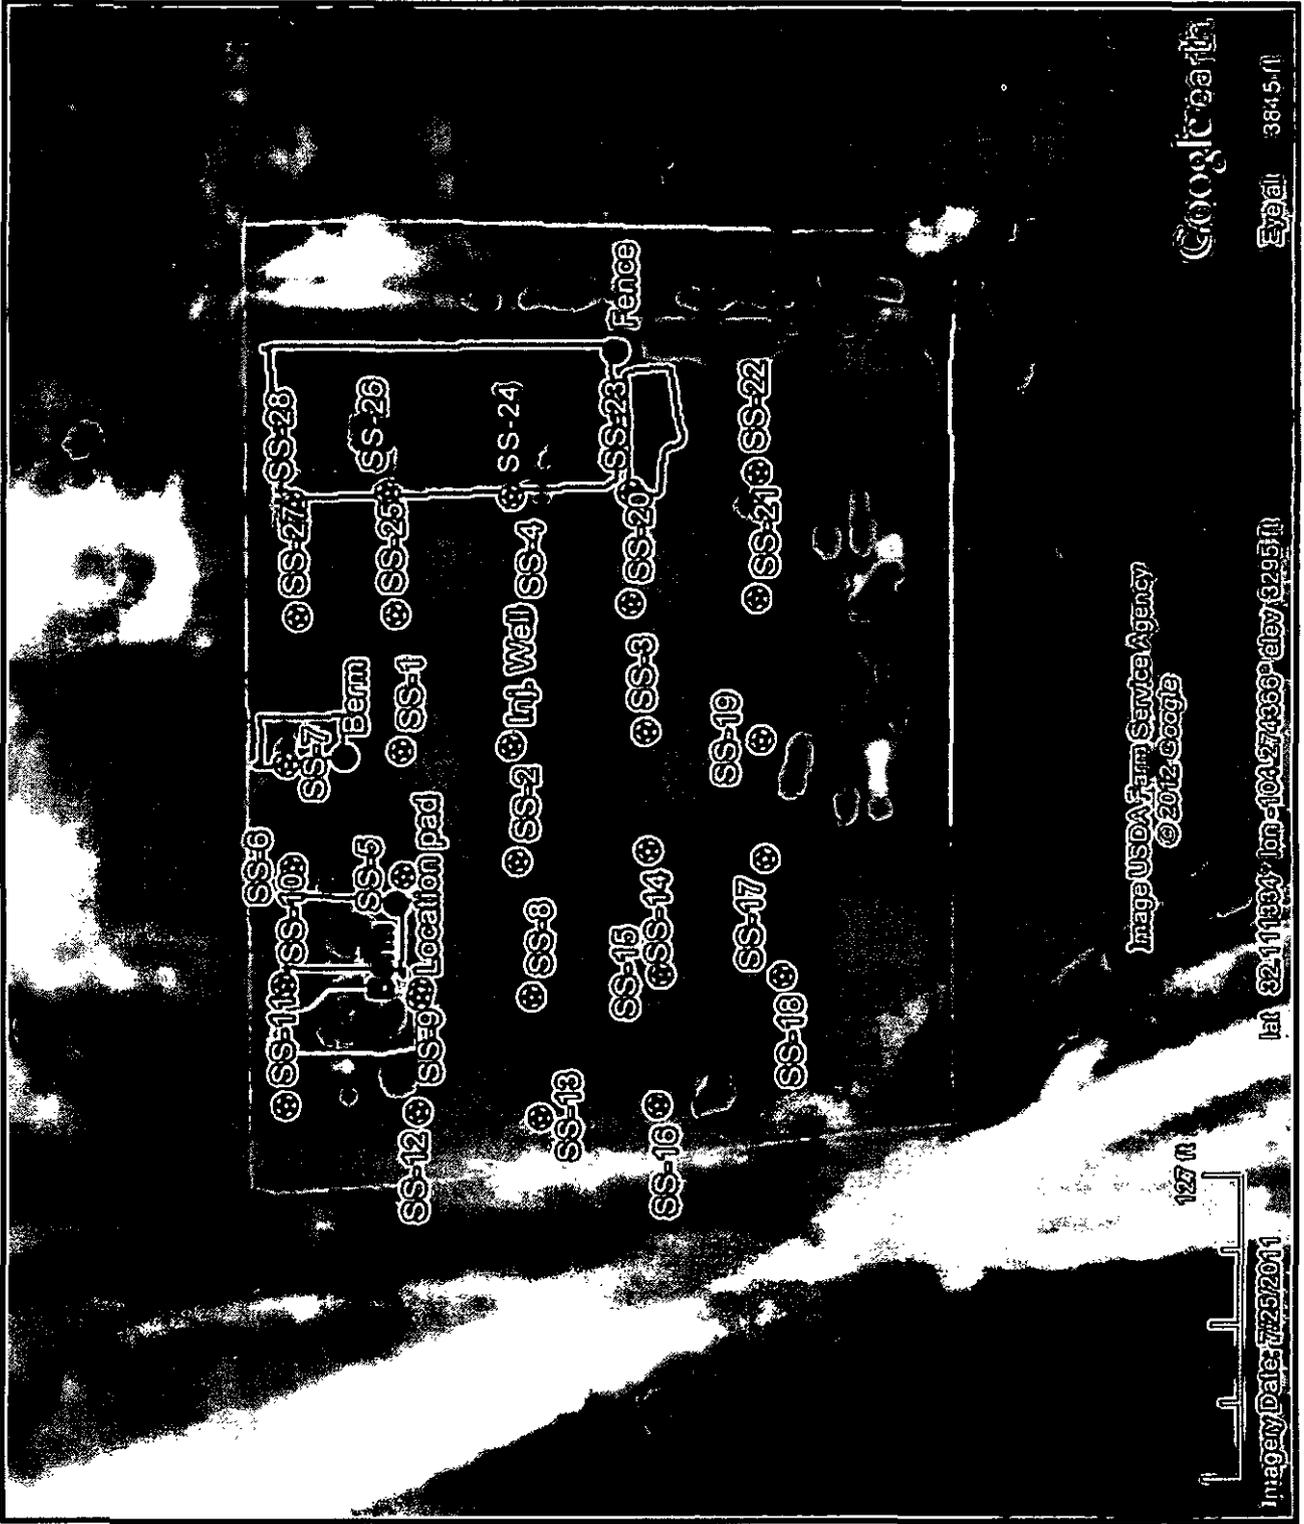
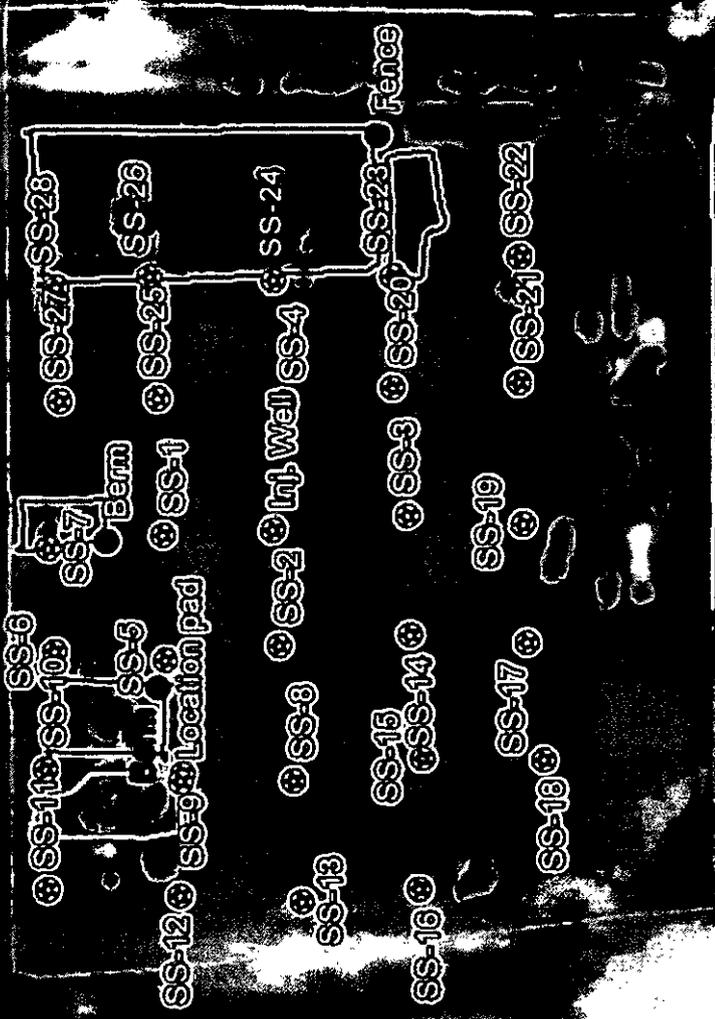
**Figure 2
Site Plan**

Cottonwood Draw 22 Federal Com 1
T26S, R26E, sec. 22
Spill Date: 07/07/11
20bbl produced water; 1bbl oil; 1bbl condensate
.4241 acres

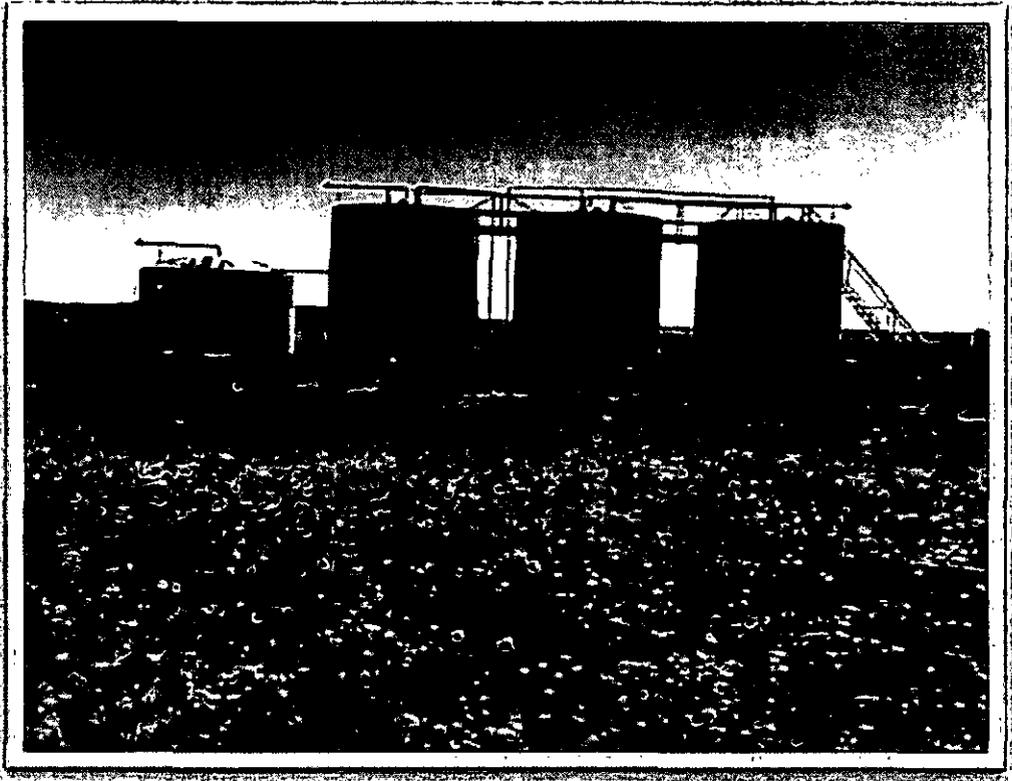
Tanks east of location facing east
