FASKEN OIL & RANCH LTD

**Fasken Oil and Ranch, LTD.
Denton SWD #5
Delineation Report/Workplan
Unit N, Section 2, Township 15S, Range 37E
Lea County, New Mexico**

December 22, 2008

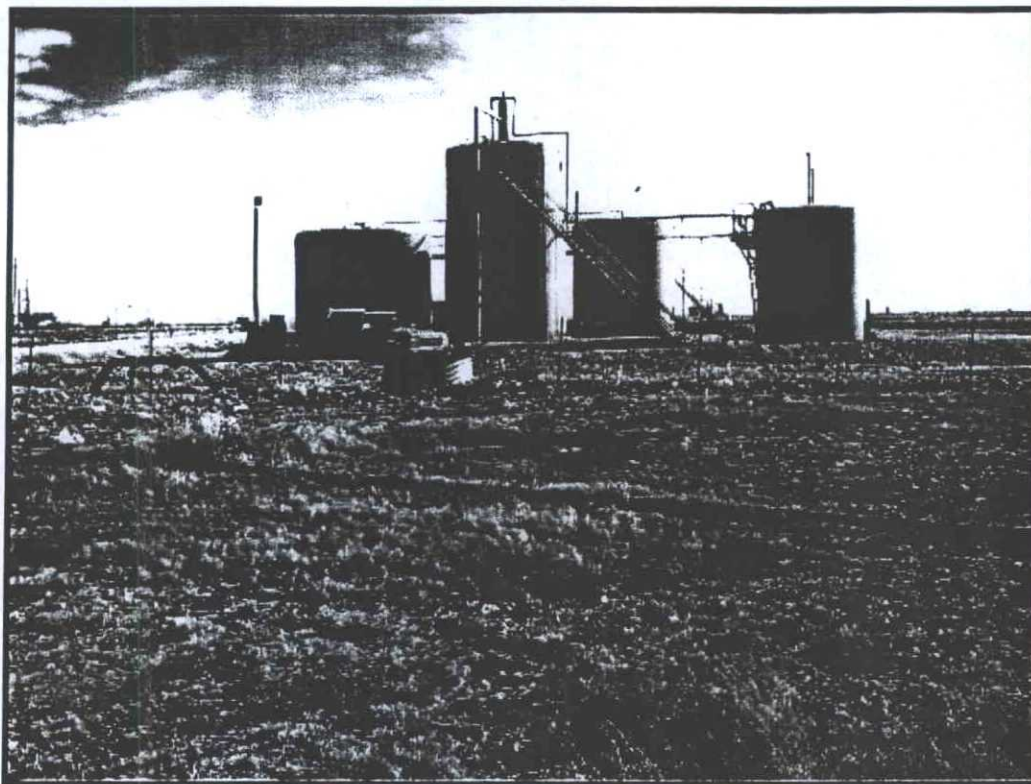
Release area facing east

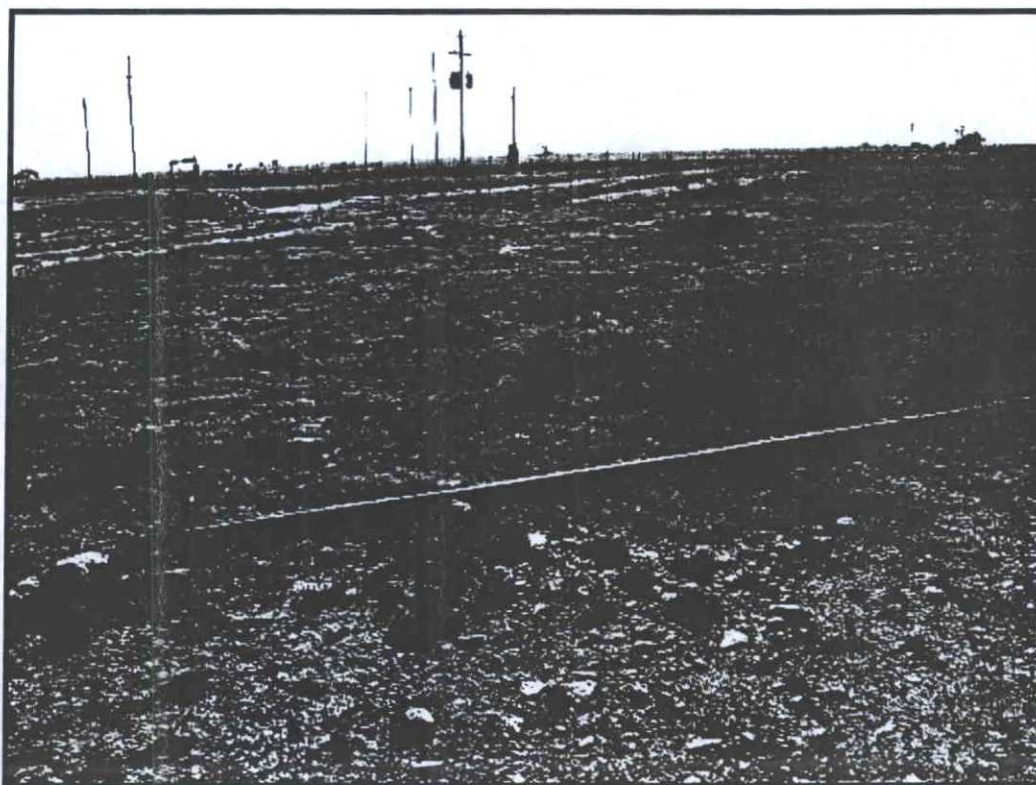
Release area facing southeast

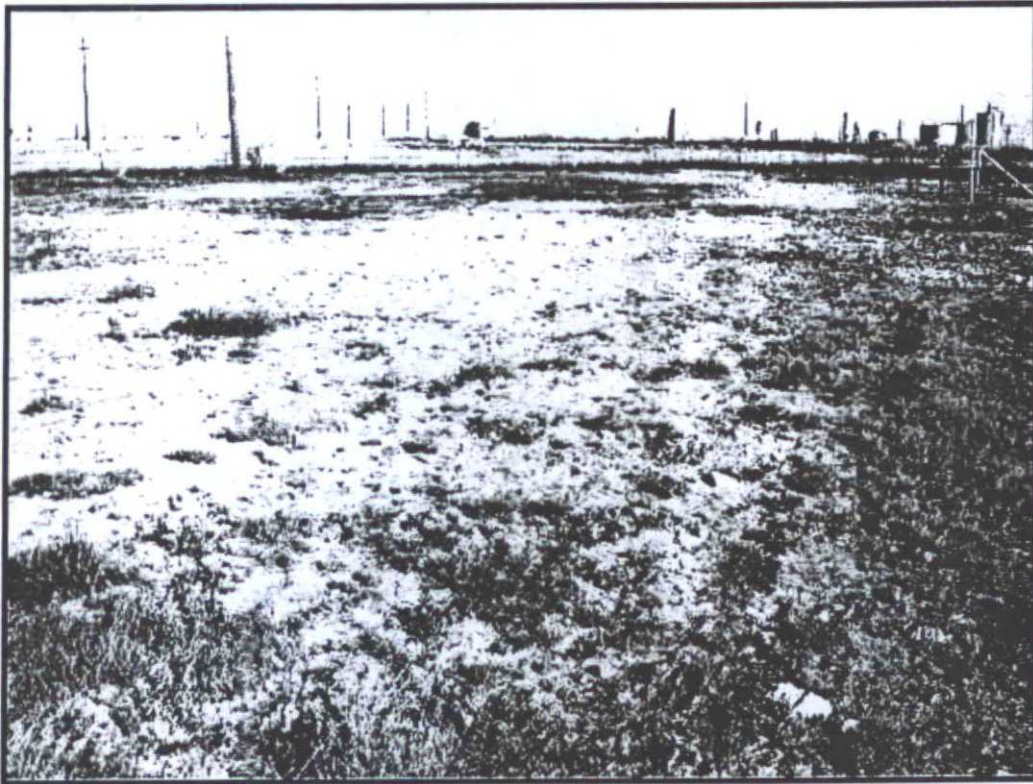
Release area facing north

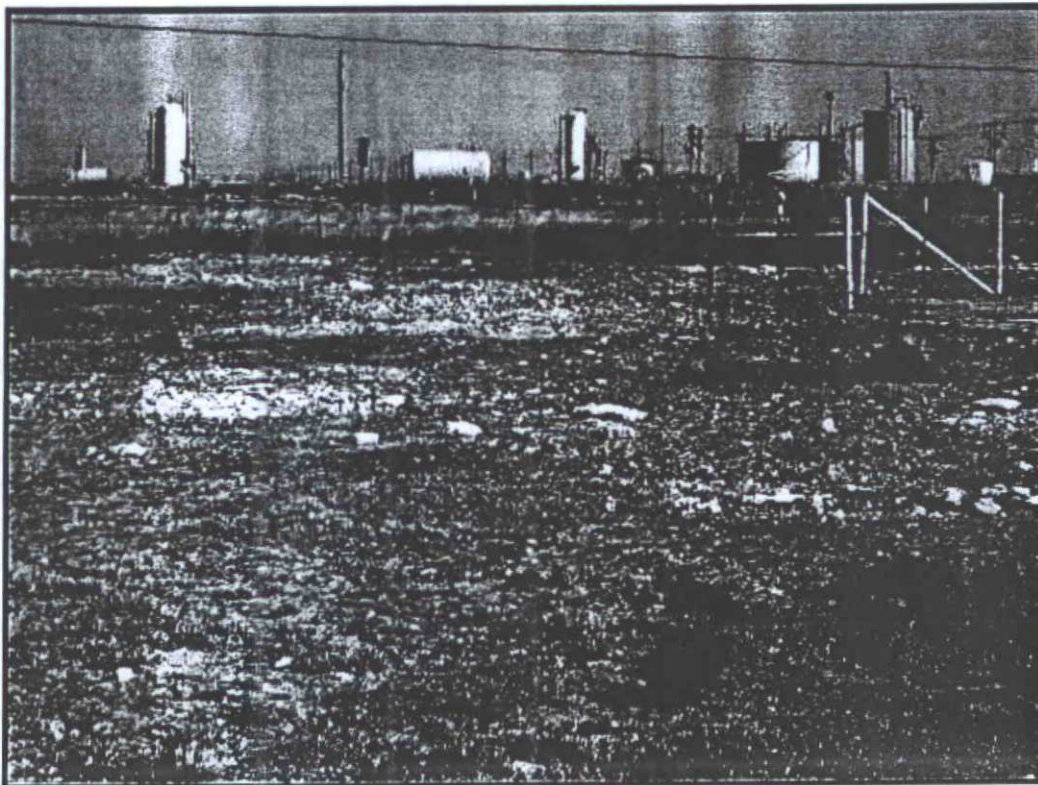
Release area facing northeast

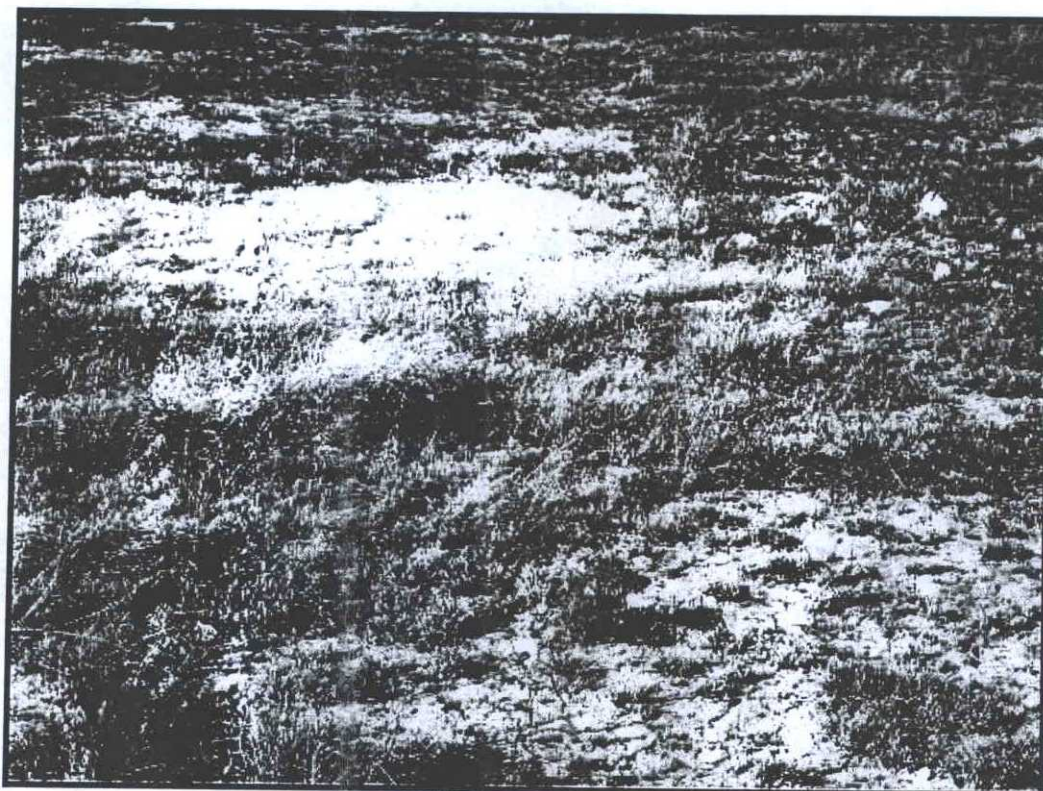
Middle of release area

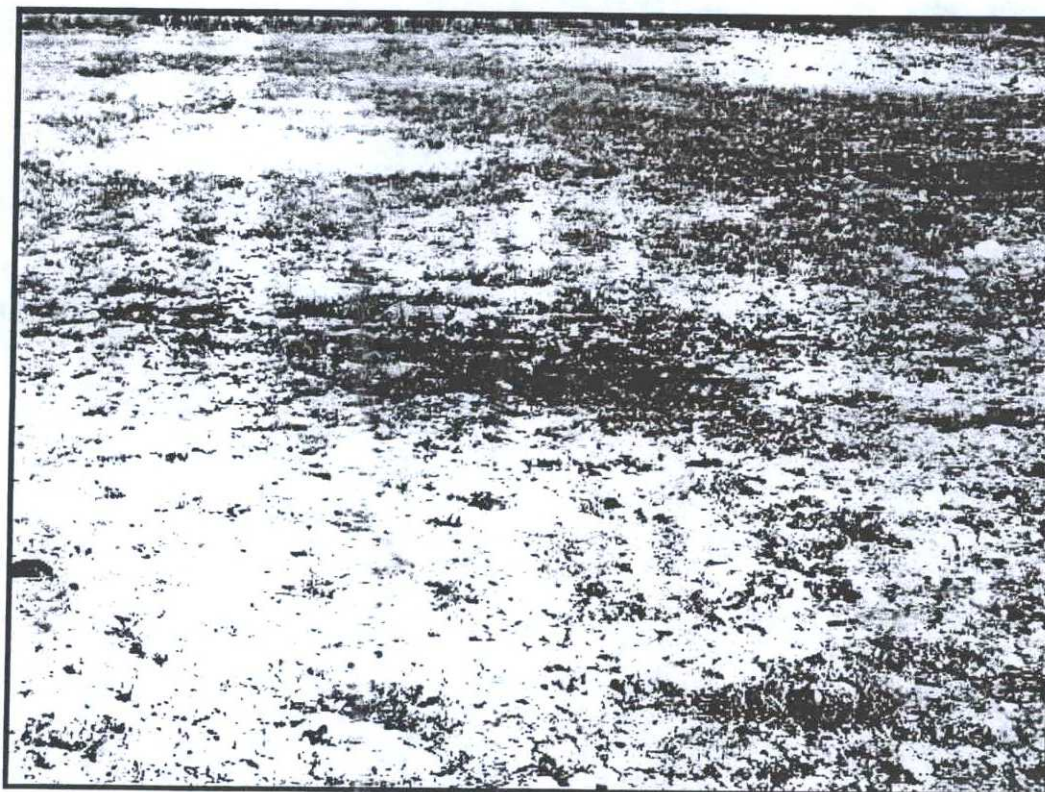
Staining in the middle of release area

It is requested that the top 3' of soil be excavated from the spill area and transported to an NMOCD approved facility for disposal. The excavation will be lined with a 40-mil impervious liner and backfilled with clean soils. The area will be contoured to natural grade and reseeded in the next growing period.

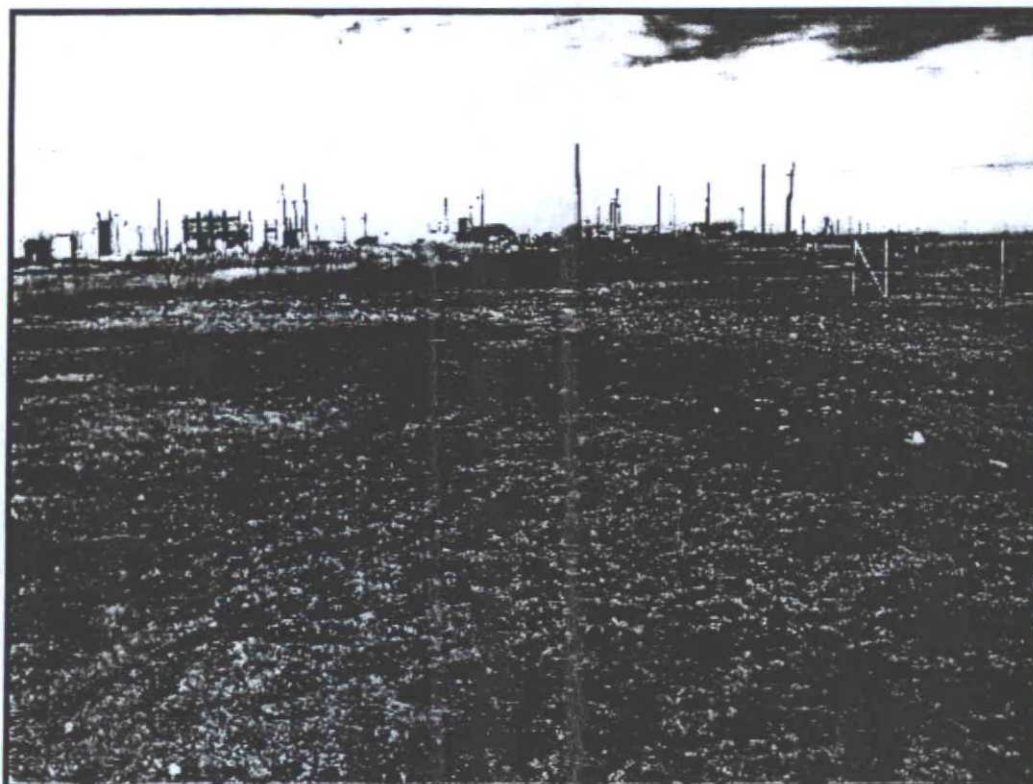
Release area facing northeast
