Release Notification and Corrective Action

Name of Company: El Paso Natural Gas Company, LLC (a Kinder Morgan owned company) 7046	Contact Sheila Castellano
Address: approximately 1.5 miles south of HW404 and 1.1 miles west of CR213(War Road)	Telephone No. (719) 520-3719
Facility Name: El Paso Natural Gas Company Line No. 1100	Facility Type 26-inch Natural Gas Pipeline
Surface Owner: Bureau of Land Management	Mineral Owner: BLM
API No.

2RP-4252

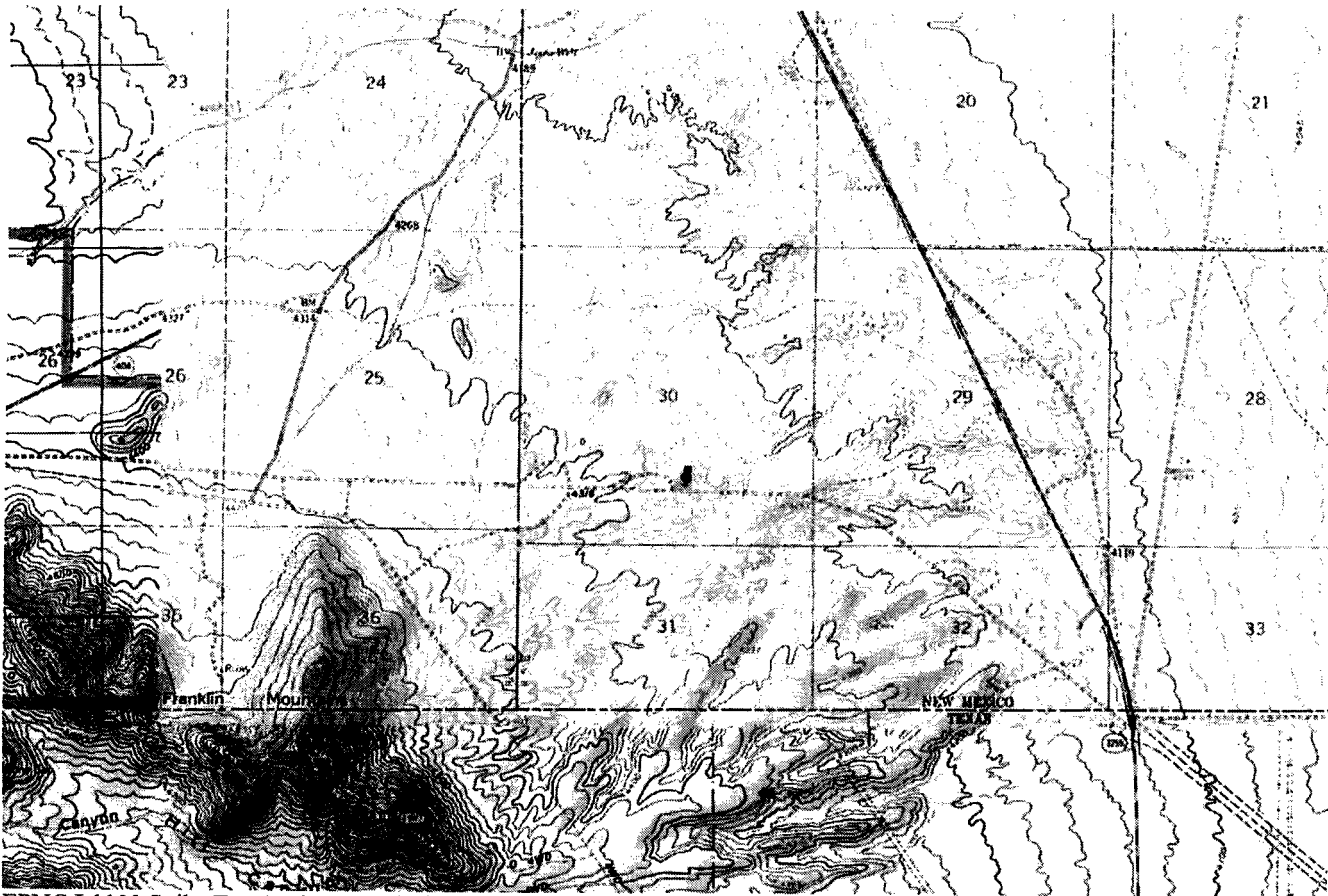
The inadvertent release of hydrostatic test water was fully contained on the right of way, within the open trench below the test manifold, measuring approximately 100-ft long x 10-ft wide x 6-ft deep. Analysis results are pending.

EPNG L1100 Spike Test Project_Manifold 5-6. Location of hydrostatic test water release.

EPNG was conducting a hydrostatic spike test of the existing L1100. During transfer of test water from one test section into the next, a valve in the test manifold was opened to release the air pressure as the pig entered the test manifold. Hydrostatic test water was inadvertently discharged into the open trench below. A sample of the hydrostatic test water was collected for analysis. All hydrostatic water discharged into the trench (bellhole) was collected and will be disposed of accordingly. A soil sample was collected from the location after all discharged material had been taken from the site.

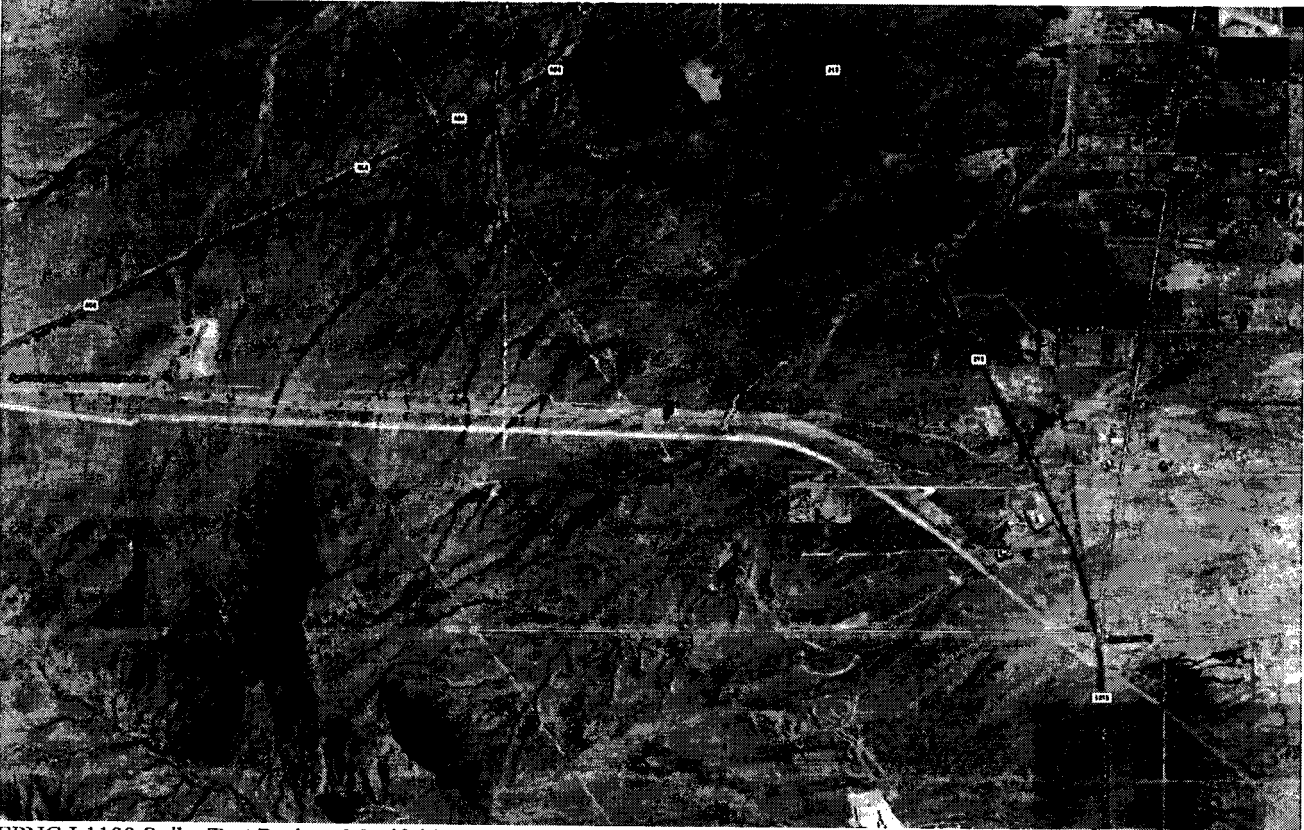
EPNG L1100 Spike Test Project_Manifold 5-6. Location of hydrostatic test water release.
