Closure Report

API# 30025 305920000

2RP-1035

Saber Resources
F M Hollyway S W D # 1

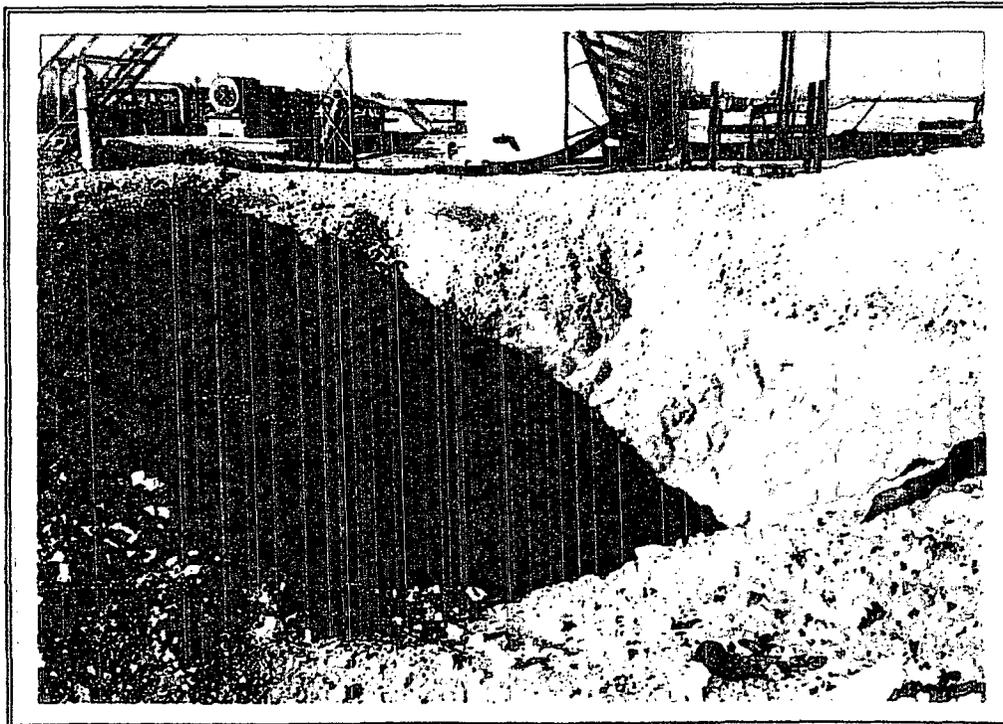
40. F.M. Holloway #1 SWD Facility - trench open hole at southwest corner of diked spill area.

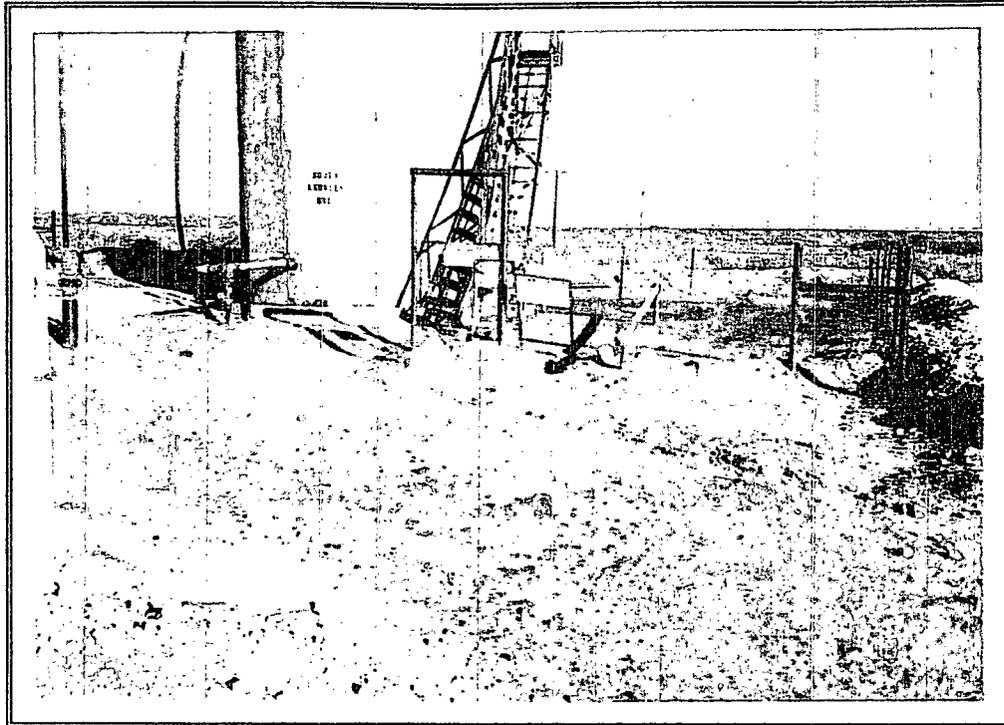
37. F.M. Holloway #1 SWD Facility - spills at facility.

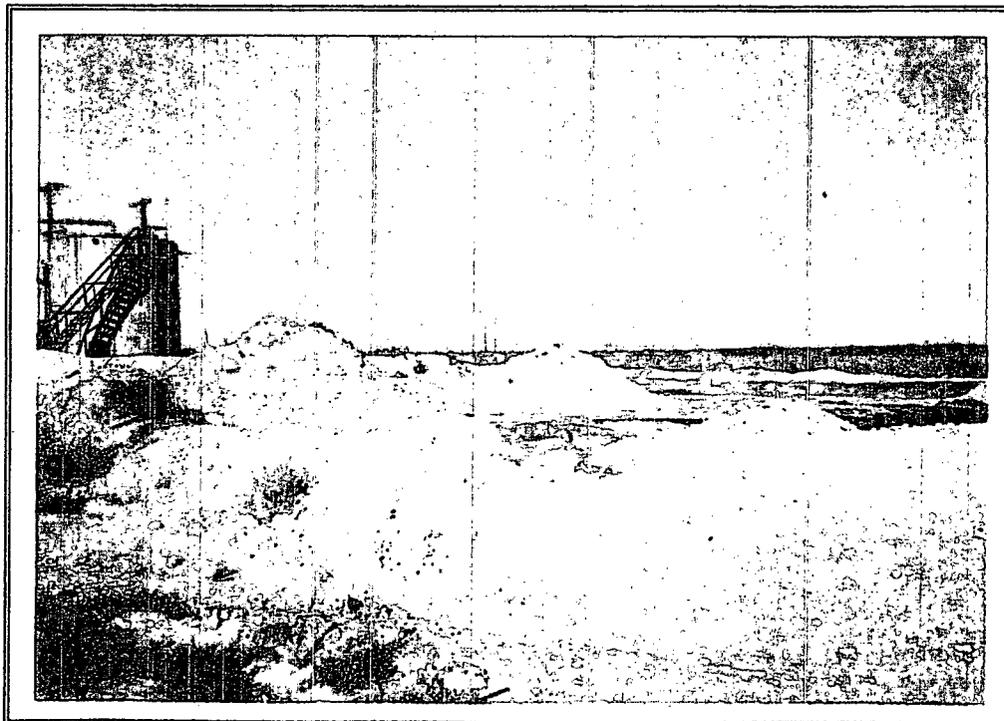
38. F.M. Holloway #1 SWD Facility - diked spill area, east of facility.

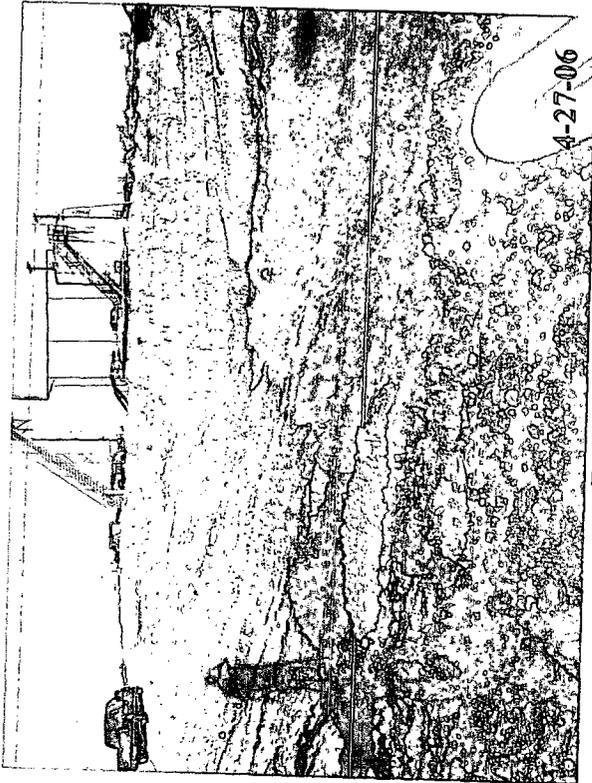
East to West Excavation

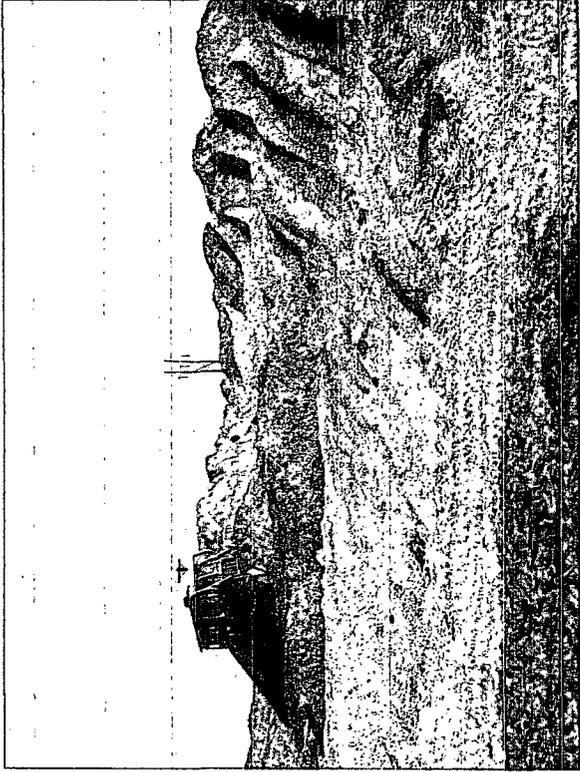
Blending Spoil Pile

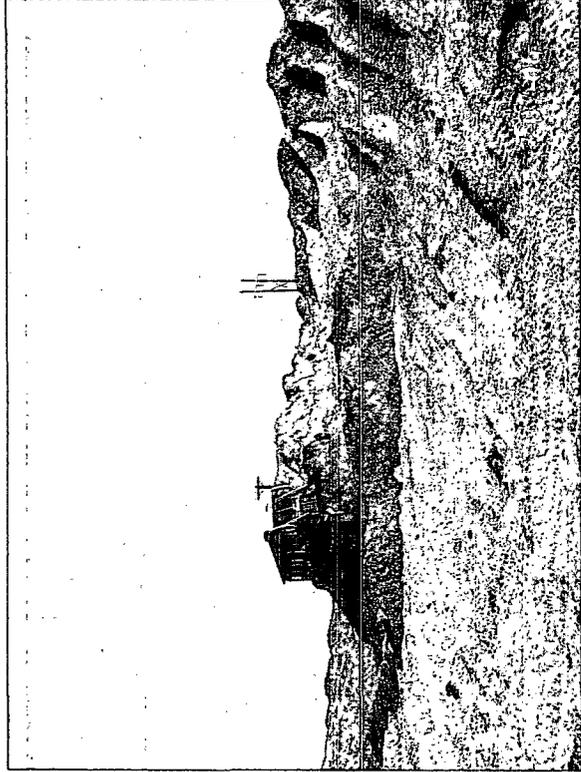
Blending Spoil Pile

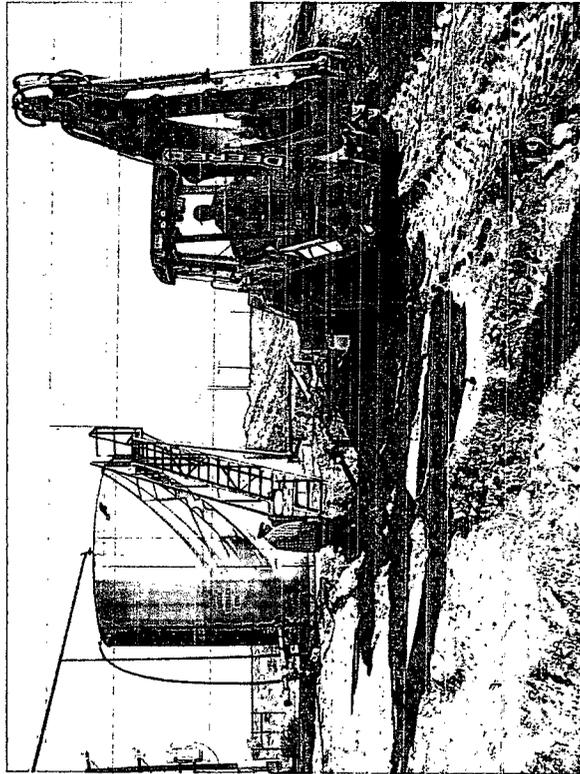
Backfilling Tank Battery
