### Release Notification and Corrective Action

Name of Company Occidental Permian Limited Partnership	Contact Steven M. Bishop
Address 1017 West Stanolind Road, Hobbs, N.M. 88240	Telephone No. (505) 397-8251
Facility Name South Hobbs Unit #33	Facility Type Production

RE: Remediation Plan  
South Hobbs Unit #33 3" Steel Injection Line  
UL 'G', Sec. 4, T-19-S, R-38-E

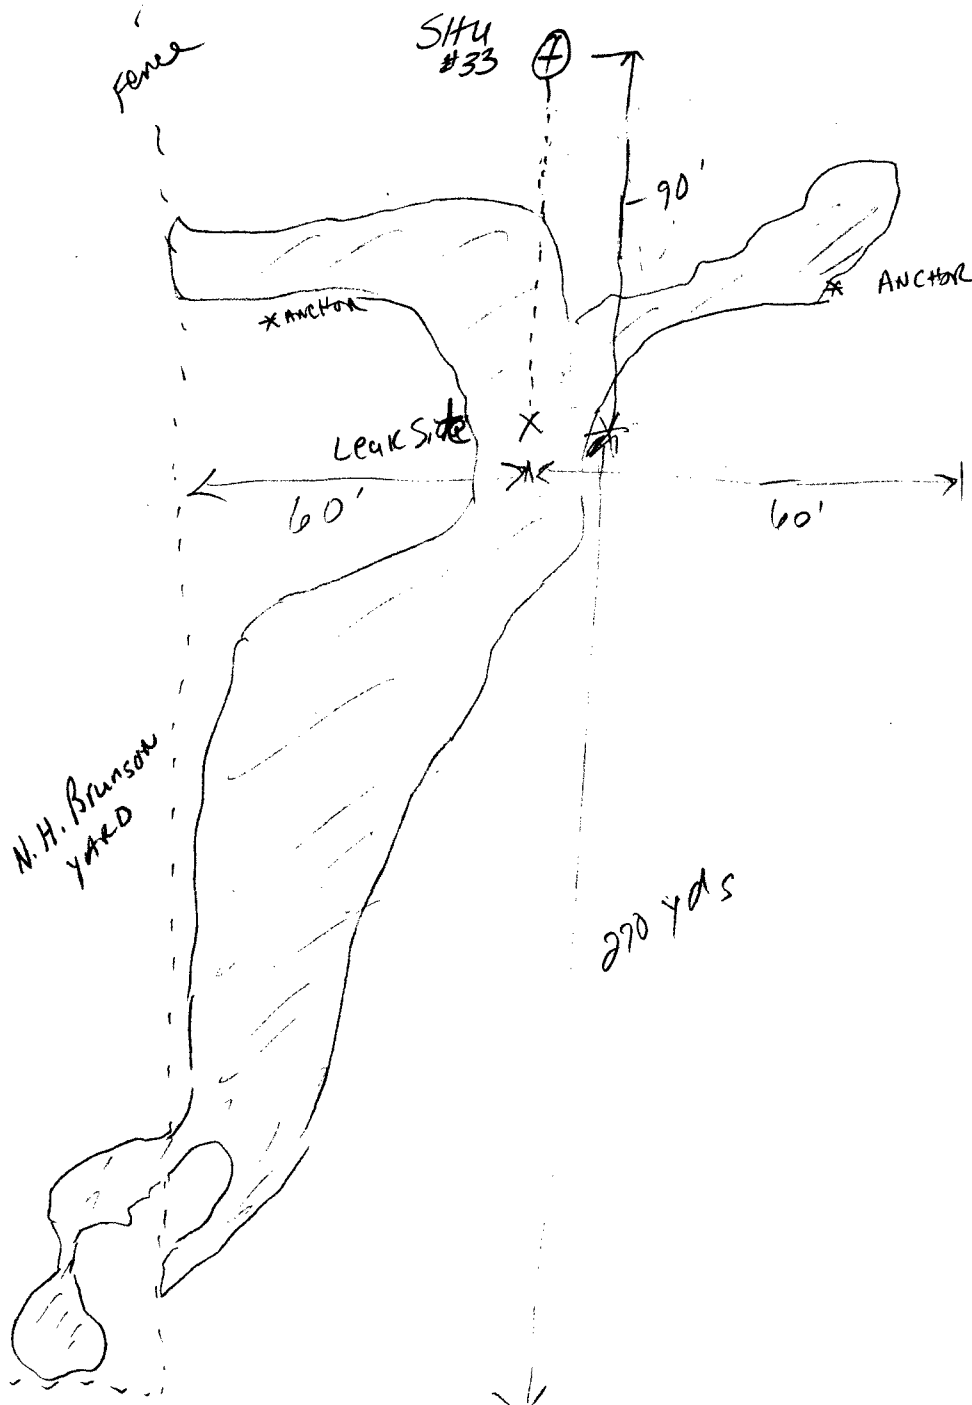
## SPILL MAP

2/26/07 PLEASE DRAW SKETCH OF SPILL AND INDICATE WHERE SPILL ORIGINATED.  
12:00 Noon

416 G' Sec 4 T-19-S R-38-E INJECTION WATER Spill

SITU #33 INJECTION LEAK Spill 0 x 35 SW

N 32° 41' 24" W 103° 09' 00" 90" Reco x 21 SW
