RE: Remediation Plan

Turner Tract 2 Central Tank Battery UL 'D', Sec. 10, T-19-S, R-38-E

Release Notification and Corrective Action

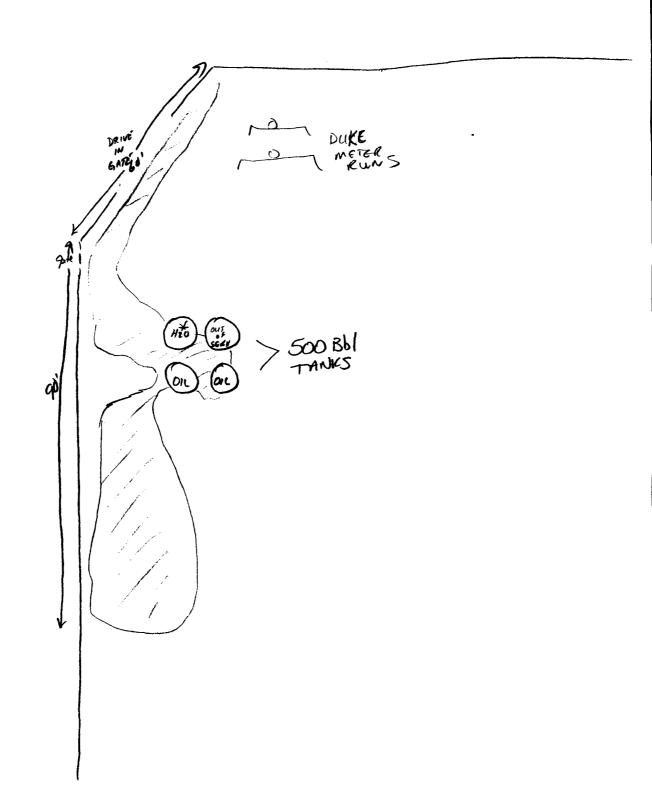
SPILL MAP

PLEASE DRAW SKETCH OF SPILL AND INDICATE WHERE SPILL ORIGINATED.

4/18/07 TURNER TR 2 LEASE

Sp.11 10 80 × 0 BN REC 8 BD × 0 BN

RAN DER WATER THAK
