8 November, 2007

RE: **Remediation Closure Report**
Chesapeake Operating, Inc.
JK Rector Tank Battery
UL-A (NE ¼ of the NE ¼), Section 31, T 21 S, R 36 E
Latitude: 32° 26' 26.51"; Longitude: 103° 18' 00.42"
NMOCD 1RP#1586; EPI Ref. #160282

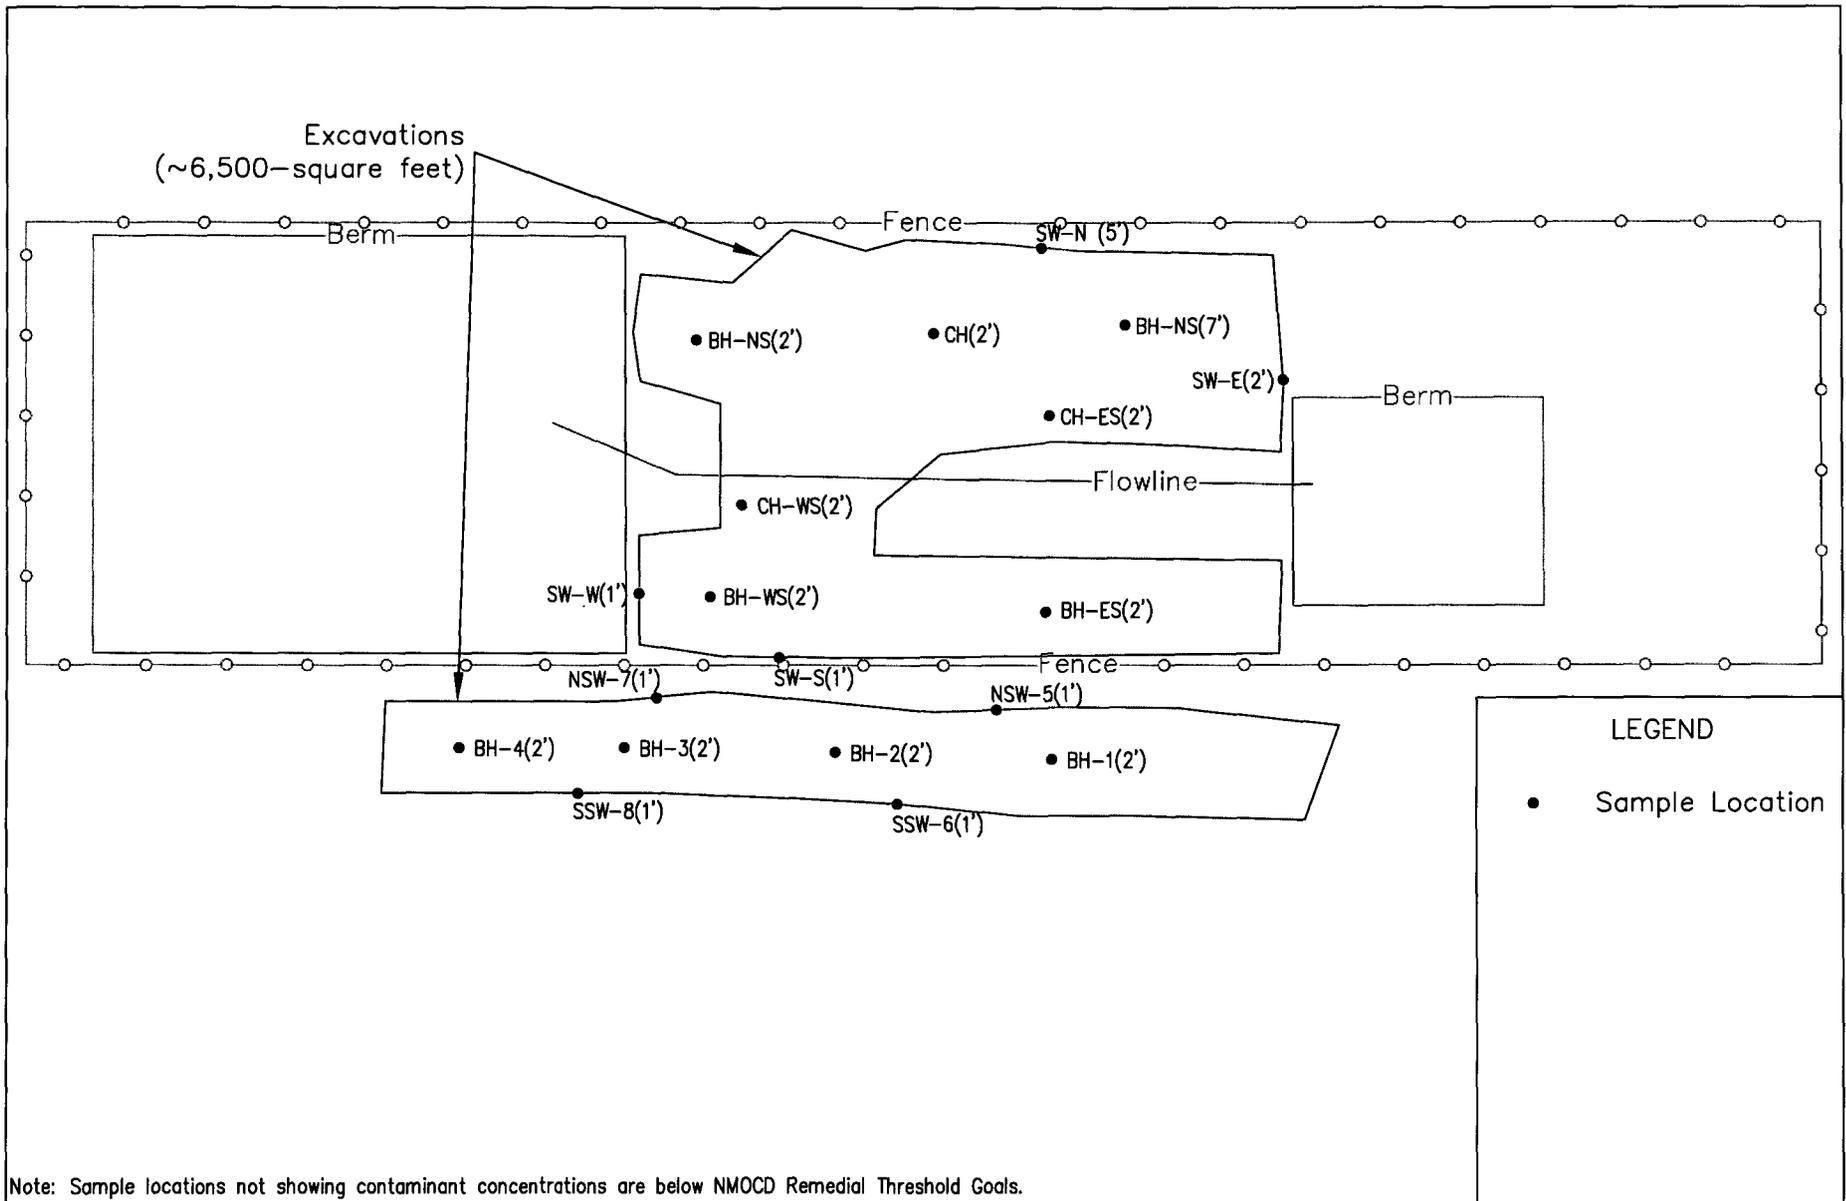
A. **Site Delineation** – Upon discovery of the release, Chesapeake Operating, Inc. contacted EPI for an emergency response team. The emergency response team worked on the release area continuous from September 19, 2007 to September 29, 2007. Standing liquid was solidified and impacted material loaded on plastic barriers. On September 26, 2007 soil samples were collected from the excavation area south of the tank battery perimeter at depths ranging from 1- to 2-ft bgs (reference *Figure 4*).

On September 28, 2007 soil samples were collected from the excavation within the confines of the tank battery perimeter at depths ranging from 1- to 2-ft bgs (reference *Figure 4*). BTEX and TPH constituent concentrations were reported below NMOCD remedial threshold goals of 50mg/Kg and 5,000 mg/Kg, respectively in all sampling events. Similarly, chloride concentrations were reported below remedial goal of 250 mg/Kg for all sampling events (reference *Table 2*).

B. **Remedial Activities** - From September 20, 2007 through September 29, 2007, approximately 1,050 yds³ of impacted soil were excavated from a surface area of 6,500-ft² at depths ranging from 1- to 2-ft bgs. Impacted soil was transported to EPI Landfarm for treatment. Laboratory analysis confirmed removal of impacted soils above NMOCD remedial goals in sidewalls and bottom of excavations. From October 18, 2007 through October 22, 2007, the excavations were backfilled with a combination of caliche (~578 yds³) and topsoil (~324 yds³) purchased from a pit located on the Dasco Cattle Company property. The disturbed areas were contoured to allow natural drainage.

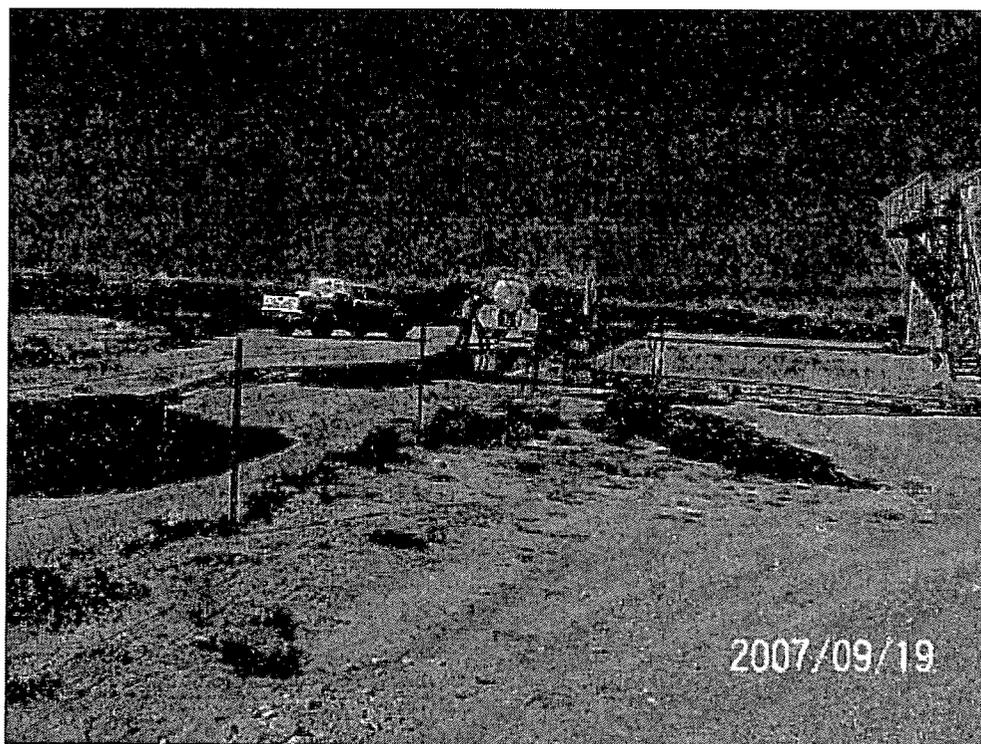
Photograph No. 2 – Looking westerly across release area.

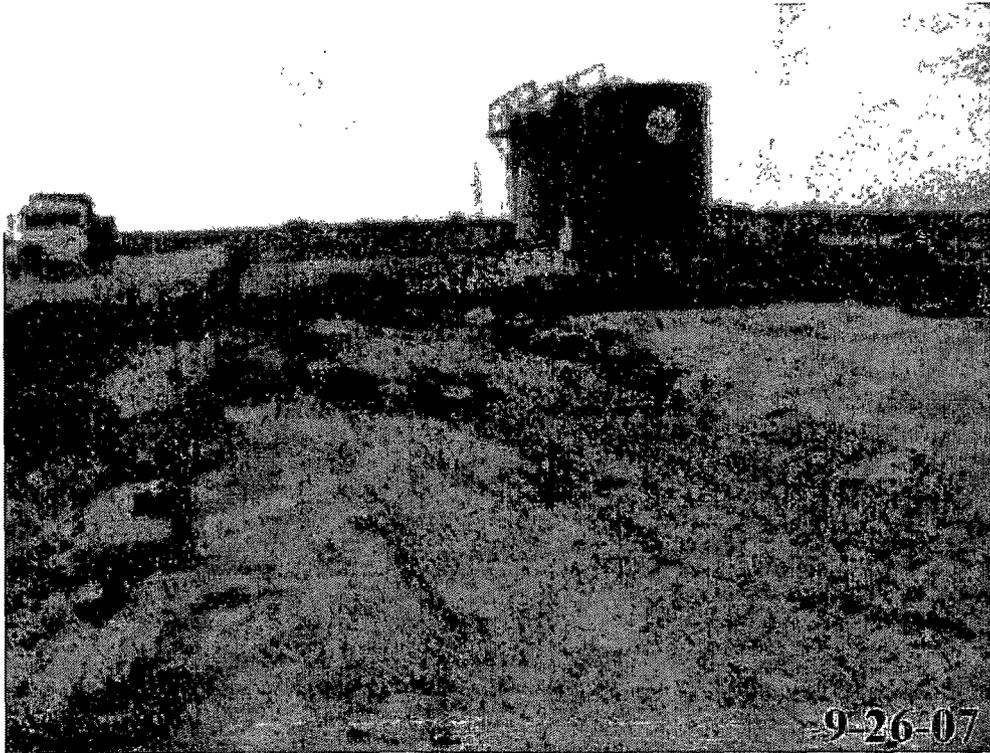
Photograph No. 5 – Looking northwesterly across excavation area.

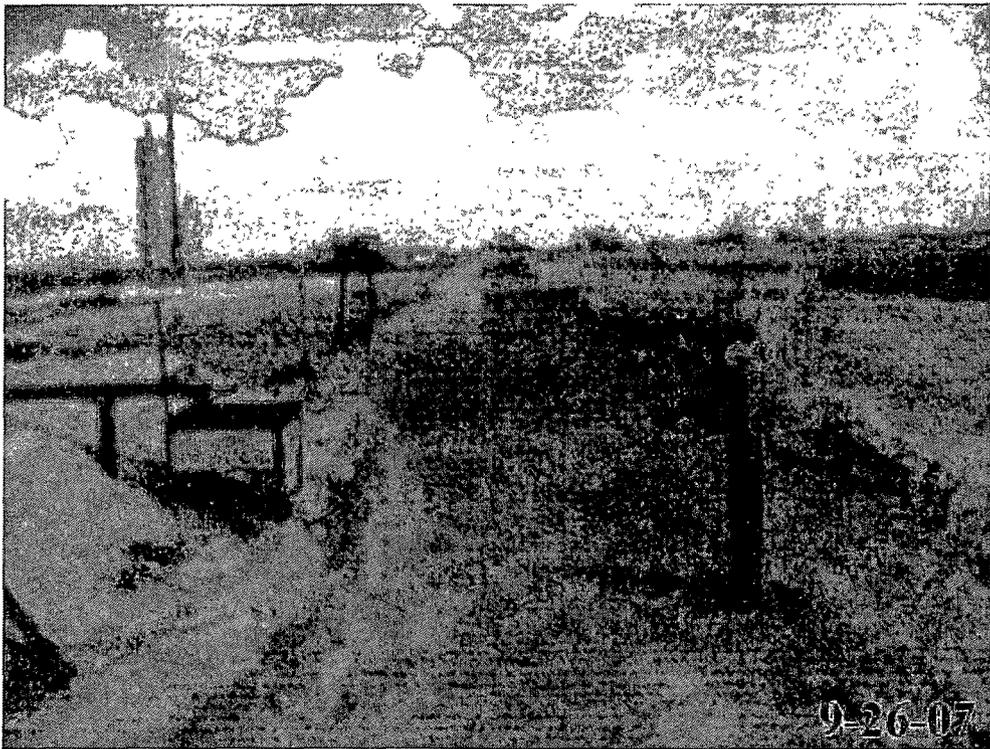
Photograph No. 6 – Looking easterly across excavation area.

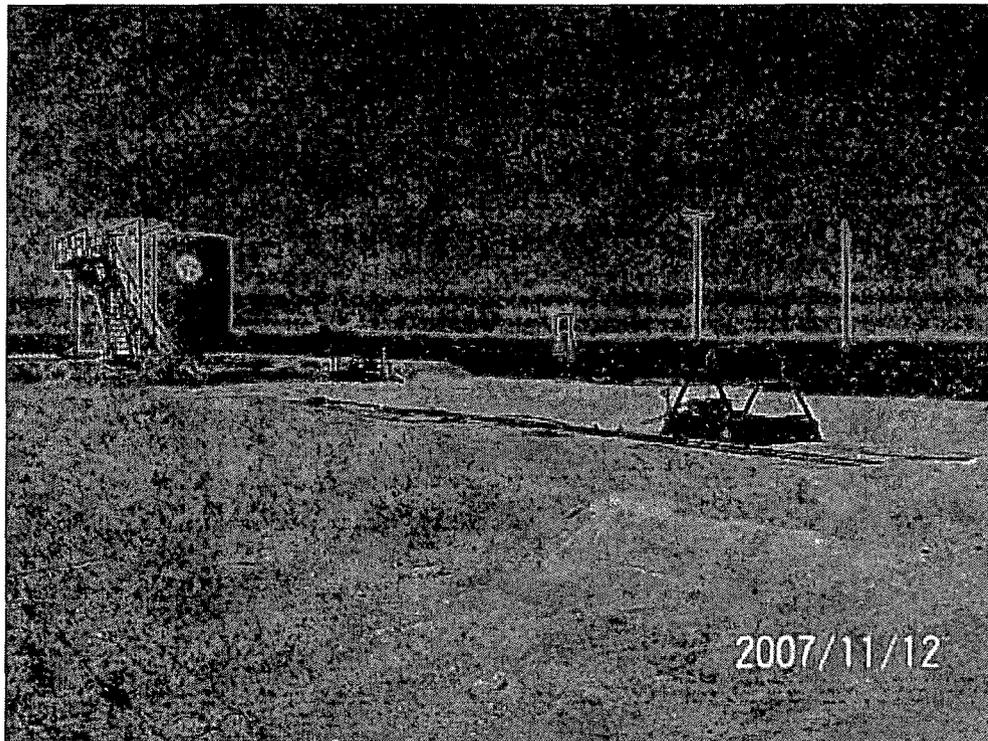
Photograph No. 8 – Looking westerly across remediated site.
