Pit or Below-Grade Tank Registration or Closure

**Re: Remediation and Reclamation Workplan
Chevron Marquardt Federal #3
Unit Letter K, Section 12, T25S, R26E
Eddy County, New Mexico
Lat. N 32° 08.526', Long. W 104° 14.974'**

**Re: Remediation and Reclamation Workplan
Marquardt Federal #3
Unit Letter K, Section 12, T25S, R26E
Eddy County, New Mexico
Lat. N 32° 08.526', Long. W 104° 14.974'**

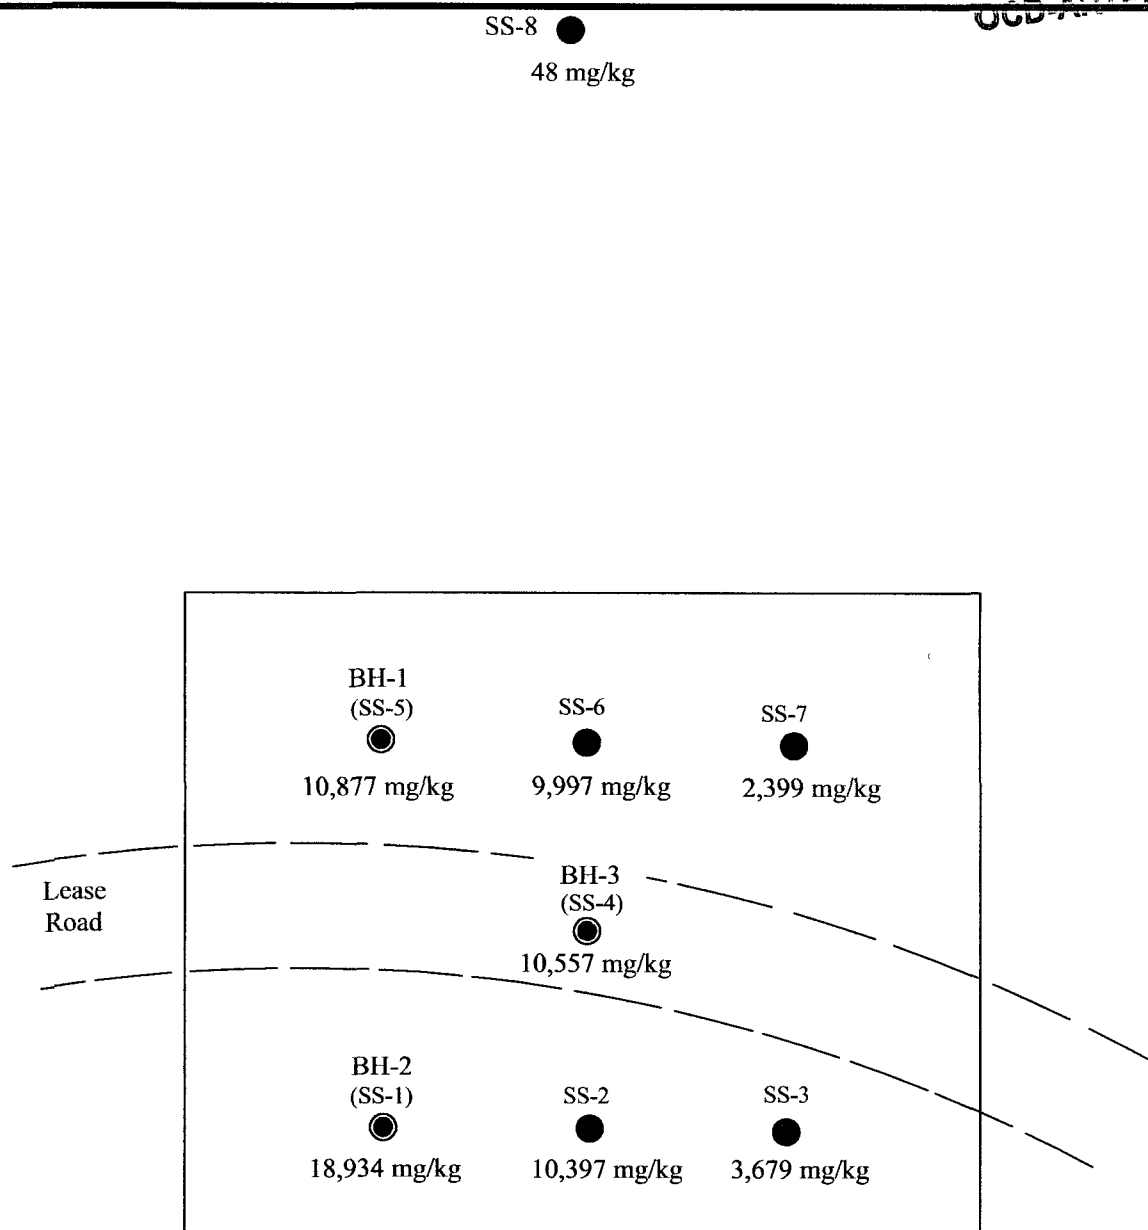
FIGURE # 2

On July 31, 2007, Ocotillo collected soil samples (SS-1 through SS-7) at the site from seven (7) locations at a depth of 0 to 6 inches below ground surface (bgs). A background surface sample (SS-8) was also collected, approximately 185 feet north of the site. The soil samples were placed in clean glass jars and submitted under chain of custody control to Cardinal Laboratories (Cardinal) of Hobbs, New Mexico for chloride analysis. Figure 2 shows the sample locations and the chloride results. Table 1 reports a summary of the laboratory analyses. Laboratory results and chain of custody documentation are included in Appendix A.

Referring to Table 1, all samples reported chloride concentrations above 3,000 mg/kg, with the exception of sample SS-7 (2,399 mg/kg) located at the northeast edge of the site, and the background sample SS-8 (48 mg/kg).

On September 17, 2007, Ocotillo installed three (3) soil borings at the site (BH-1, BH-2 and BH-3) using an air rotary drilling rig, in order to determine the vertical extent of chloride impact. The rig was operated by Scarborough Drilling of Lamesa, Texas. Soil boring BH-1 was drilled to a depth of approximately 26 feet bgs, BH-2 to a depth of approximately 22 feet bgs, and

Referring to Table 1, the laboratory results reported chloride concentrations less than 3,000 mg/kg in boring BH-1 at a depth of 15 to 17 feet bgs (1,710 mg/kg), in boring BH-2 at 10 to 12 feet bgs (1,120 mg/kg), and in boring BH-3 at a depth of 15 to 17 feet bgs (1,340 mg/kg).

Chevron proposes to close the Marquardt Federal #3 reserve pit in accordance with New Mexico State Rule 50. The entire contents of the reserve pit will be excavated and buried in place, encapsulated in a 20 mil plastic liner. Soil samples will be collected below the liner, and the laboratory results will be submitted to the NMOCD with the final C144 form, for closure of the reserve pit. The pit contents will be buried at least three (3) feet below ground surface and covered with clean soil from the pit located immediately north of sample point SS-8. Upon completion of backfilling, the area will be contoured to surface conditions and re-seeded with BLM #4 mixture. The area will be watered periodically to promote re-vegetation of the site. An initial C144 form is included in Appendix C, for approval by the NMOCD.
