Remediation Plan

Trunk "O" 30"

Project # 2008-003

Release Notification and Corrective Action

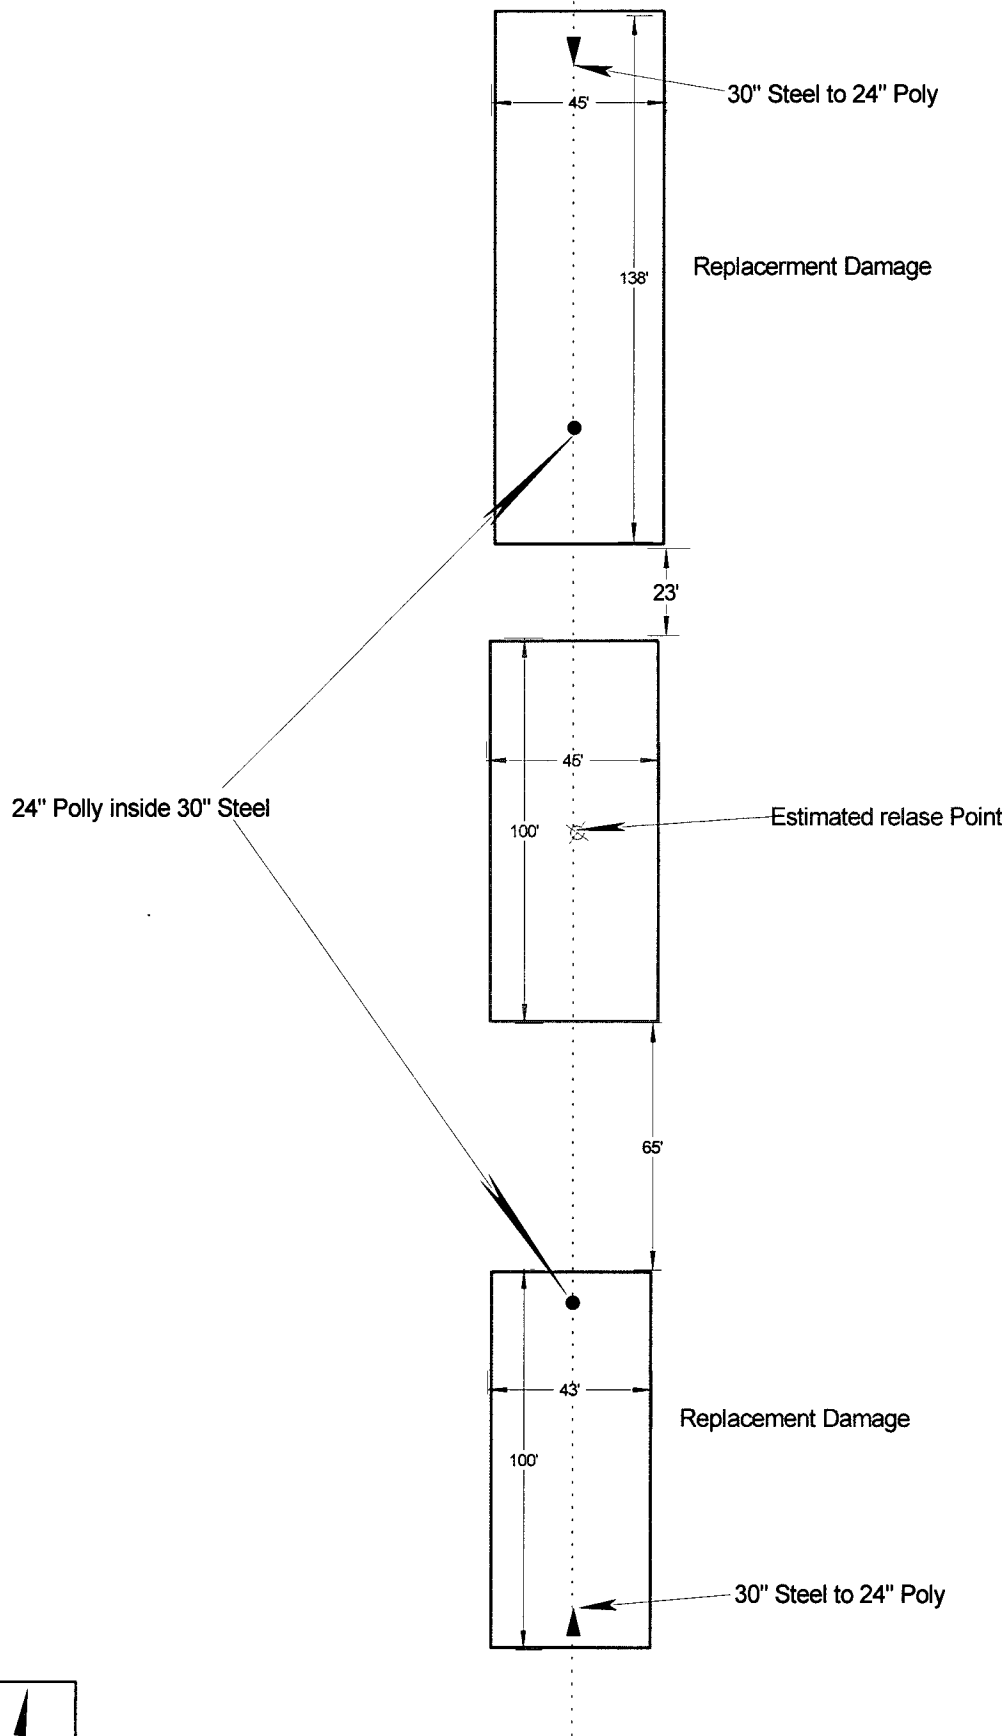
Figure 1

SITE PLAN: Trunk "O" 30"

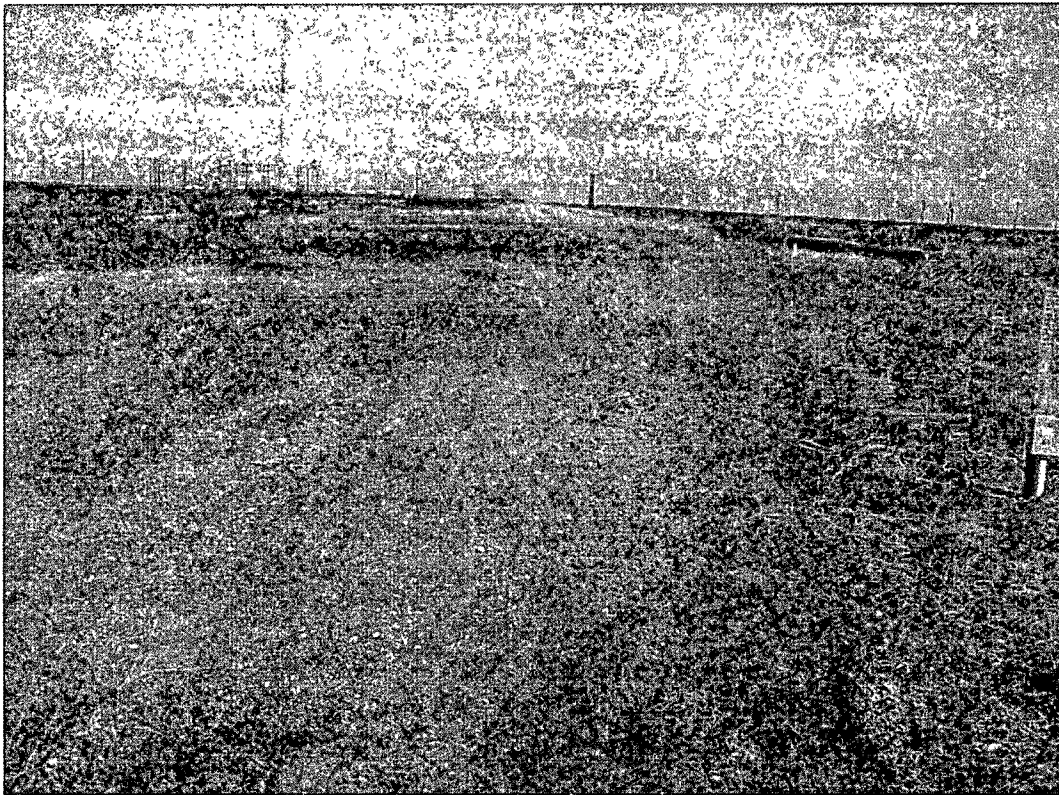
Photo 1

Describe Area Affected and Cleanup Action Taken. An area of pasture land measuring approximately 4,500sq. ft. has discolored soil in the backfill material, the soil is dark to light gray in appearance. Final remediation will follow the NMOCD recommended guidelines for leaks and spills.
