Site Closure Report

Clay Osborn Rocky Top Ranch Jalmat #2 Release Site

SRS No. 2000-10607
NMOCD No. 1R-0466

May 2007

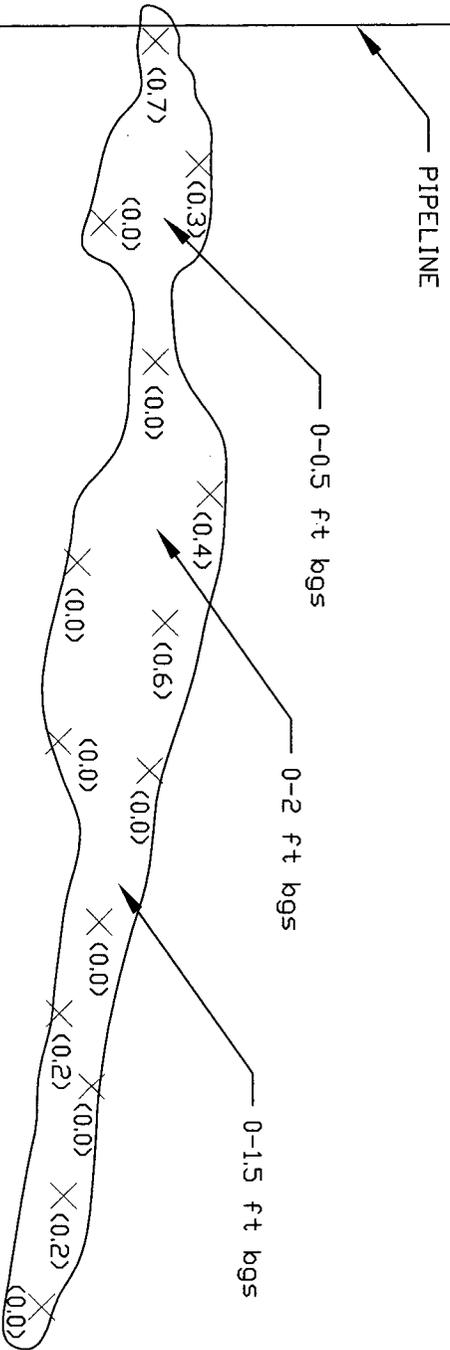
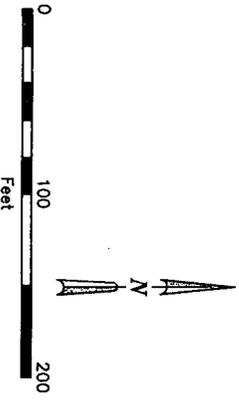
Figure 2: Excavation Areas

The final surface area remediated was approximately 35,000 square feet. The volume of excavated soils transported to the central land farm totaled 660 cubic yards. Areas with observed asphaltines and where laboratory analytical results indicated that surface impacts did not extend below 2 feet bgs were addressed under the Work Plan Scenario 1. Surface asphaltines and underlying soils were scraped to a depth of up to 2 ft bgs and the underlying soils blended in place. In areas where the asphaltines had become covered with windblown sand, the sand was blended with excavated soils, transported to the central land farm, stockpiled and sampled. The remediated area is shown in Figure 2.

After removal of the asphaltines in accordance with the site-specific work plan, the area was backfilled with clean soils obtained from the landowner, contoured to the original grade surrounding the site, and reseeded with approved grass seed.

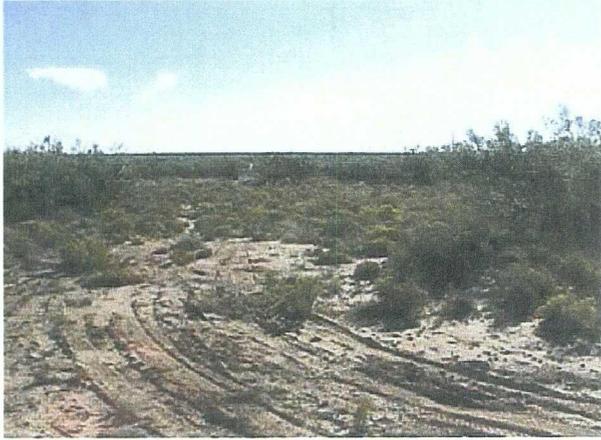
JALMAT 2 Photo taken Facing east from
the Plains pipeline ROW

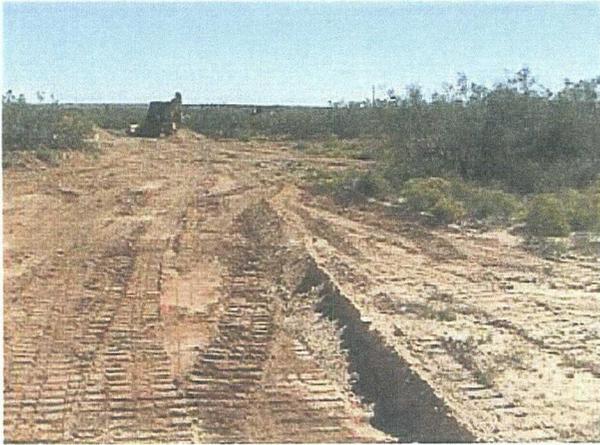
JALMAT 2 Photo from same location as
above following surface scraping.
NOTE: Orange flag indicates a small area
of deeper impacts near pipeline. (PID = 0.7)

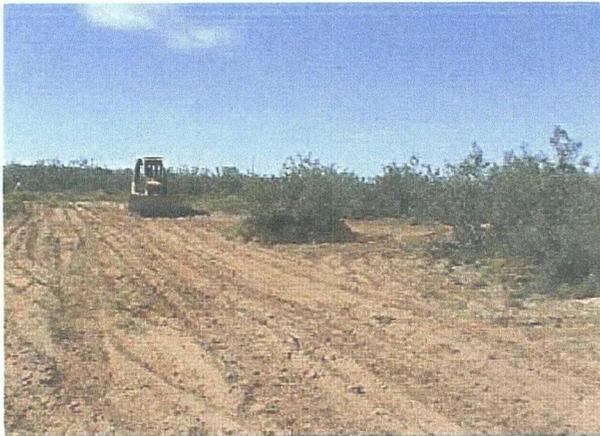
JALMAT 2 Photo from same locations as
above following blending of soils
to 2 ft bgs.

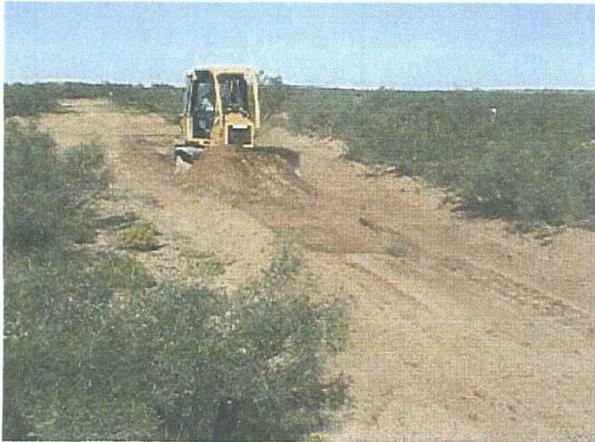
JALMAT 2 Photo taken facing west. This area is located approx 200 ft from the Plains pipeline and exhibited a thin layer of asphaltines and impacted sandstone at 1 to 2 ft bgs.

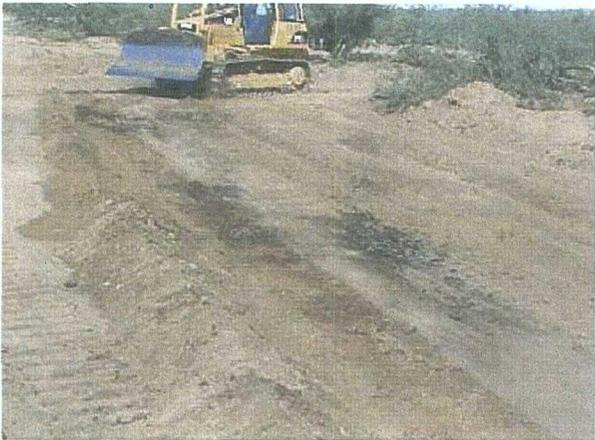
JALMAT 2 Photo taken facing west. This area is located approx. 200 ft from the Plains pipeline and exhibited a thin layer of asphaltines and impacted sandstone at 1 ft bgs.

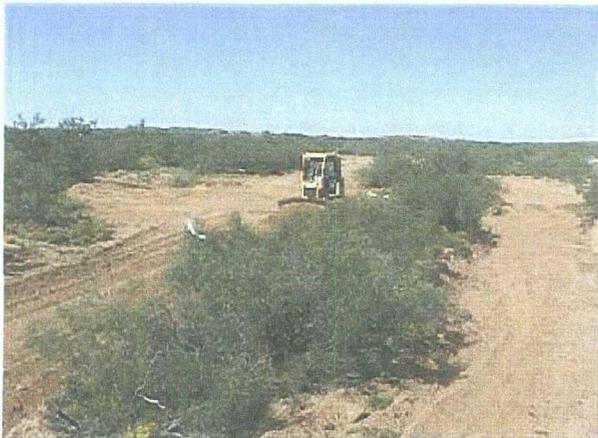
JALMAT 2 Photo taken facing west. Both areas described above are represented in this photo indicating a divergent spill path in this area.

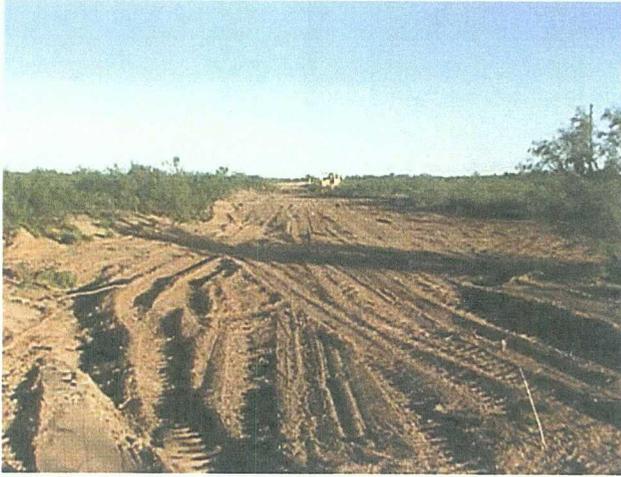
JALMAT 2 Scrape completed.
Photo taken facing east. 10-17-06
