**RE: Phase I and II Remediation, Former Enersource Facility, Monument, Lea County,
New Mexico**

Phase I and II Remediation, Former Enersource Facility Monument, Lea County, New Mexico

June 29, 2007

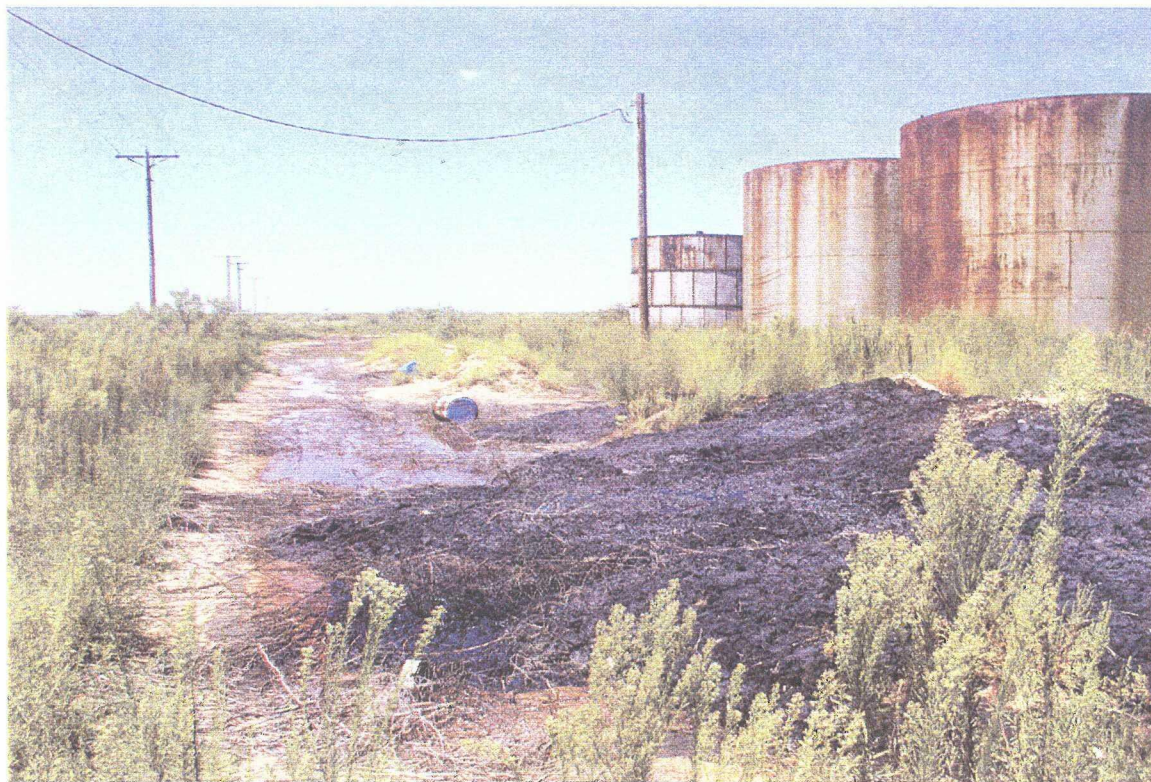
No. 2 – Sludge, Tanks 9, 10, and 11, drums, and pit located on the southwest side of the Site.

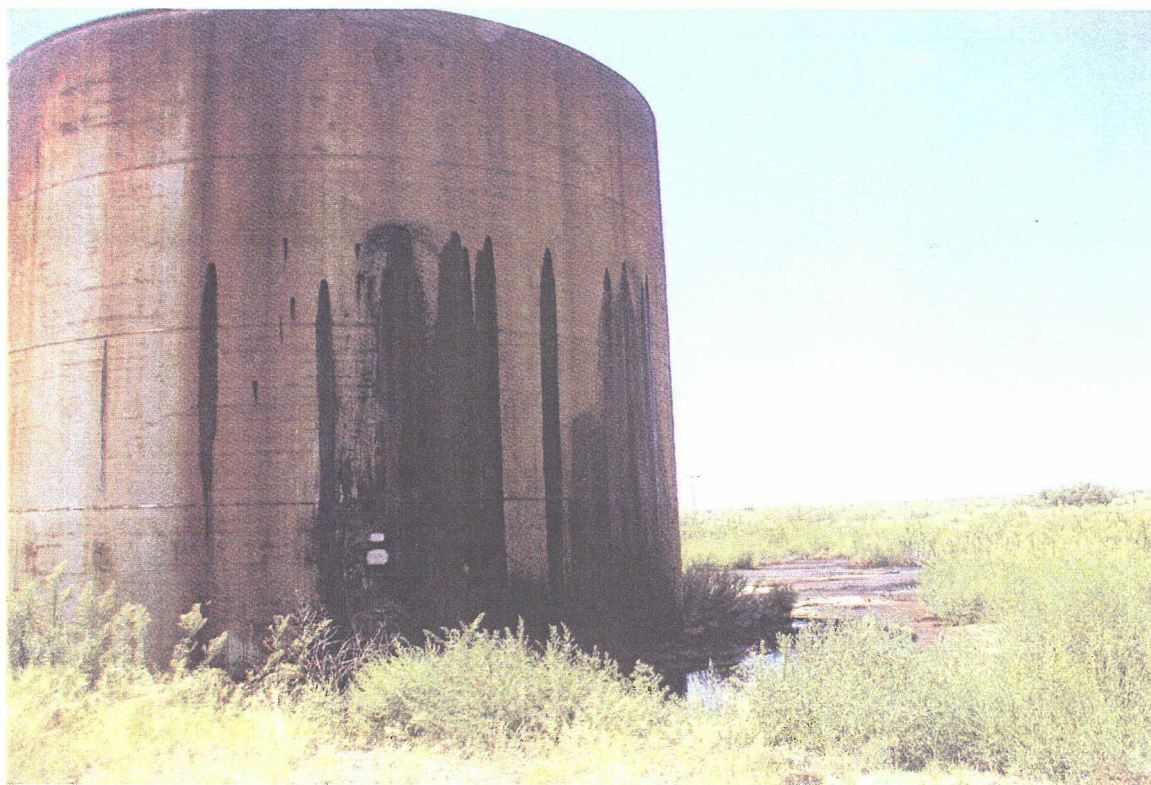
No. 3 – Some of the tanks had holes in them and crude oil leaked onto the ground as seen in the photograph.

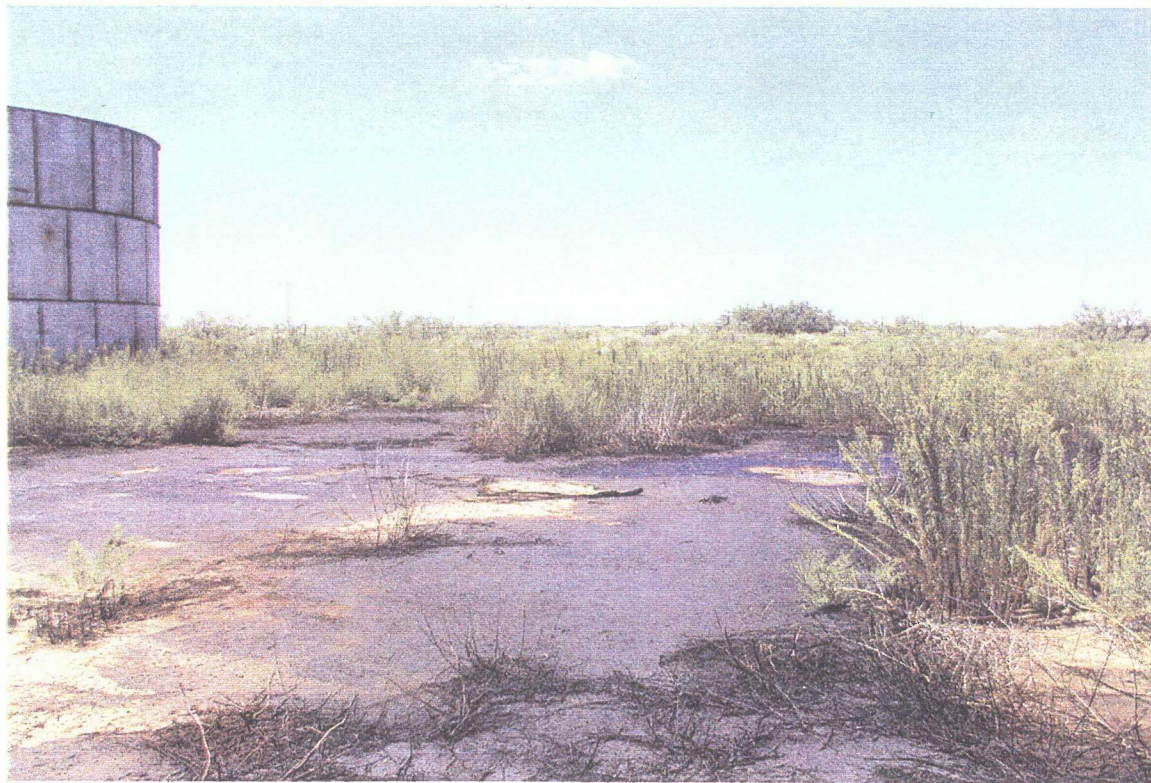
No. 4 – Some of the staining from the leaking tanks.

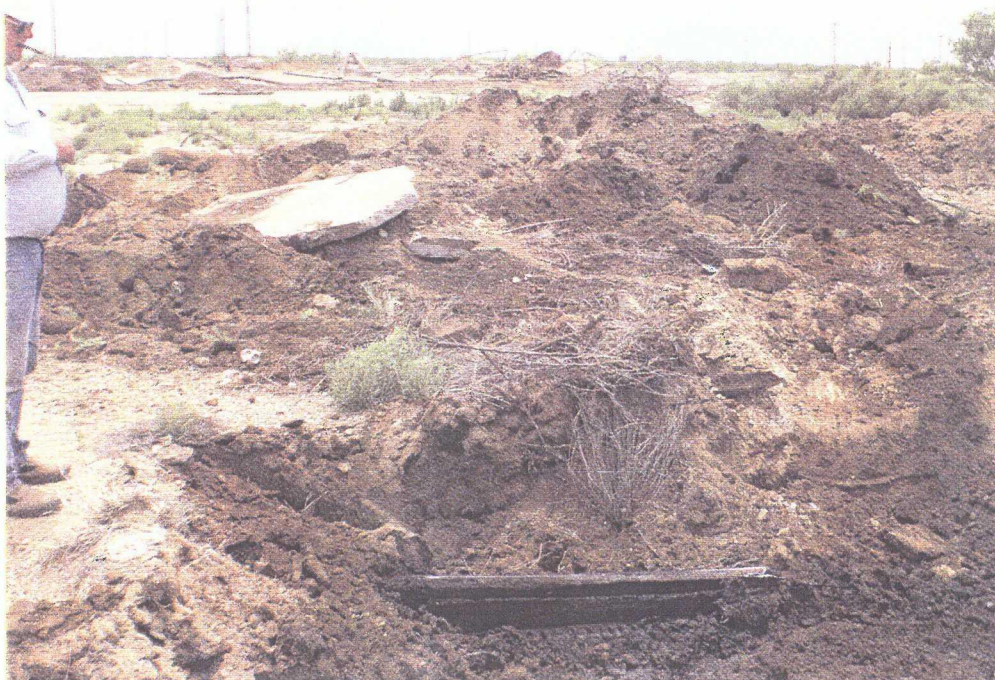
Grid Cells G and L. Grid cells G and L contained a large volume of pipes and grossly petroleum-hydrocarbon impacted soil (Photo 22). Petroleum hydrocarbon odors were noted at several locations. A 5-inch diameter pipe was capped and cut at the west-central grid cell boundary. Soil encountered in this area was very loose resulting in frequent trench collapse.

No 22 - This is Section G, looking southwest over an area from a north-central perspective. Concrete footings and a variety of pipe diameters and lengths were excavated in this vicinity. A 4" pipe is been excavated in the foreground.

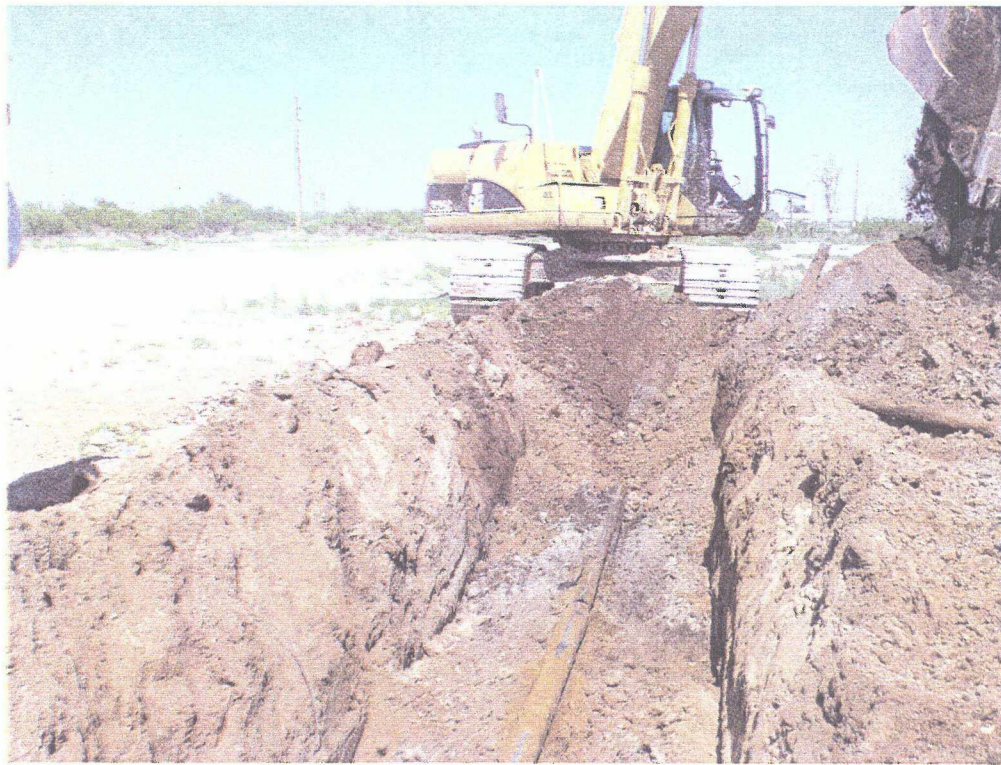
No 23 - This is Section H, as seen from the north east corner. The view is to the east, looking along a 4" pipe trench, where soil discoloration is observed.

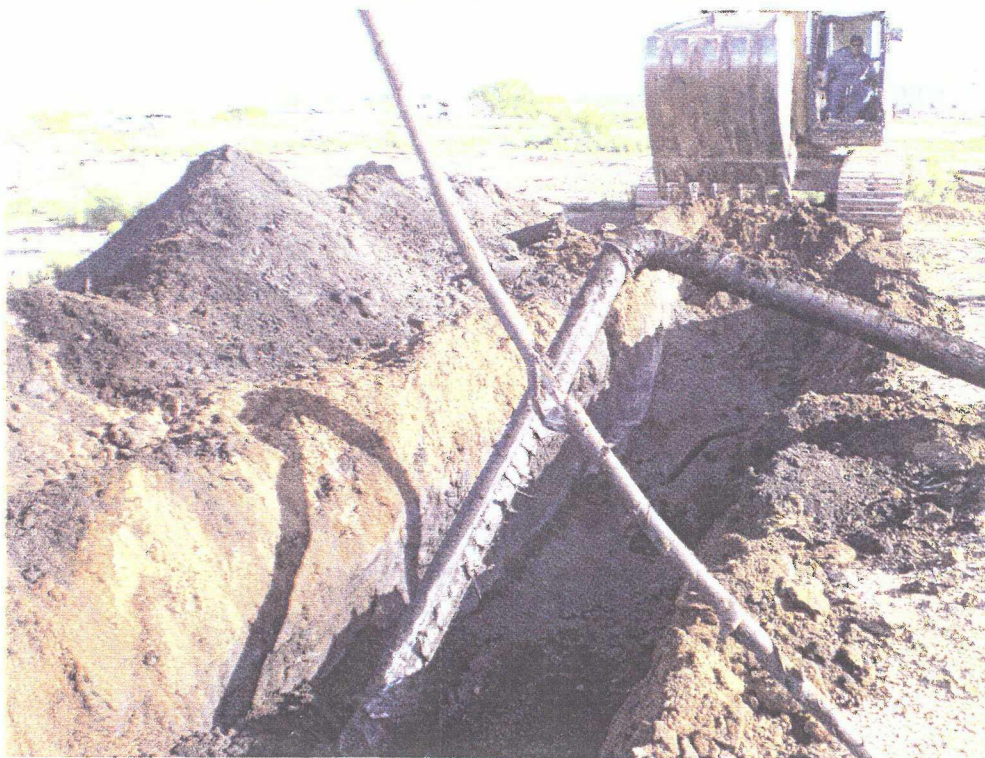
No 24 - This is Section I. The view is to the north where a 5.5" pipe-offset elbow is being pulled. Contaminated soils are clearly evident in the excavated materials.

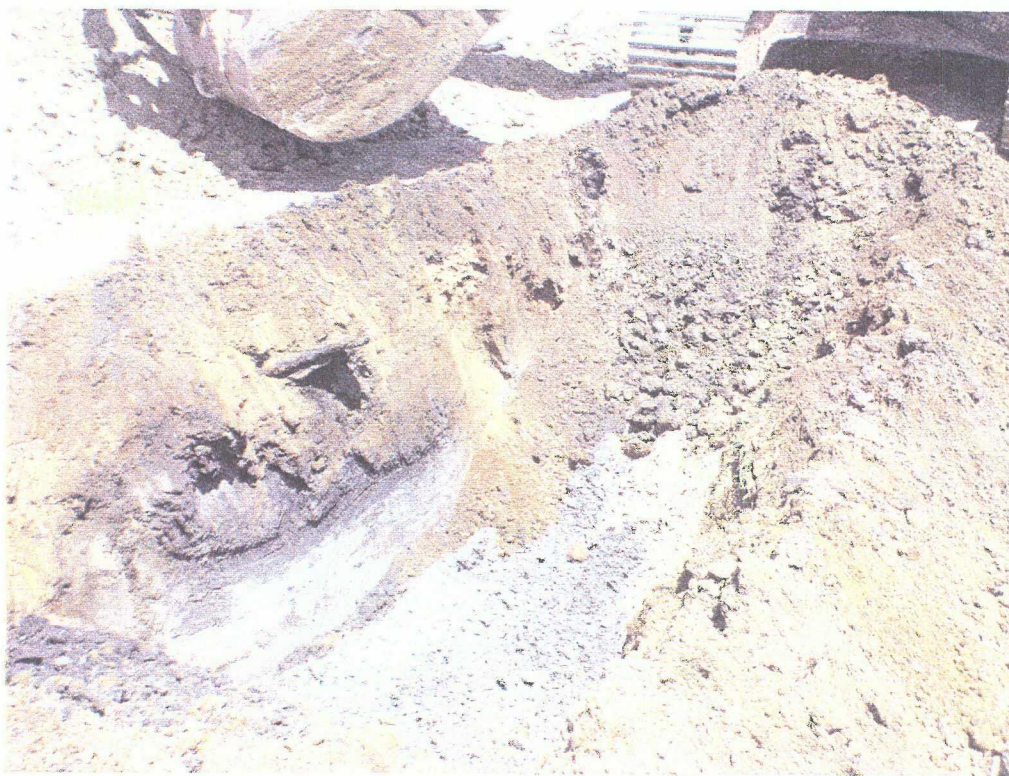
Grid Cells J, N, and M. A large volume of buried pipe was removed from grid cells J, N, and M. Pipe sizes varied in diameter from 2 to 5.5 inches (Photo 25). A 6-foot by 6-foot by 0.5 inch thick steel plate was removed from the northwest corner of grid cell M. A pesticide-like odor was noted during trench backfilling in the east side of grid cell J and the west side of grid cell N.

No 25 - This is Section J, looking to the northeast at a portion of 3" pipe trench which runs east-west. Soil discoloration can be seen to approximately 4 ft.

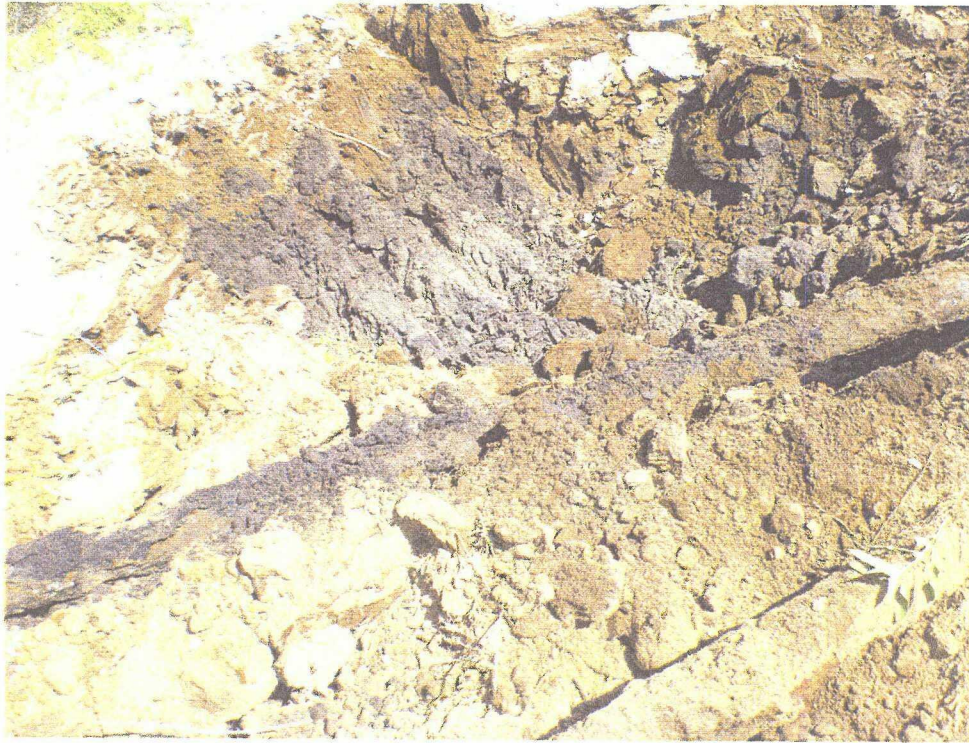
No 28 - This is Section M, looking southeast at two shallow 3" pipes that were dug out of some shallow, discolored soils.

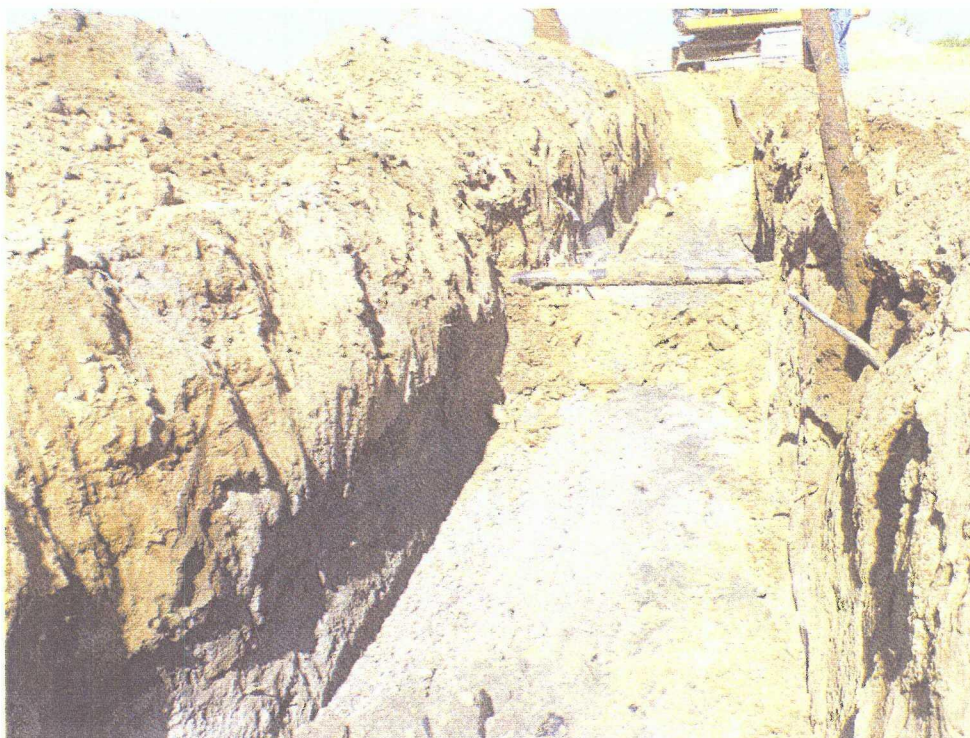
No 34 - This photo is to demonstrate contamination. It is looking west in the south of Section E, along a trench where 9" pipe is being excavated from 3.5 ft. The foreground shows a 4" pipe crossing. Soil discoloration and a distinct HC odor were observed from a depth of 2 ft.

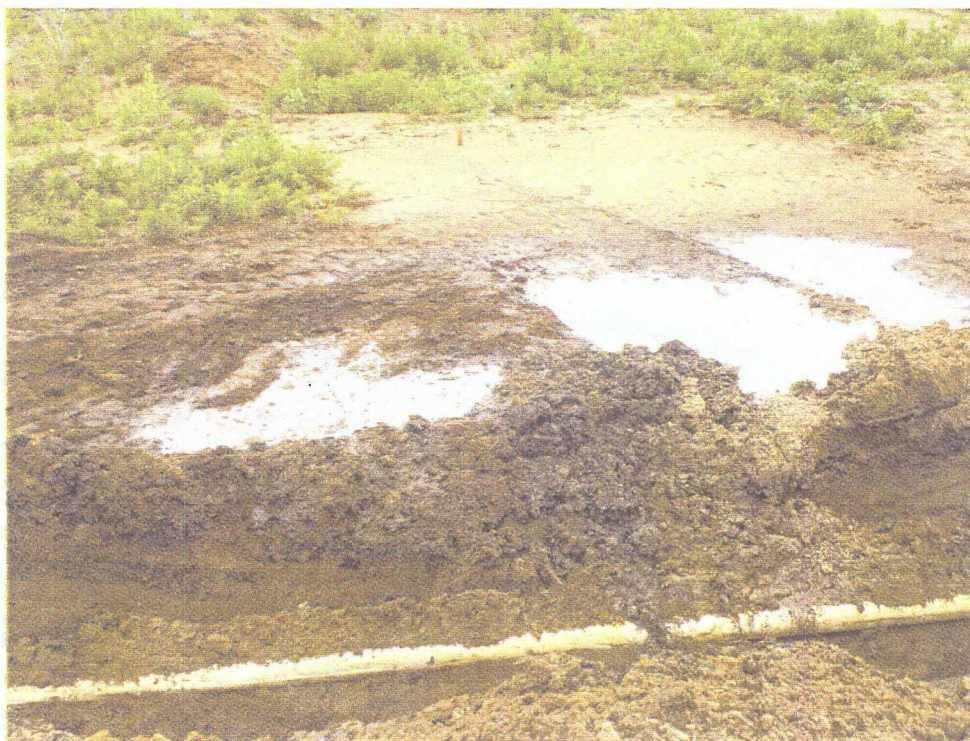
No 35 - This is another photo to demonstrate soil contamination. This is looking west in south-central Section B, at a surface, oily pool that is caving into a 2 ft. deep trench where 4" PVC is being excavated.

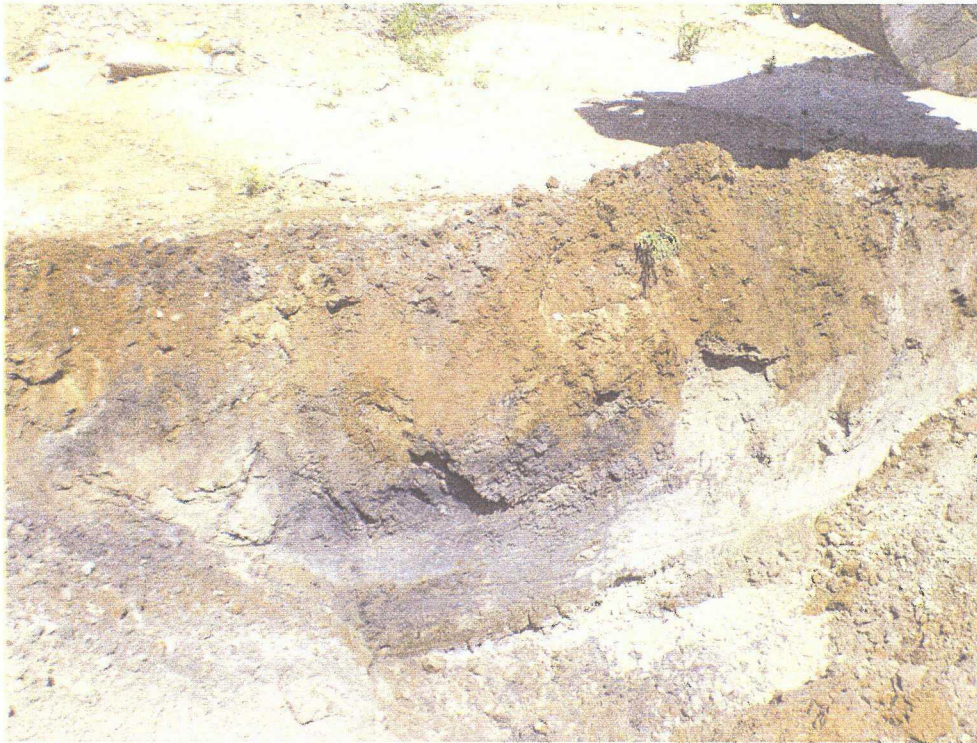
No 36 - This photo was taken of a north-south trench to a depth of 3 ft. in Section J. It shows the discolored soil conditions from 1-3 ft. along the trench wall.

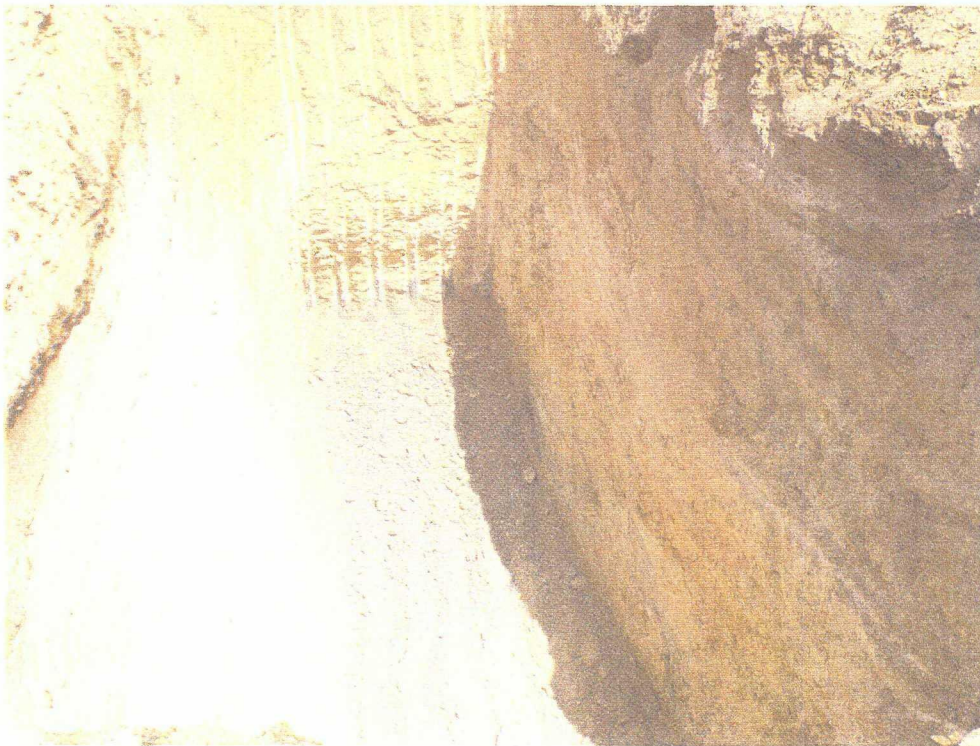
A test pit was excavated in grid cell F to a depth of 14.5 feet bgs (Photo # 37). The purpose of the test pit was to determine if layers hard enough to cause direct push technology or hollow-stem auger drilling refusal existed. The following information was recorded:

- 0 to 3.0 feet bgs – fine- to medium-grained sand; discolored from 0.5 to 3.0 feet bgs
- 3.0 to 6.5 feet bgs – silty, fine-grained sand
- 6.5 to 9.0 feet bgs – calcareous (?) clayey, fine- to medium-grained sand
- 9.0 to 10.0 feet bgs – orange/brown medium-grained sand, moist, hard
- 10.0 to 12.0 feet bgs – as above – discolored; lumpy; hard
- 12.0 to 13.0 feet bgs – fine-grained sandy silty with distinct hydrocarbon odor; harder digging at depth
- 13.0 to 14.5 feet bgs – very hard digging

No 37 - This photo was taken at a test pit, centrally located at 500'E and 200'N. The pit was excavated with the track hoe to a depth of 14.5 ft. where refusal occurred. Discolored soils were encountered and can be seen at the bottom of the pit.

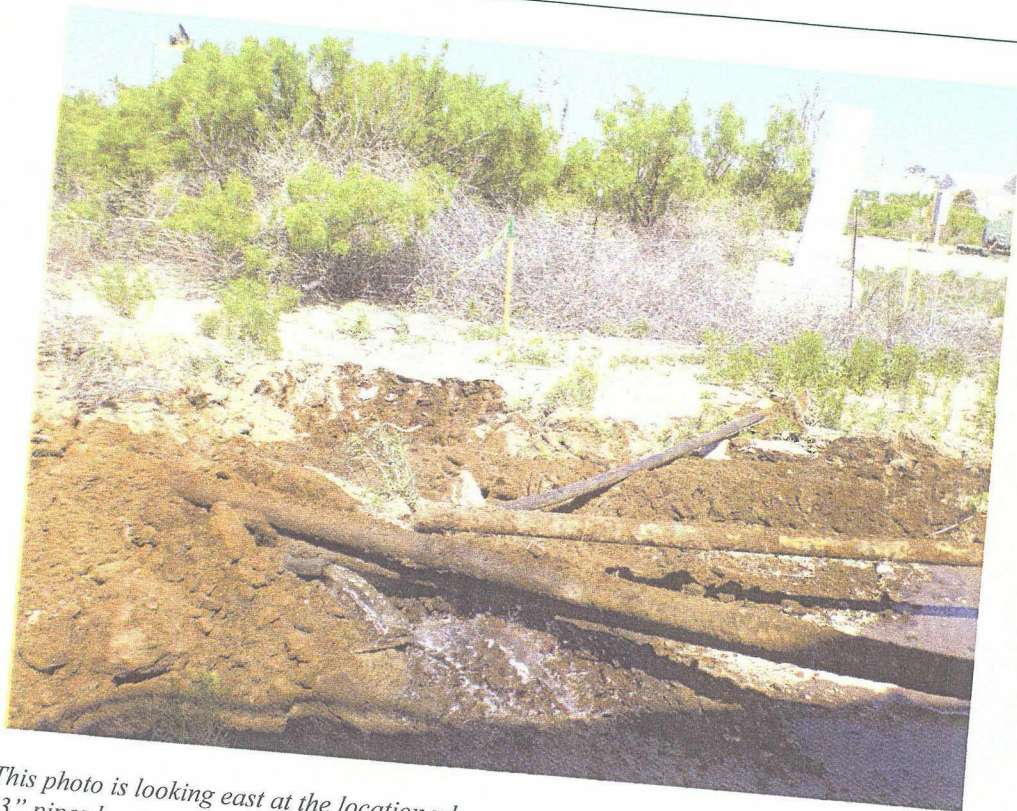
No 42 - This photo is looking east at the location where a 2" poly water line was broken by excavating 2-3" pipes located along the east perimeter of the site boundary in Section M. The line was under pressure and utilized by a local cattle rancher. The water line was repaired.

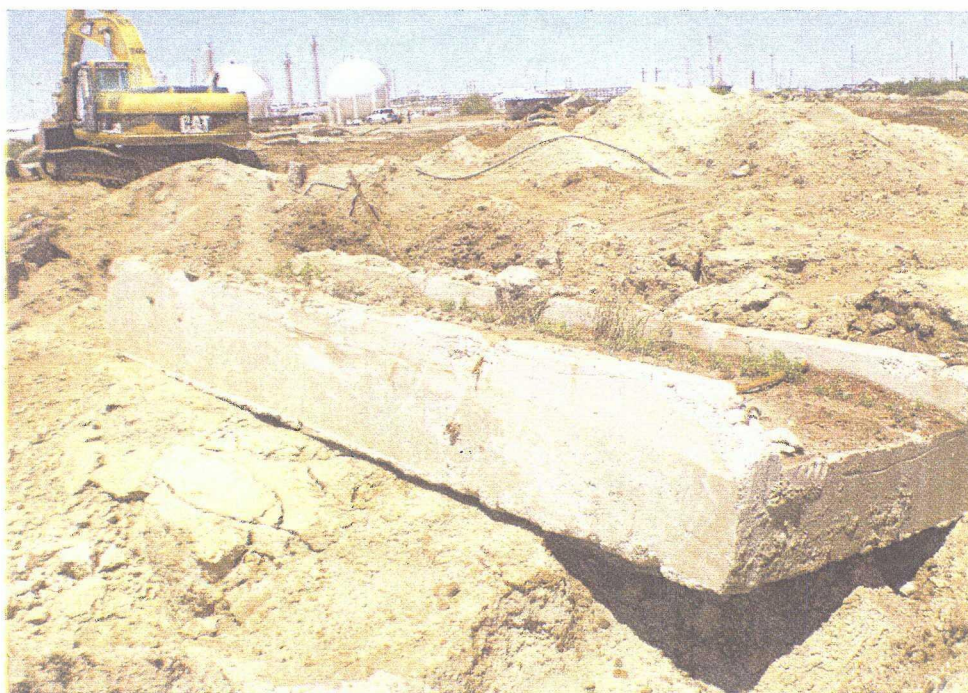
No 47 - This is one of three concrete slabs that are too heavy for the track hoe to load into the bin. It had to be left on site at central, Section E.

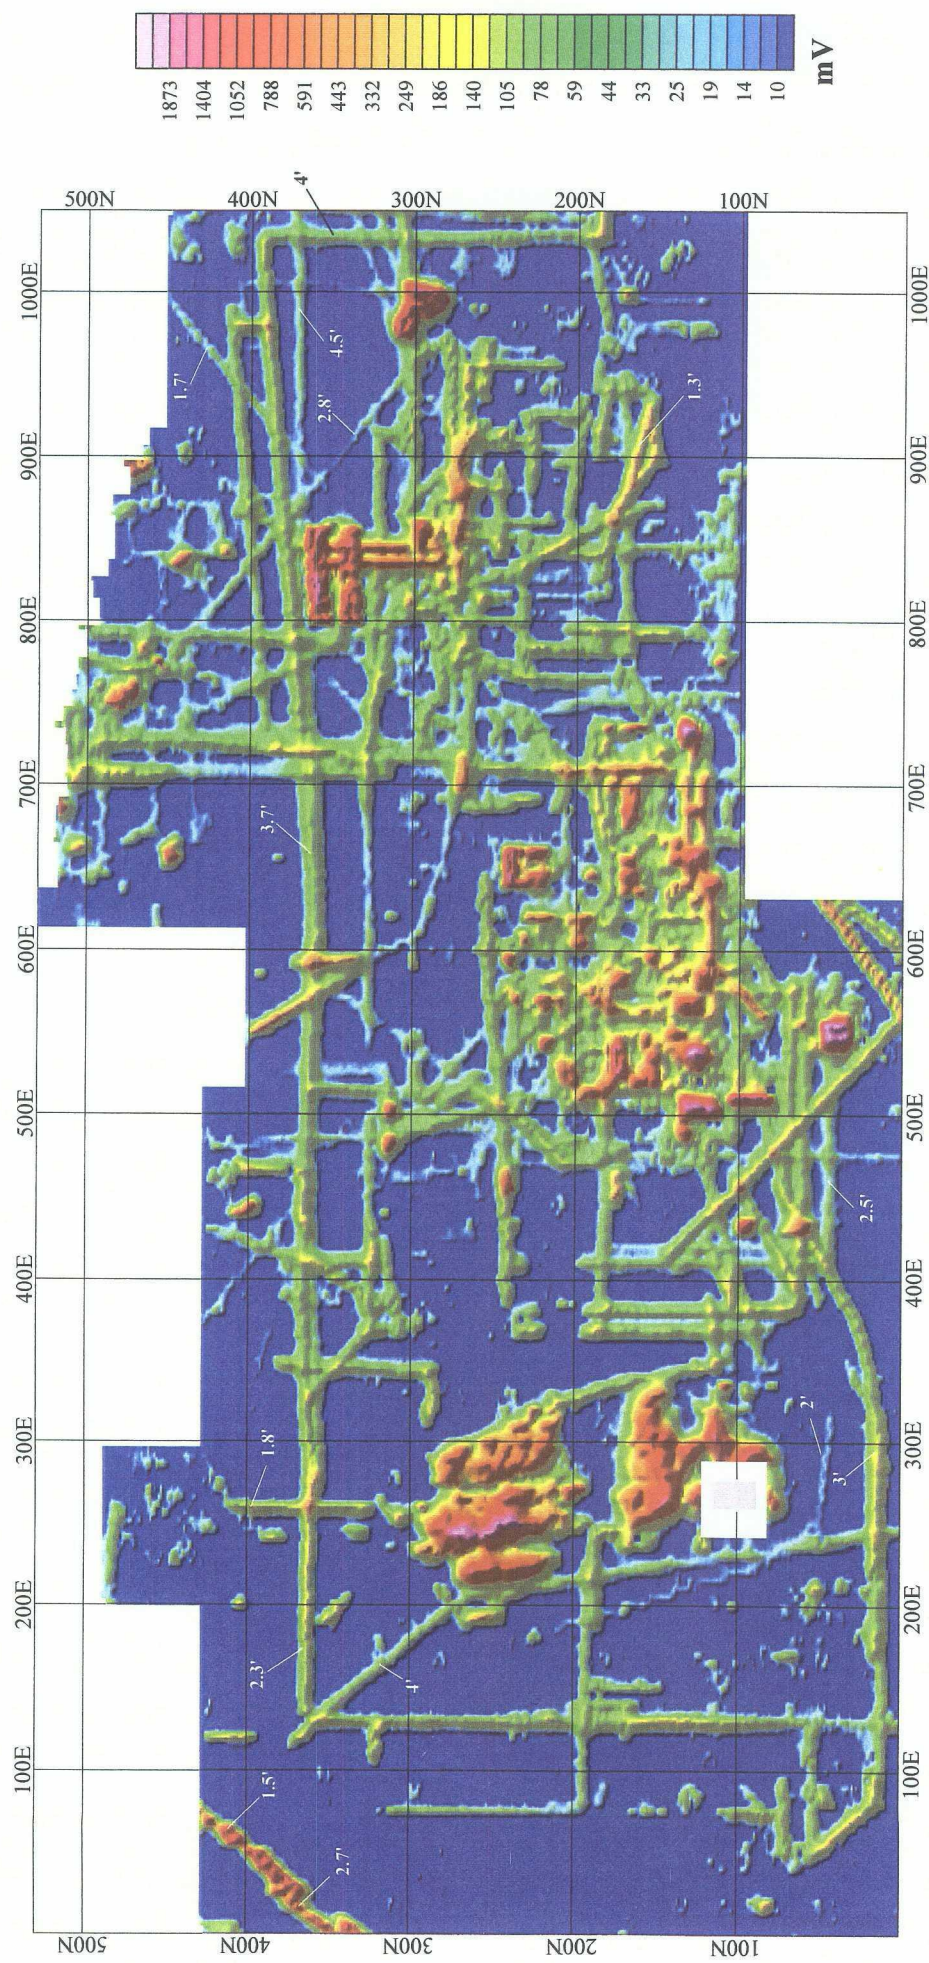
Figure 2. Enersource Site - Monument, New Mexico
Higher Resolution EM-61 Response

The EM-61 data are re-projected at higher resolution in Figure 2. The color contours are presented on a logarithmic scale to enhance low magnitude features (buried pipes) while retaining the larger features seen in Figure 1. Observations include:

- Buried pipes are found essentially across the entire site. The lateral runs of buried pipes combine to over one mile in total length. The approximate depths of several pipes are annotated, ranging from just below the surface to approximately 4.5 ft.
- Buried pipes associated with the Enersource Site penetrate the north, south, and east edges of the survey.
- There appears to be considerable interconnection by buried pipes between the concrete pads in the area 500E, 0N to 750E, 250N.
- Another concentration of buried pipes is found immediately south of the concrete basin.
