**GW - 385**

**INSPECTION**

**From:** Lowe, Leonard, EMNRD  
**Sent:** Thursday, October 23, 2008 9:06 AM  
**To:** 'Savoie, Tony'  
**Cc:** Price, Wayne, EMNRD  
**Subject:** GW-385, House Compressor Station

**Southern Union Gas Services**  
**A-14 Compressor Station**  
GW-385

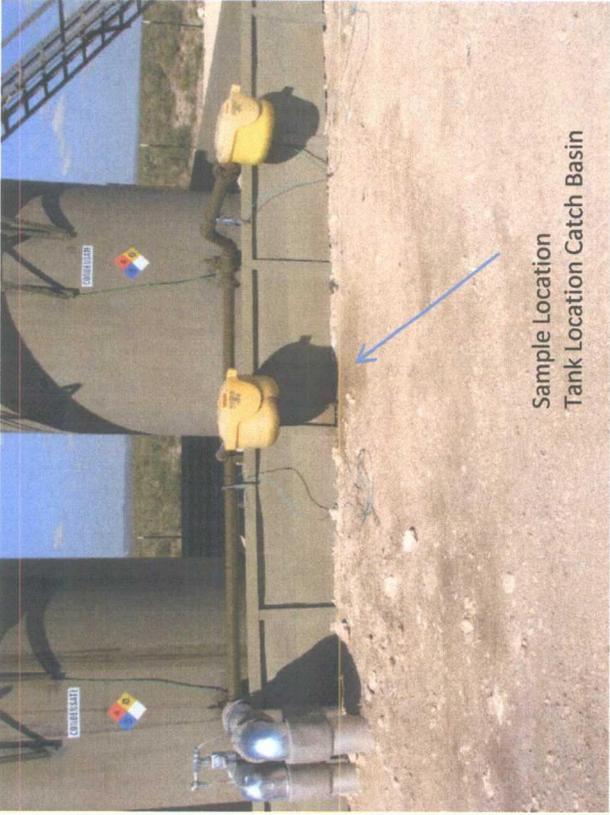
Sample Location  
Tank Location Catch Basin

The area under the leaking tank valve and catch basin was sampled at the surface and approximately 1 ft. below the surface. These samples will be analyzed for TPH EPA Method 8015M, BTEX, and Chlorides. The sample collected at 1ft. below the surface did not appear to demonstrate vertical extent. The impacted soil will be excavated and placed on plastic sheeting until a complete analysis of the excavated soil and the excavated area can be done.

The area under the truck load catch basin will be excavated to approximately 4 ft. in depth, since the soil/chloride levels exceed 1000 mg/kg all of this material will be transported to a facility permitted to receive chloride contaminated soil. Samples will be collected from the bottom and sides of the excavation and analyzed for TPH Method 8015 m, BTEX, and Chlorides. The excavation will continue until the site closures levels have been obtained.
The area under the former air compressor will be excavated and placed on plastic until a complete analysis of the soil has been done. If the material demonstrates to be non- hazardous it will be transported to the SUGS Landfarm for remediation. Samples will be collected from the excavated area and analyzed for TPH Method 8015 Extended to include lube oil and diesel ranges. If the area meets the closure levels it will be backfilled with clean soil and caliche.

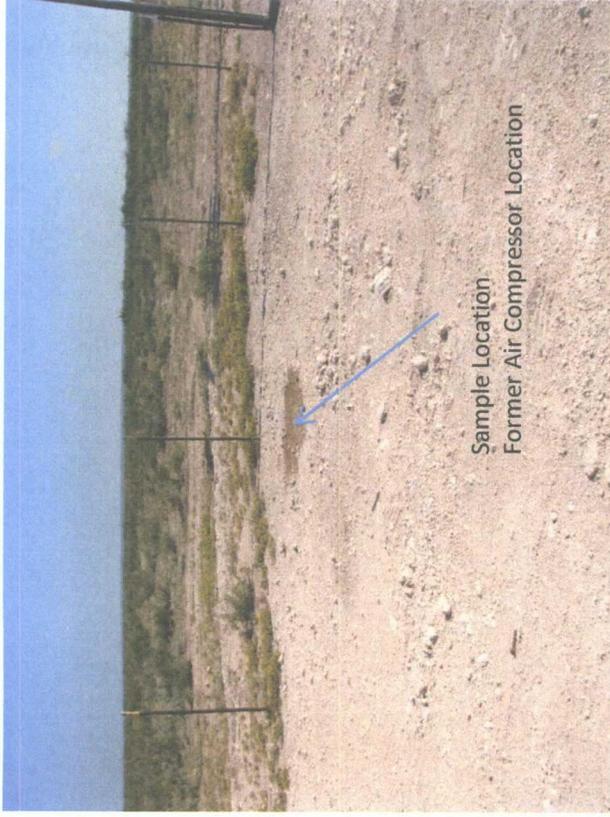
Sample Location  
Former Air Compressor Location

Since the fluid that was released was not exempt under RCRA Subtitle C, a waste determination sample was collected from the surface of the release area and approximately 9" below the surface in an attempt to demonstrate vertical extent.

If the samples collected demonstrate that the stained soil is non-hazardous it will be transported to the Southern Union Gas Services landfarm for remediation.

The excavated area will be sampled for TPH using EPA method 8015M, if the excavated area meets the NMOCD guidelines from the remediation of leaks and spills, clean soil and caliche will be brought to the site for backfill. *Still open*

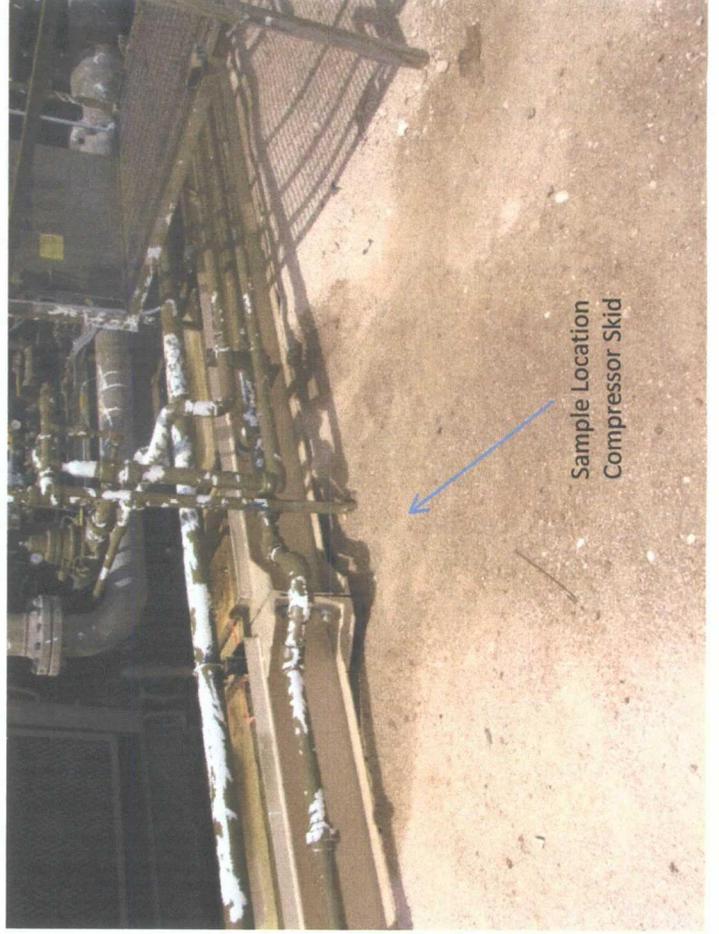
Sample Location  
Compressor Skid

The stained areas around the compressor skid was a result of leaking piping and skid containment failures which allowed lube oil to leak onto the soil.

The areas around the gas compressor will be excavated and placed on plastic until a complete analysis of the soil has been done. If the material demonstrates to be non- hazardous it will be transported to the SUGS Landfarm for remediation. Samples will be collected from the excavated area and analyzed for TPH Method 8015 Extended to include lube oil and diesel ranges. If the area meets the closure levels it will be backfilled with clean soil and caliche.
