R. T. HICKS CONSULTANTS, LTD.

August 12, 2009

RE: Seven Produced Fluid Releases at sites operated by Marks and Garner Production Ltd, Company in Eddy County, NM as follows:

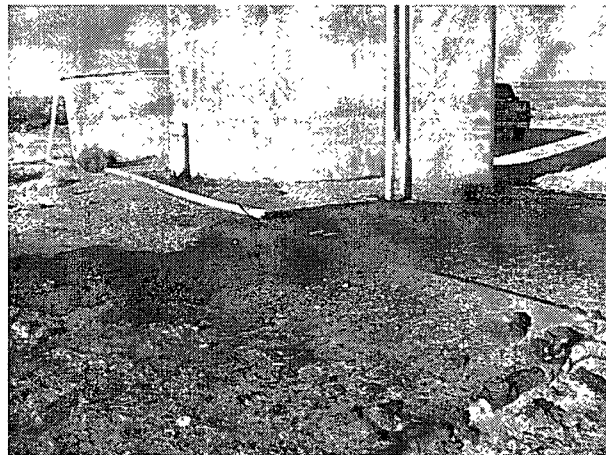
Levers Federal No. 7 Battery (OCD Reference No. 2RP-304)

A release of heavy "tank bottom" oil occurred from a broken valve at the base of a large separator and extends approximately 30 feet down slope. We used a hand auger to obtain soil samples at depths of 0.5, 1.0, and 3.0 feet below the free liquid. Results of laboratory analyses on selected samples for benzene, toluene, ethylbenzene, xylenes; and gasoline, diesel, and oil range hydrocarbons as well as field screening and laboratory results are provided on the table below:

None of the hydrocarbon concentrations measured at the Levers Federal No. 7 site exceeds the 1993 NMOCD or 2006 NMED Guideline soil screening levels. The fact that the concentrations of regulated constituents do not exceed NMED Guidelines allows us to conclude that the impacted soil does not represent a threat to fresh water or public health. The recommended corrective action for this site is:

1. Remove out-of-service vessels or repair all leaks
2. Excavate the upper 6-inches of earth within the spill footprint
3. Mix the excavated spill material with 2-5 parts clean soil

4. Use this blended soil for the construction of firewalls around tank batteries (use now or stockpile on site for future use)
5. At abandonment of the site the surface will be restored according to the landowner's specifications

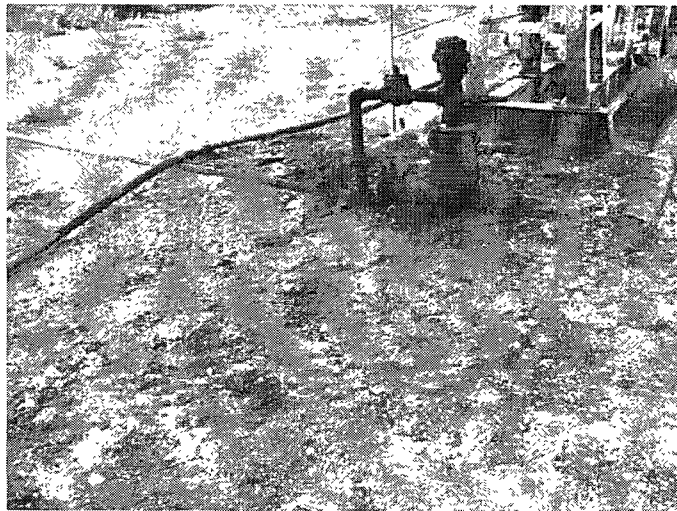
Levers No. 3 Well (OCD Reference No. 2RP-305)

A release of oil occurred from the well head which extends approximately 10 feet in all directions. The table below presents field screening and the laboratory results from soil samples at the surface and at depths of 2.0, 3.0, 4.0, 5.0 and 6.0 feet below the stained area.

Total Petroleum Hydrocarbon (TPH) concentrations measured at the Levers No. 3 site exceeds the 1993 NMOCD Guideline levels but concentrations generally decrease from the surface to the auger refusal depth (6 feet below the surface). Most importantly, none of the regulated hydrocarbon concentrations exceed the 2006 NMED Guideline levels. The fact that the concentrations of regulated constituents do not exceed NMED Guidelines allows us to conclude that the impacted soil does not represent a threat to fresh water or public health. The recommended corrective action for this site is:

1. Remove out-of-service vessels or repair all leaks
2. Excavate the upper 1-2 feet of earth within the spill footprint
3. Mix the excavated spill material with 2-5 parts clean soil
4. Use this blended soil for the construction of firewalls around tank batteries (use now or stockpile on site for future use)
5. Collect a composite sample of the blended soil to demonstrate that constituents are at concentrations that comply with NMOCD Rules and provide letter report to NMOCD
6. At abandonment of the site the surface will be restored according to the landowner's specifications

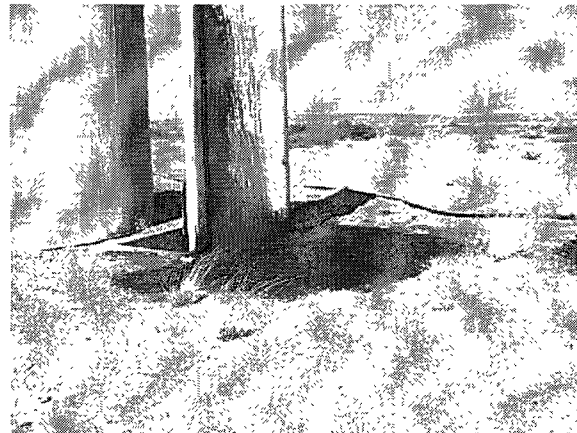
Red-12 Federal No. 1 Battery (OCD Reference No. 2RP-306)

A release of heavy "tank bottom" oil occurred from a broken valve at the base and from a pipe joint near the top of the separator. The spill area extends approximately 30 feet down slope. Laboratory results of soil samples recovered using a hand auger at depths of 0.5, 1.0, and 3.0 feet below the free liquid and field screening are provided on the table below:

TPH concentrations measured from near the surface at the Red-12 Federal No. 1 site exceeds the 1993 NMOCD Guideline levels but decreases to below the guideline levels at 3 feet below the surface. None of the regulated hydrocarbon concentrations exceed the 2006 NMED Guideline levels. The fact that the concentrations of regulated constituents do not exceed NMED Guidelines allows us to conclude that the impacted soil does not represent a threat to fresh water or public health. The recommended corrective action for this site is:

1. Remove out-of-service vessels or repair all leaks
2. Excavate the upper 6-12 inches of earth within the spill footprint
3. Mix the excavated spill material with 2-5 parts clean soil
4. Use this blended soil for the construction of firewalls around tank batteries (use now or stockpile on site for future use)
5. Collect a composite sample of the blended soil to demonstrate that constituents are at concentrations that comply with NMOCD Rules and provide letter report to NMOCD
6. At abandonment of the site the surface will be restored according to the landowner's specifications

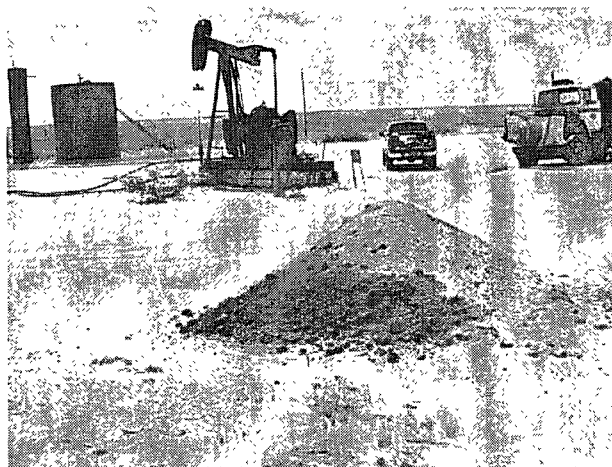
Cave State No. 4 Well (OCD Reference No. 2RP-307)

The operator excavated and stockpiled soil from an apparent release of oil that occurred prior to our characterization. Laboratory and field results from soil samples recovered from the stockpile and below the spill footprint are provided on the table below:

The hydrocarbon concentrations from the removed stockpiled soil at Cave State No. 4 site exceeds the 1993 NMOCD Guideline levels for TPH and the 2006 NMED Guideline levels for benzene. None of the hydrocarbon concentrations measured from the remaining (deeper) soil exceeds either the 1993 NMOCD or 2006 NMED Guideline soil screening levels.

The fact that the concentrations of regulated constituents do not exceed NMED Guidelines allows us to conclude that the impacted soil below the original spill footprint does not represent a threat to fresh water or public health.

We recommend that the operator mix the stockpile with clean soil and utilize it for the construction of a firewall at one of the active tank batteries.

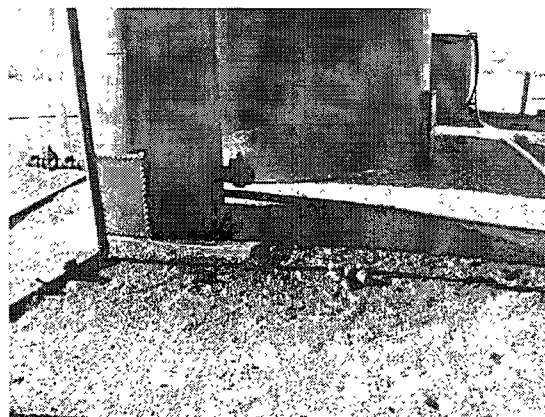
Red-12 State No. 2 Battery (OCD Reference No. 2RP-308)

A release of heavy “tank bottom” oil occurred from a broken valve at the base of a separator and extends approximately 20 feet down slope. Results of laboratory and field analyses of soil samples recovered using a hand auger at depths of 0.5, 1.0, and 3.0 feet below the free liquid are provided on the table below:

TPH concentrations measured from near the surface at the Red-12 State No. 2 site exceeds the 1993 NMOCD Guideline levels but decreases to below the guideline levels at 3 feet below the surface. None of the measured hydrocarbon concentrations exceed the 2006 NMED Guideline levels. The fact that the concentrations of regulated constituents do not exceed NMED Guidelines allows us to conclude that the impacted soil does not represent a threat to fresh water or public health. The recommended corrective action for this site is:

1. Remove out-of-service vessels or repair all leaks
2. Excavate the upper 6-12 inches of earth within the spill footprint
3. Mix the excavated spill material with 2-5 parts clean soil
4. Use this blended soil for the construction of firewalls around tank batteries (use now or stockpile on site for future use)
5. Collect a composite sample of the blended soil to demonstrate that constituents are at concentrations that comply with NMOCD Rules and provide letter report to NMOCD.
6. At abandonment of the site the surface will be restored according to the landowner's specifications.

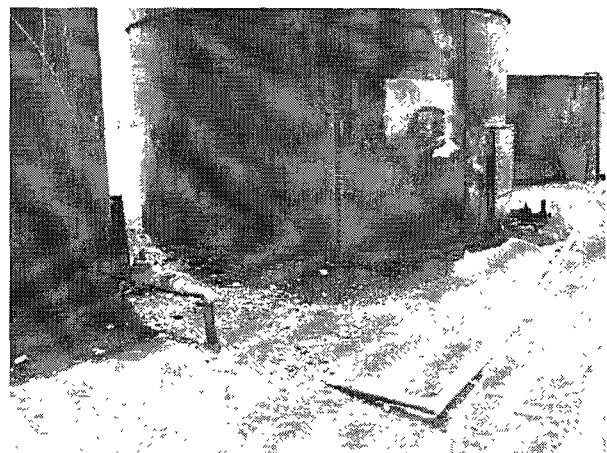
Red-12 State No. 3 Battery (OCD Reference No. 2RP-309)

A release of heavy "tank bottom" oil occurred from leaks located at the base of a 500-bbl oil tank and a separator. The surface staining is present in an area of approximately 500 ft². A composite surface soil sample was recovered from the stained area and subsurface soil samples were recovered from two hand auger borings at depths of 1.0 and 2.0 feet below the free liquid. Laboratory analyses were performed to determine the concentrations of benzene, toluene, ethylbenzene, xylenes; and gasoline, diesel, and oil range hydrocarbons. Field screening and laboratory results are provided on the table below:

TPH concentrations measured from near the surface at the Red-12 State No. 3 site exceeds the 1993 NMOCD Guideline levels but decreases to below the guideline levels at 1 and 2 feet below the surface. None of the measured hydrocarbon concentrations exceed the 2006 NMED Guideline soil screening levels. The fact that the concentrations of regulated constituents do not exceed NMED Guidelines allows us to conclude that the impacted soil does not represent a threat to fresh water or public health. The recommended corrective action for this site is:

1. Remove out-of-service vessels or repair all leaks
2. Excavate the upper 1-2 feet of earth within the spill footprint
3. Mix the excavated spill material with 2-5 parts clean soil
4. Use this blended soil for the construction of firewalls around tank batteries (use now or stockpile on site for future use)
5. Collect a composite sample of the blended soil to demonstrate that constituents are at concentrations that comply with NMOCD

Rules and provide letter report to NMOCD

6. At abandonment of the site the surface will be restored according to the landowner's specifications.

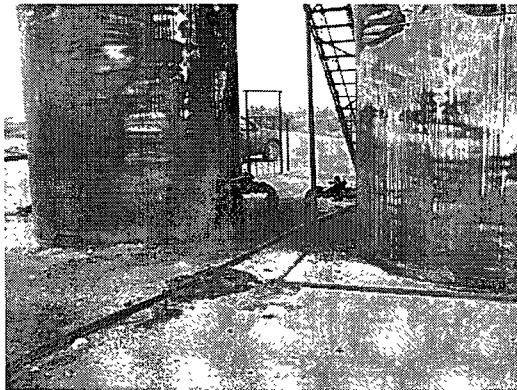
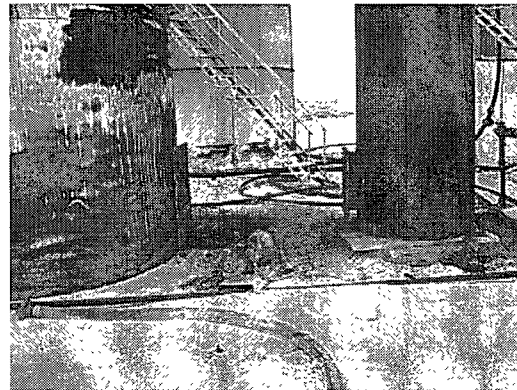
Red-12 State No. 4 Battery and Injector (OCD Reference No. 2RP-310)

Historic spills within the tank battery have occurred resulting in an "asphalt-like" stained soil area of approximately 400 ft². A composite surface soil sample was recovered from the stained area and laboratory analyses were performed to determine the concentrations of benzene, toluene, ethylbenzene, xylenes; and gasoline, diesel, and oil range hydrocarbons. Laboratory results are provided on the table below:

TPH concentrations measured from near the surface at the Red-12 State No. 4 battery site exceed the 1993 NMOCD Guideline levels but none of the measured hydrocarbon concentrations exceed the 2006 NMED Guideline levels. The fact that the concentrations of regulated constituents do not exceed NMED Guidelines allows us to conclude that the hydrocarbon-impacted soil does not represent a threat to fresh water or public health. The recommended corrective action for this site is:

1. Repair all leaks
2. Excavate the upper 1-2 feet of earth within the spill footprint
3. Mix the excavated spill material with 2-5 parts clean soil
4. Use this blended-asphaltic soil for the construction of firewalls around tank batteries (use now or stockpile on site for future use)
5. Collect a composite sample of the blended soil to demonstrate that constituents are at concentrations that comply with NMOCD Rules and provide letter report to NMOCD
6. At abandonment of the site, disc hay and other organic material into hydrocarbon-impacted soil to open soil structure and permit infiltration of precipitation. Repeat tilling and addition of organic material or other soil amendments as necessary to meet landowner mandates for surface restoration and thereby eliminate the threat to the environment (i.e. soil and habitat) posed by the hydrocarbon-impacted soils

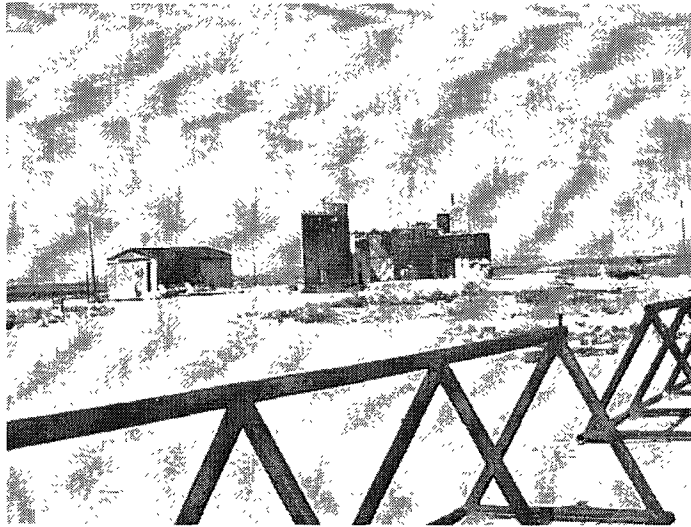
The tank battery is located on a topographically high area and much of the soil within the bermed area and the surrounding topographically low areas exhibit characteristics of one or more historic brine water releases. Three hand auger borings were installed in the low areas surrounding the tank battery in order to better characterize the extent of the chloride-impacted soil. Plate 2 is a site map drawn on a July 2005 satellite photograph that depicts the current extent of stressed vegetation, the location of the hand auger borings, and the laboratory results from soil samples recovered at the site. It should be noted that the extent of the stressed vegetation observed during the inspection has changed since 2005. Some of the vegetation to the north and south has decreased while areas to the west appear to have recovered.

At the topographically low areas to the north and west of the tank batteries chloride concentrations in soil prevent re-vegetation. The vertical extent of the impacted soil could not be determined due to auger refusal. Further investigations at the Red-12 State No. 4 site will be conducted to verify the vertical extent of the chloride-impacted soil in order to determine the potential threat to ground water. Following the completion of these activities a final report will be submitted to the NMOCD.
