August 12, 2009

RE: Seven Produced Fluid Releases at sites operated by Marks and Garner Production Ltd, Company in Eddy County, NM as follows:

R.T. Hicks Consultants is pleased to submit the results of the initial characterization activities on the behalf of Marks and Garner Production Ltd. The production area is approximately 6.5 miles northwest of Loco Hills, New Mexico. Plate 1 depicts the location of each site relative to lease roads, sections lines, and Bear Grass Draw. On June 22 and 23, 2009 Hicks Consultants inspected each of the sites to document the source and type of release, describe the resulting environmental impact, and recover "worst case" soil samples in order to determine the corrective actions required under NMOCD Rule Part 29.

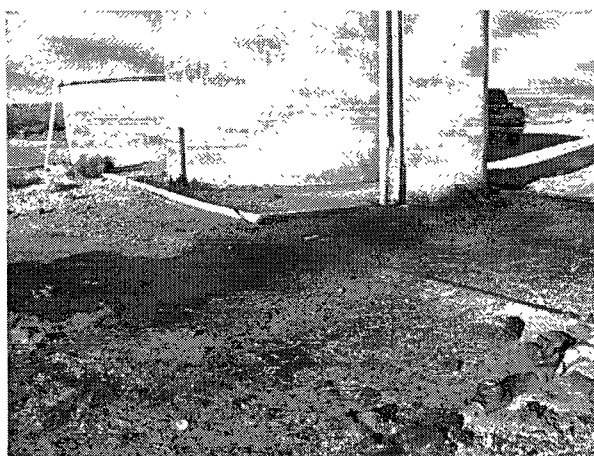
Levers Federal No. 7 Battery (OCD Reference No. 2RP-304)

A release of heavy “tank bottom” oil occurred from a broken valve at the base of a large separator and extends approximately 30 feet down slope. We used a hand auger to obtain soil samples at depths of 0.5, 1.0, and 3.0 feet below the free liquid. Results of laboratory analyses on selected samples for benzene, toluene, ethylbenzene, xylenes; and gasoline, diesel, and oil range hydrocarbons as well as field screening and laboratory results are provided on the table below:

None of the hydrocarbon concentrations measured at the Levers Federal No. 7 site exceeds the 1993 NMOCD or 2006 NMED Guideline soil screening levels. The fact that the concentrations of regulated constituents do not exceed NMED Guidelines allows us to conclude that the impacted soil does not represent a threat to fresh water or public health. The recommended corrective action for this site is:

1. Remove out-of-service vessels or repair all leaks
2. Excavate the upper 6-inches of earth within the spill footprint
3. Mix the excavated spill material with 2-5 parts clean soil

4. Use this blended soil for the construction of firewalls around tank batteries (use now or stockpile on site for future use)
5. At abandonment of the site the surface will be restored according to the landowner's specifications

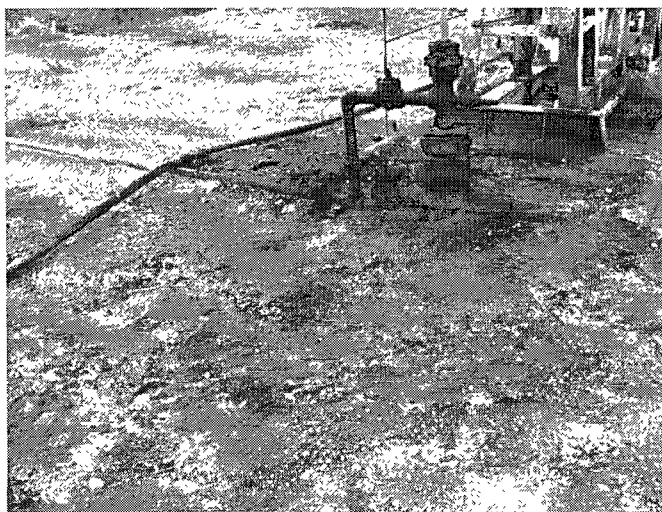
Levers No. 3 Well (OCD Reference No. 2RP-305)

A release of oil occurred from the well head which extends approximately 10 feet in all directions. The table below presents field screening and the laboratory results from soil samples at the surface and at depths of 2.0, 3.0, 4.0, 5.0 and 6.0 feet below the stained area.

Total Petroleum Hydrocarbon (TPH) concentrations measured at the Levers No. 3 site exceeds the 1993 NMOCD Guideline levels but concentrations generally decrease from the surface to the auger refusal depth (6 feet below the surface). Most importantly, none of the regulated hydrocarbon concentrations exceed the 2006 NMED Guideline levels. The fact that the concentrations of regulated constituents do not exceed NMED Guidelines allows us to conclude that the impacted soil does not represent a threat to fresh water or public health. The recommended corrective action for this site is:

1. Remove out-of-service vessels or repair all leaks
2. Excavate the upper 1-2 feet of earth within the spill footprint
3. Mix the excavated spill material with 2-5 parts clean soil
4. Use this blended soil for the construction of firewalls around tank batteries (use now or stockpile on site for future use)
5. Collect a composite sample of the blended soil to demonstrate that constituents are at concentrations that comply with NMOCD Rules and provide letter report to NMOCD
6. At abandonment of the site the surface will be restored according to the landowner's specifications

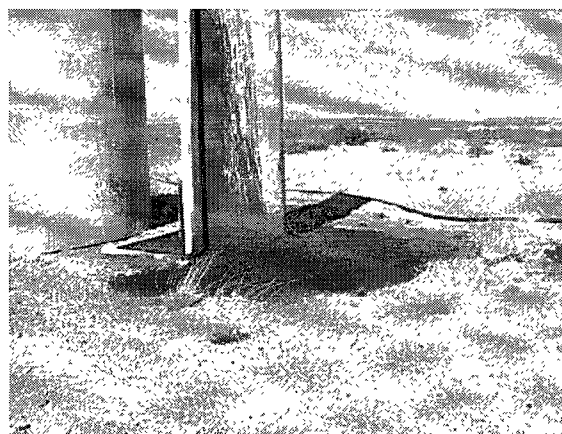
Red-12 Federal No. 1 Battery (OCD Reference No. 2RP-306)

A release of heavy “tank bottom” oil occurred from a broken valve at the base and from a pipe joint near the top of the separator. The spill area extends approximately 30 feet down slope. Laboratory results of soil samples recovered using a hand auger at depths of 0.5, 1.0, and 3.0 feet below the free liquid and field screening are provided on the table below:

TPH concentrations measured from near the surface at the Red-12 Federal No. 1 site exceeds the 1993 NMOCD Guideline levels but decreases to below the guideline levels at 3 feet below the surface. None of the regulated hydrocarbon concentrations exceed the 2006 NMED Guideline levels. The fact that the concentrations of regulated constituents do not exceed NMED Guidelines allows us to conclude that the impacted soil does not represent a threat to fresh water or public health. The recommended corrective action for this site is:

1. Remove out-of-service vessels or repair all leaks
2. Excavate the upper 6-12 inches of earth within the spill footprint
3. Mix the excavated spill material with 2-5 parts clean soil
4. Use this blended soil for the construction of firewalls around tank batteries (use now or stockpile on site for future use)
5. Collect a composite sample of the blended soil to demonstrate that constituents are at concentrations that comply with NMOCD Rules and provide letter report to NMOCD
6. At abandonment of the site the surface will be restored according to the landowner's specifications

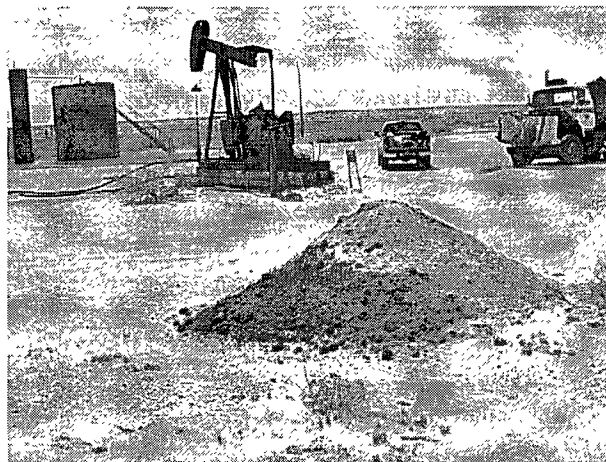
Cave State No. 4 Well (OCD Reference No. 2RP-307)

The operator excavated and stockpiled soil from an apparent release of oil that occurred prior to our characterization. Laboratory and field results from soil samples recovered from the stockpile and below the spill footprint are provided on the table below:

The hydrocarbon concentrations from the removed stockpiled soil at Cave State No. 4 site exceeds the 1993 NMOCD Guideline levels for TPH and the 2006 NMED Guideline levels for benzene. None of the hydrocarbon concentrations measured from the remaining (deeper) soil exceeds either the 1993 NMOCD or 2006 NMED Guideline soil screening levels.

The fact that the concentrations of regulated constituents do not exceed NMED Guidelines allows us to conclude that the impacted soil below the original spill footprint does not represent a threat to fresh water or public health.

We recommend that the operator mix the stockpile with clean soil and utilize it for the construction of a firewall at one of the active tank batteries.

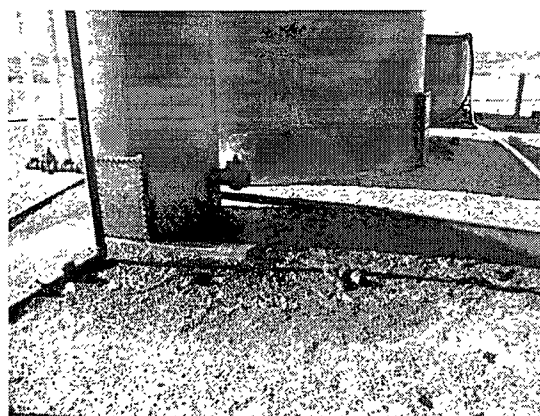
Red-12 State No. 2 Battery (OCD Reference No. 2RP-308)

A release of heavy “tank bottom” oil occurred from a broken valve at the base of a separator and extends approximately 20 feet down slope. Results of laboratory and field analyses of soil samples recovered using a hand auger at depths of 0.5, 1.0, and 3.0 feet below the free liquid are provided on the table below:

TPH concentrations measured from near the surface at the Red-12 State No. 2 site exceeds the 1993 NMOCD Guideline levels but decreases to below the guideline levels at 3 feet below the surface. None of the measured hydrocarbon concentrations exceed the 2006 NMED Guideline levels. The fact that the concentrations of regulated constituents do not exceed NMED Guidelines allows us to conclude that the impacted soil does not represent a threat to fresh water or public health. The recommended corrective action for this site is:

1. Remove out-of-service vessels or repair all leaks
2. Excavate the upper 6-12 inches of earth within the spill footprint
3. Mix the excavated spill material with 2-5 parts clean soil
4. Use this blended soil for the construction of firewalls around tank batteries (use now or stockpile on site for future use)
5. Collect a composite sample of the blended soil to demonstrate that constituents are at concentrations that comply with NMOCD Rules and provide letter report to NMOCD.
6. At abandonment of the site the surface will be restored according to the landowner's specifications.

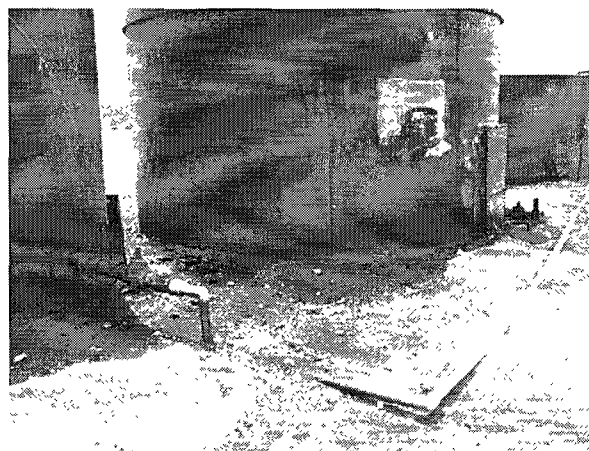
Red-12 State No. 3 Battery (OCD Reference No. 2RP-309)

A release of heavy "tank bottom" oil occurred from leaks located at the base of a 500-bbl oil tank and a separator. The surface staining is present in an area of approximately 500 ft². A composite surface soil sample was recovered from the stained area and subsurface soil samples were recovered from two hand auger borings at depths of 1.0 and 2.0 feet below the free liquid. Laboratory analyses were performed to determine the concentrations of benzene, toluene, ethylbenzene, xylenes; and gasoline, diesel, and oil range hydrocarbons. Field screening and laboratory results are provided on the table below:

TPH concentrations measured from near the surface at the Red-12 State No. 3 site exceeds the 1993 NMOCD Guideline levels but decreases to below the guideline levels at 1 and 2 feet below the surface. None of the measured hydrocarbon concentrations exceed the 2006 NMED Guideline soil screening levels. The fact that the concentrations of regulated constituents do not exceed NMED Guidelines allows us to conclude that the impacted soil does not represent a threat to fresh water or public health. The recommended corrective action for this site is:

1. Remove out-of-service vessels or repair all leaks
2. Excavate the upper 1-2 feet of earth within the spill footprint
3. Mix the excavated spill material with 2-5 parts clean soil
4. Use this blended soil for the construction of firewalls around tank batteries (use now or stockpile on site for future use)
5. Collect a composite sample of the blended soil to demonstrate that constituents are at concentrations that comply with NMOCD

Rules and provide letter report to NMOCD

6. At abandonment of the site the surface will be restored according to the landowner's specifications.

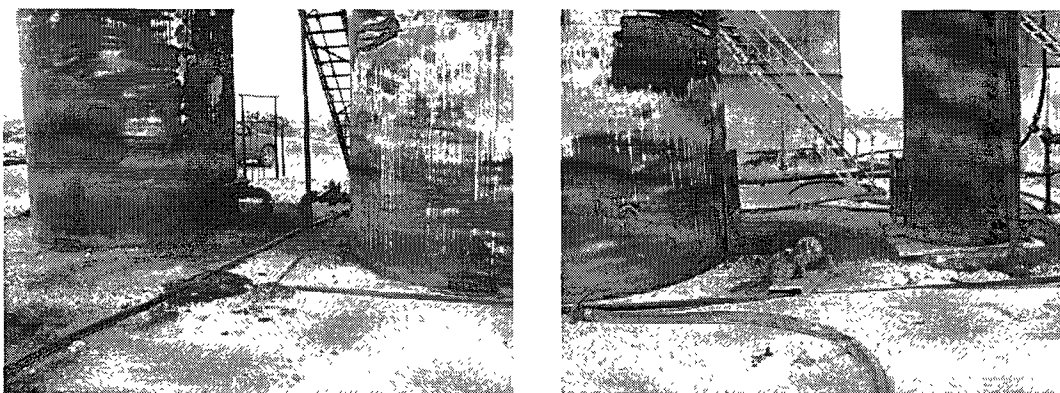
Red-12 State No. 4 Battery and Injector (OCD Reference No. 2RP-310)

Historic spills within the tank battery have occurred resulting in an "asphalt-like" stained soil area of approximately 400 ft². A composite surface soil sample was recovered from the stained area and laboratory analyses were performed to determine the concentrations of benzene, toluene, ethylbenzene, xylenes; and gasoline, diesel, and oil range hydrocarbons. Laboratory results are provided on the table below:

TPH concentrations measured from near the surface at the Red-12 State No. 4 battery site exceed the 1993 NMOCD Guideline levels but none of the measured hydrocarbon concentrations exceed the 2006 NMED Guideline levels. The fact that the concentrations of regulated constituents do not exceed NMED Guidelines allows us to conclude that the hydrocarbon-impacted soil does not represent a threat to fresh water or public health. The recommended corrective action for this site is:

1. Repair all leaks
2. Excavate the upper 1-2 feet of earth within the spill footprint
3. Mix the excavated spill material with 2-5 parts clean soil
4. Use this blended-asphaltic soil for the construction of firewalls around tank batteries (use now or stockpile on site for future use)
5. Collect a composite sample of the blended soil to demonstrate that constituents are at concentrations that comply with NMOCD Rules and provide letter report to NMOCD
6. At abandonment of the site, disc hay and other organic material into hydrocarbon-impacted soil to open soil structure and permit infiltration of precipitation. Repeat tilling and addition of organic material or other soil amendments as necessary to meet landowner mandates for surface restoration and thereby eliminate the threat to the environment (i.e. soil and habitat) posed by the hydrocarbon-impacted soils

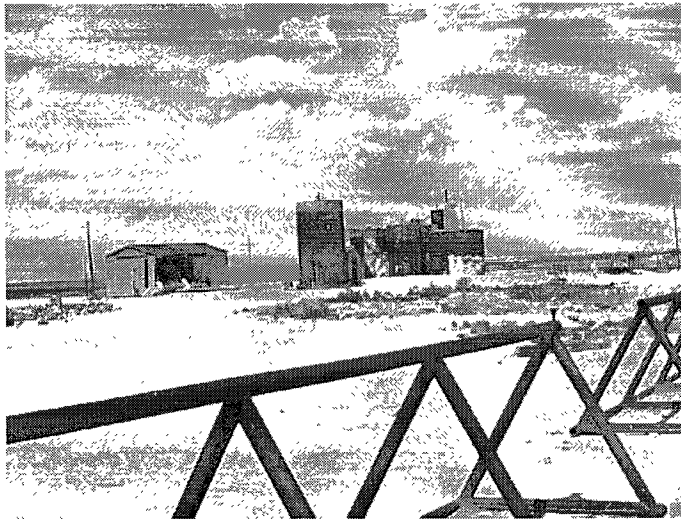
The tank battery is located on a topographically high area and much of the soil within the bermed area and the surrounding topographically low areas exhibit characteristics of one or more historic brine water releases. Three hand auger borings were installed in the low areas surrounding the tank battery in order to better characterize the extent of the chloride-impacted soil. Plate 2 is a site map drawn on a July 2005 satellite photograph that depicts the current extent of stressed vegetation, the location of the hand auger borings, and the laboratory results from soil samples recovered at the site. It should be noted that the extent of the stressed vegetation observed during the inspection has changed since 2005. Some of the vegetation to the north and south has decreased while areas to the west appear to have recovered.

At the topographically low areas to the north and west of the tank batteries chloride concentrations in soil prevent re-vegetation. The vertical extent of the impacted soil could not be determined due to auger refusal. Further investigations at the Red-12 State No. 4 site will be conducted to verify the vertical extent of the chloride-impacted soil in order to determine the potential threat to ground water. Following the completion of these activities a final report will be submitted to the NMOCD.
