REPORTS

**RE: Corrective Action Report and Termination Request
BD Jct. A-27 Release (1R-27)
T22S-R37E-Section 27, Unit Letter A
Lea County, New Mexico**

ATTACHMENT A

ATTACHMENT B

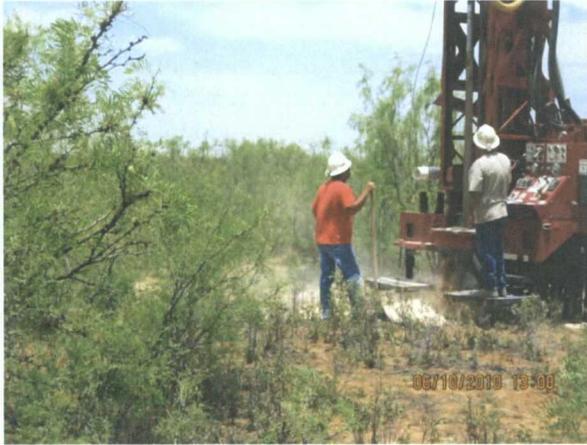
drilling SB-9

On June 10, 2010, ROC completed soil boring SB-9, located between SB-5 and SB-7. The boring was completed to a depth of 30-ft below ground surface (bgs) and confirms that the criteria for chloride delineation have been met in which three consecutive samples showed a decreasing chloride concentration with depth and the last sample at 30-ft bgs having a chloride concentration of 151 mg/kg based on field titration. Laboratory analysis confirmed the 30 ft sample at 32 mg/kg. Photographic documentation of this activity, a lithologic log with chloride concentration data, and the laboratory analytical report are included in Attachment A.

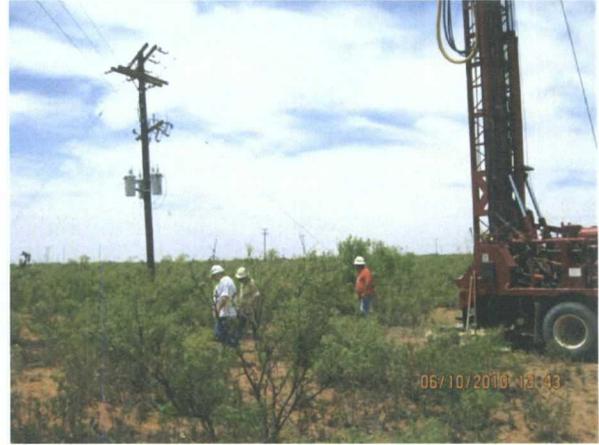
SB-9 in relation to the high line wires

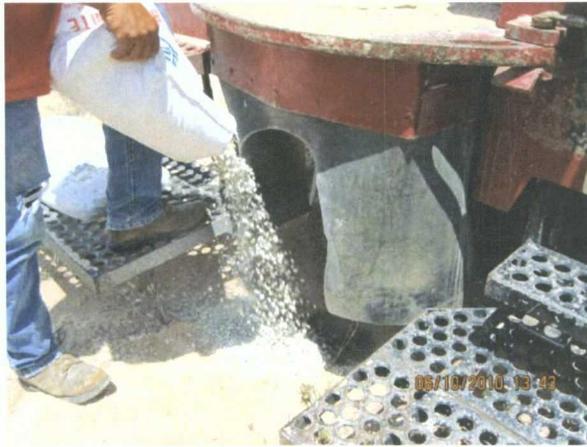
plugging SB-9 in total with bentonite

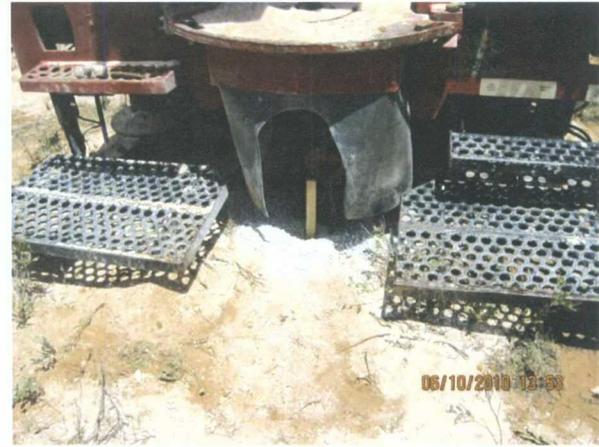
SB-9 complete

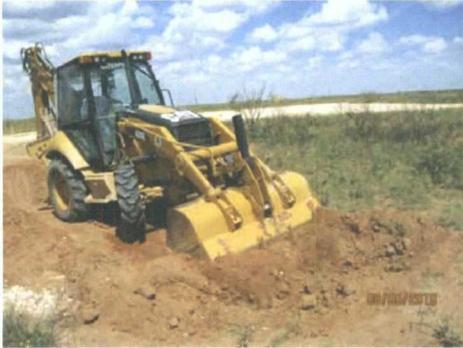
scraping the surface water management areas

On August 4, 2010, ROC began remediation of the surface water management areas by excavating the three areas to approximately 1.5 ft bgs. The three areas were then scraped and contoured resulting in the east area measuring 480 sq ft, the middle area measuring 150 sq ft., and the west area measuring 312 sq ft. Four loads (48 yd³) were hauled to an OCD-permitted landfarm facility (Sundance Services, Inc.). The three areas were finished by removing rocks and re-seeding of the finished areas was completed on August 12, 2010. Photographic documentation of this activity and a copy of the OCD-approved *Corrective Action Plan Addendum* are included in Attachment B.

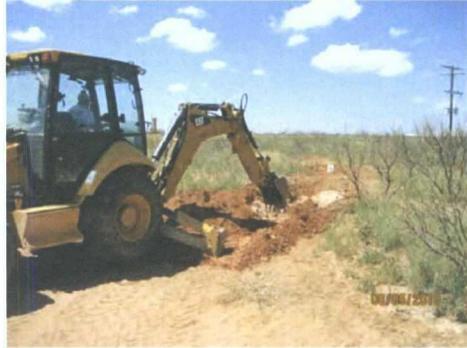
digging the surface water management areas

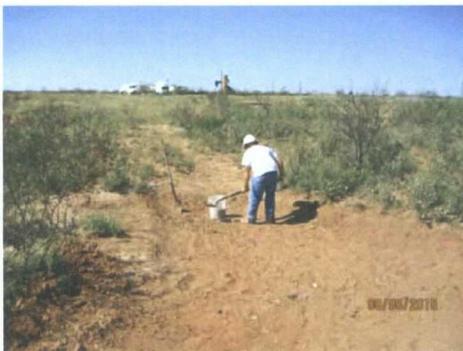
removing rocks

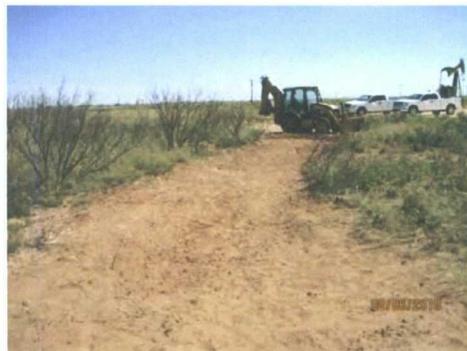
middle surface water management area complete

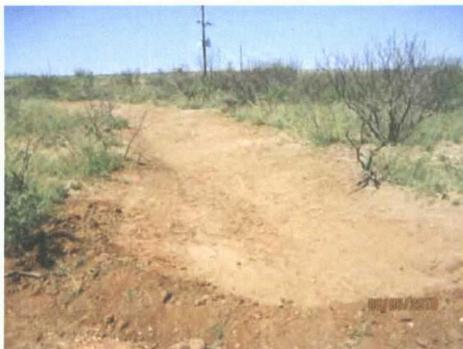
east surface water management area complete

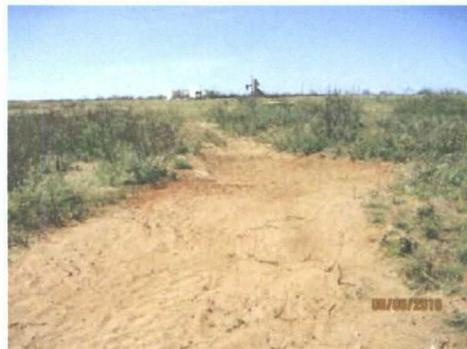
west surface water management area complete

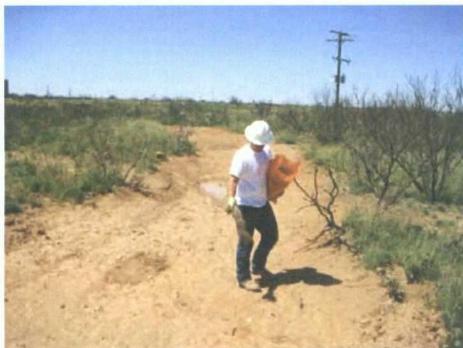
seeding the site

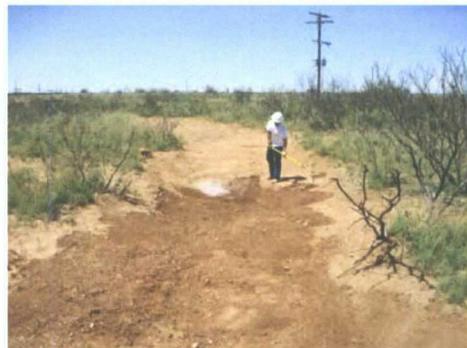
raking in seed

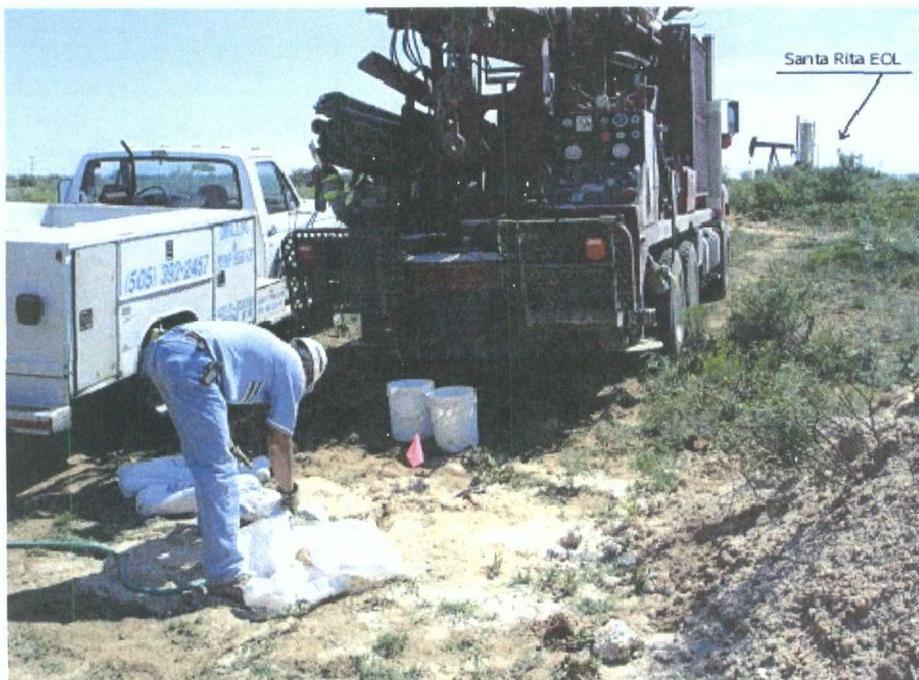
Between August 30-31, 2005, SB-1 through SB-8 were drilled at BD A-27 leak (1R27). Upon completion, each soil bore was plugged with bentonite (photo documentation is included below). If you have any questions or require any additional information, please contact Hack Conder at (575)631-6432.
