UNDERGROUND OBSERVATIONS OF MINED-THROUGH STIMULATION TREATMENTS OF COALBEDS

by William P. Diamond¹

Quarterly Review of Methane from Coal Seams Technology
Volume 4, Number 4 (June 1987), p. 19-29.

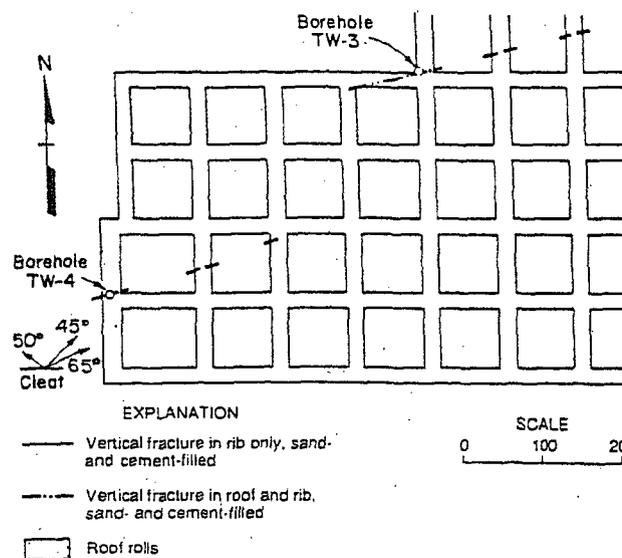
fracture wing lengths of 70 to 100 ft; and only four had wing lengths over 100 ft (Figures 1, 2 and 3).

Figure 1. Locations of vertical fractures from boreholes TW-3 and TW-4, Blue Creek Coalbed, Oak Grove mine, Jefferson County, Alabama.

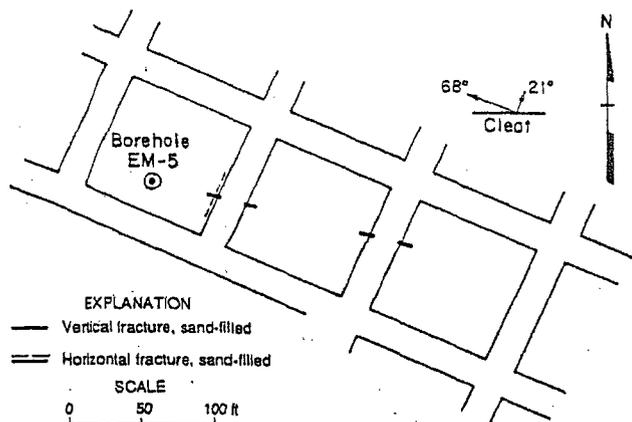
Figure 2. Location of vertical and horizontal fractures from borehole EM-5, Pittsburgh Coalbed, Emerald mine, Greene County, Pennsylvania.

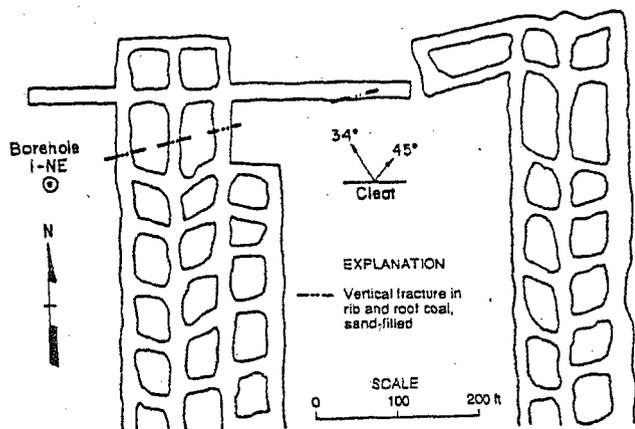
Figure 3. Location of vertical fracture from borehole 1-NE, Illinois No. 6 Coalbed, Inland Steel mine, Jefferson County, Illinois.

Most of the observed sand-filled and paint-coated vertical fractures penetrated or paralleled the coal's face cleat and occasionally butt cleat. The longest sand-filled vertical fracture (416 ft, Illinois No. 6 Coalbed, borehole 1-NE) notably did not parallel either cleat direction but trended approximately 30° from the butt cleat orientation (Figure 3). This variant trend may have resulted from the influence of local horizontal stress fields; or it may actually be an unobserved stair-stepping of the fracture along both the face and butt cleat, which results in an apparent oblique orientation. At several locations, fractures paralleling the face cleat did not directly intercept the borehole when projected from their points of observation. Apparently these treatment fluids followed stair-step pathways through the coalbed, with only the face cleat fractures observable on exposed ribs and pillars.

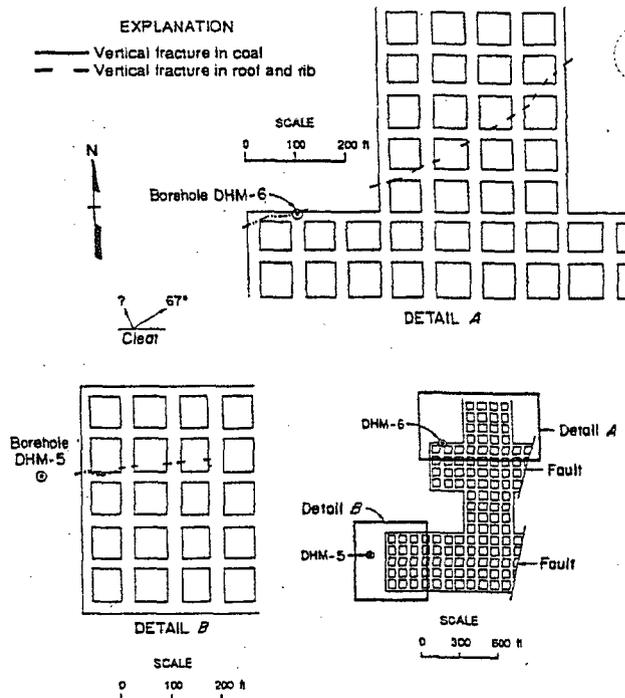
whether or not the fractures represented by paint-coated cleat represent paths of increased permeability that can enhance the flow of water and gas to the wellbore. An excellent example of additional traceable fracture length was observed at borehole DHM-6 in the Blue Creek Coalbed, where sand-filled fractures could be traced a maximum 95 ft southwestward from the borehole, compared to paint-coated cleat observed 630 ft to the northeast (Figure 4).

Figure 4. Locations of vertical fractures from boreholes DHM-5 and DHM-6, Blue Creek Coalbed, Oak Grove mine, Jefferson County, Alabama.

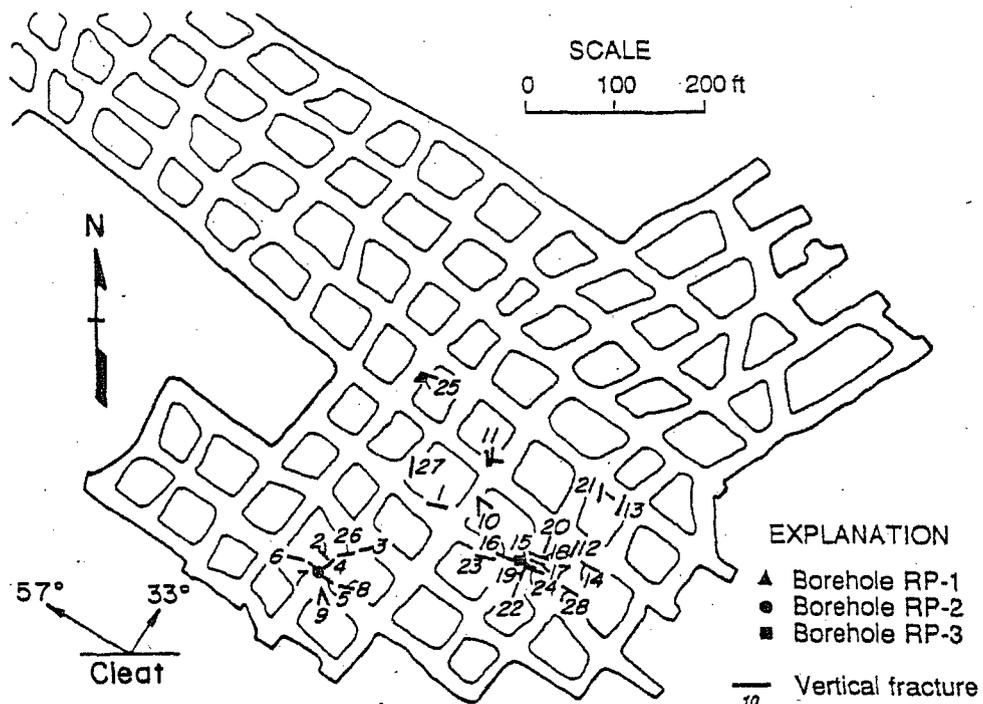
The most extensive paint-coated paths of fluid movement were observed in the vicinity of boreholes RP-2 and RP-3 in the Upper Freeport Coalbed (Figure 5) and borehole TW-5 in the Blue Creek Coalbed (Figure 6). Fluid volume appears to have influenced the extent of fluid movement in that a greater number of fractures were associated with borehole RP-3, whose treatment volume was approximately one-third larger than that for RP-2. Borehole TW-5 also had one of the largest volume treatments.

Figure 5. Locations of vertical fractures around boreholes RP-1, RP-2, and RP-3, Upper Freeport Coalbed, Lucerne No. 6 mine, Indiana County, Pennsylvania.

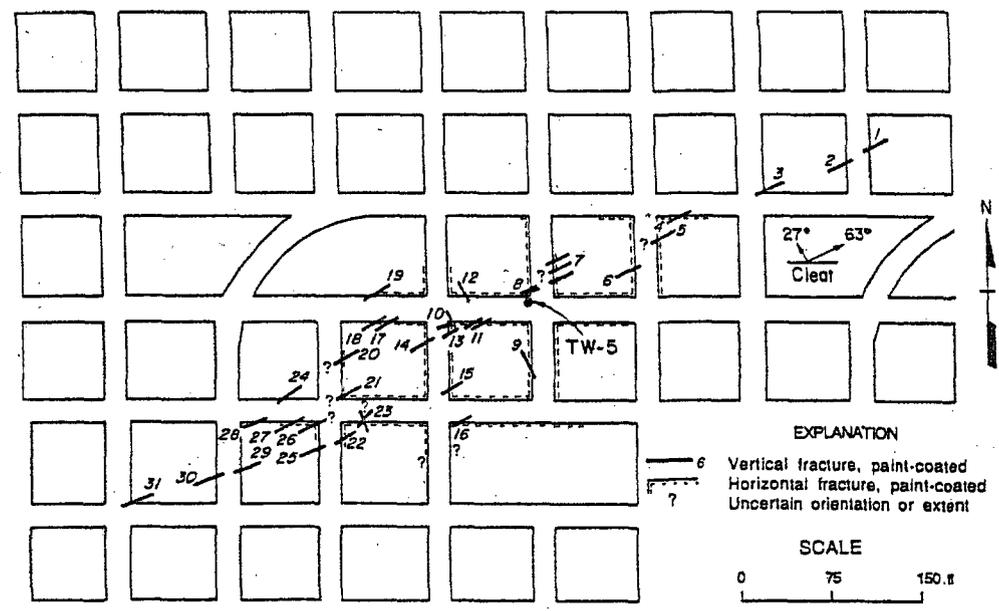
Figure 6. Locations of vertical and horizontal fractures around borehole TW-5, Blue Creek Coalbed, Oak Grove mine, Jefferson County, Alabama.

Horizontal fractures were most commonly observed at the interfaces between coalbeds and the roof rock, but some also were found along other distinct interfaces such as shale partings, shaly or hard, dense bands in the coalbed, or the bottoms or tops of rider coals in the immediate roof rock. Although generally erratic (in part because of difficulty in mapping their entire extent), the distribution of sand and paint on horizontal surfaces in two boreholes, RP-2 and RP-3, suggests some correlation between cleat orientation and the axes of horizontal lobes of paint (Figures 9 and 10). At borehole TW-5 the horizontal (and vertical) fractures covered a generally elliptical area whose long axis paralleled the face cleat orientation (Figure 6).

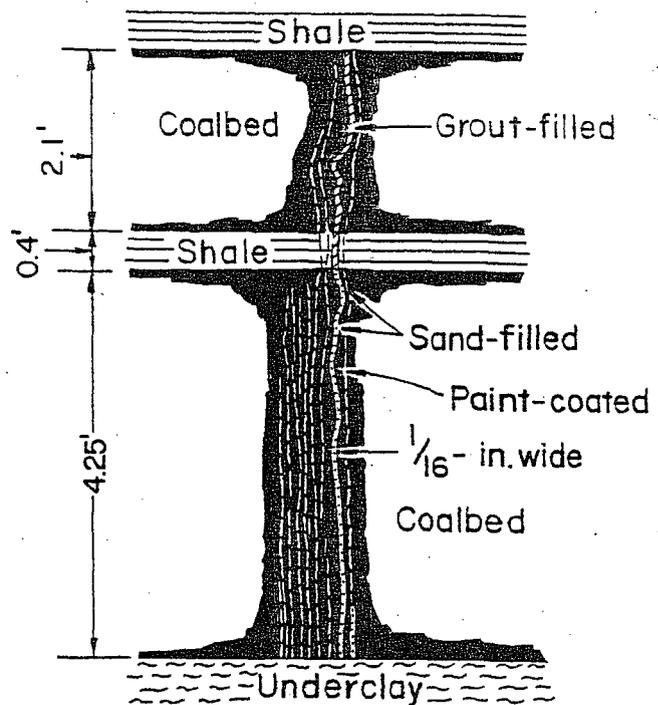
Zones of multiple parallel sand-filled and/or paint-coated fractures commonly occur near the boreholes. Progressively farther from the boreholes, the number of multiple vertical fractures usually decreased to a point at which only a single fracture remained. The fluorescent paint was particularly useful in identifying multiple fluid pathways that were essentially only the width of a cleat (Figure 7). The occur-

rence of multiple fractures correlates with coal friability—fracture zones were more prevalent in friable coalbeds, such as the Upper Freeport (Figure 7) and the Blue Creek (Figure 8). On the other hand, single, wide, sand-filled fractures were predominant in hard, blocky coalbeds, such as the Pittsburgh. These observations may, however, be somewhat biased because none of the treatments in the Pittsburgh Coalbed contained paint, and many zones of multiple fractures in the friable coalbeds were identifiable only as paint-coated cleat. One must therefore exercise caution when comparing the results of treatments with and without paint.

Figure 7. Cross-section of vertical fractures at location 25 on southeastern coal rib near borehole RP-1, Upper Freeport Coalbed, Lucerne No. 6 mine, Indiana County, Pennsylvania.

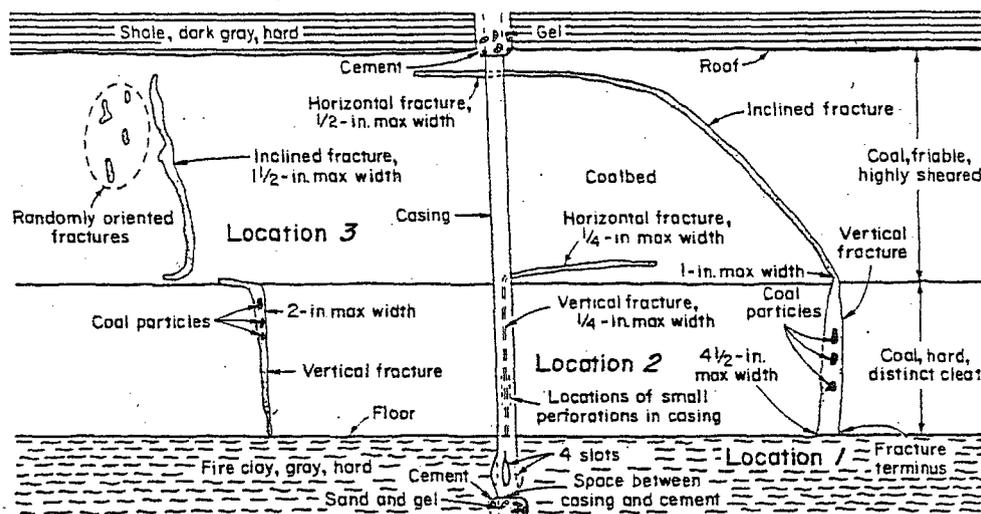
Perkins and Kern (1961), Halliburton Services (1971), and Lambert and others (1980) have suggested that gelled-water stimulation treatments with sand proppant would theoretically produce relatively short, wide, sand-filled vertical fractures, and foam treatments would produce longer, narrower, sand-filled fractures. The widest sand-filled fracture observed (4 1/2 in., borehole TW-2) was from a gelled-water treatment in the Blue Creek Coalbed (Figure 8). A 2 1/2-in.

Figure 8. Cross-section of coal face at borehole TW-2, showing orientations and characteristics of fractures in the Blue Creek Coalbed, Oak Grove mine, Jefferson County, Alabama.

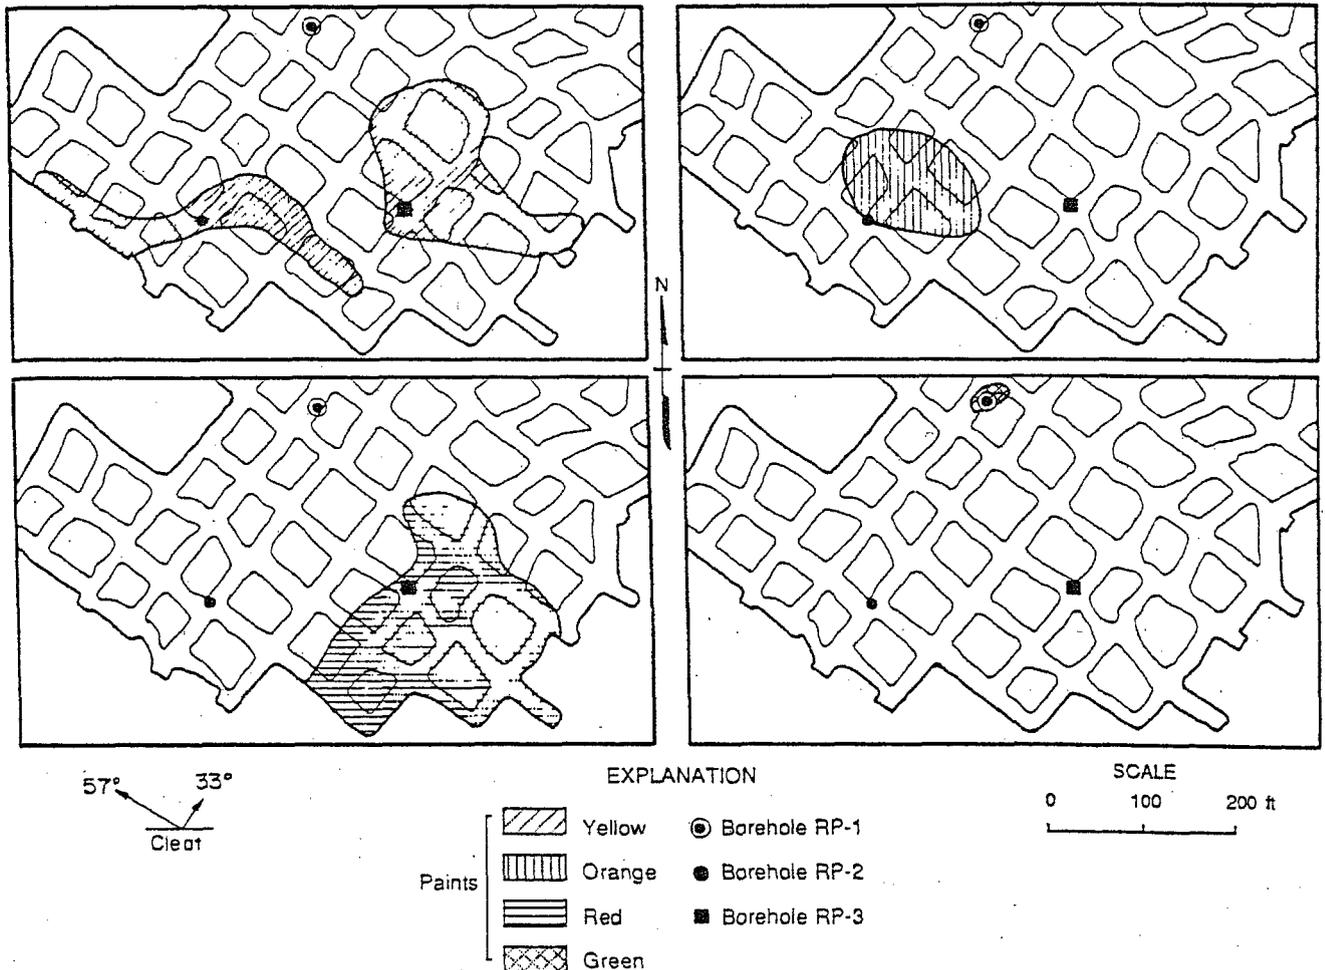
Multiple horizontal fractures on different planes have been observed in several cases. Although usually thin (< 1/2 in.), they vary considerably in width over short distances and may be discontinuous along an exposed rib (Figure 11). Sand-filled horizontal fractures were generally widest near the wellbore (maximum 1 in.). Their maximum observed lateral extents ranged from 200 ft in the Upper Freeport Coalbed at borehole RP-3 (Figure 10) to 250 ft in the Jawbone Coalbed at borehole DG-1A (Lambert and others, 1980). Maximum lateral extents of paint-coated horizontal fractures varied from 230 ft in the Blue Creek Coalbed at borehole TW-5 (Figure 6) to 200 ft and 265 ft in the Upper Freeport Coalbed at boreholes RP-2 and 3 (Figures 9 and 10).

Figure 9. Horizontal extent of indicator paints on mine roof around boreholes RP-1, RP-2, and RP-3, Lucerne No. 6 mine, Indiana County, Pennsylvania.

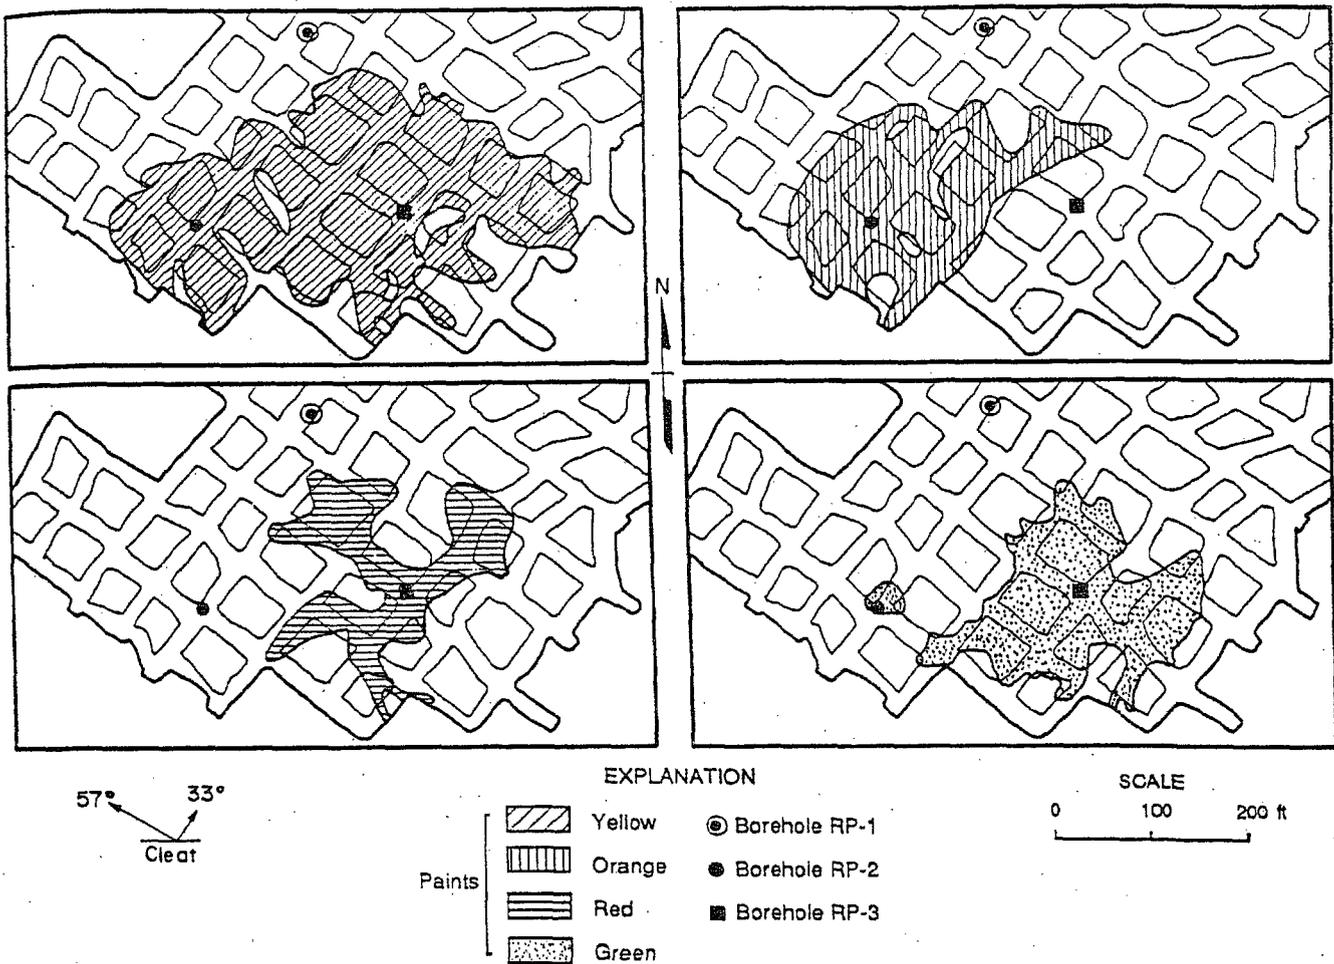
Figure 10. Horizontal extent of indicator paints and sand on top of shale parting around boreholes RP-1, RP-2, and RP-3, Lucerne No. 6 mine, Indiana County, Pennsylvania.

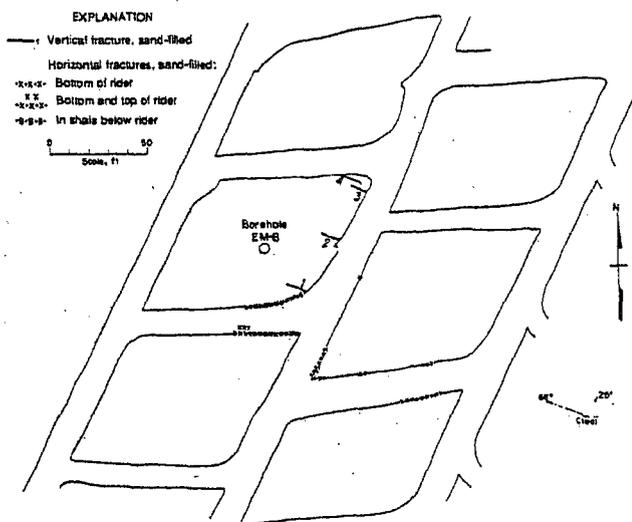
Figure 11. Locations of vertical and horizontal fractures around borehole EM-8, Pittsburgh Coalbed, Emerald mine, Greene County, Pennsylvania.

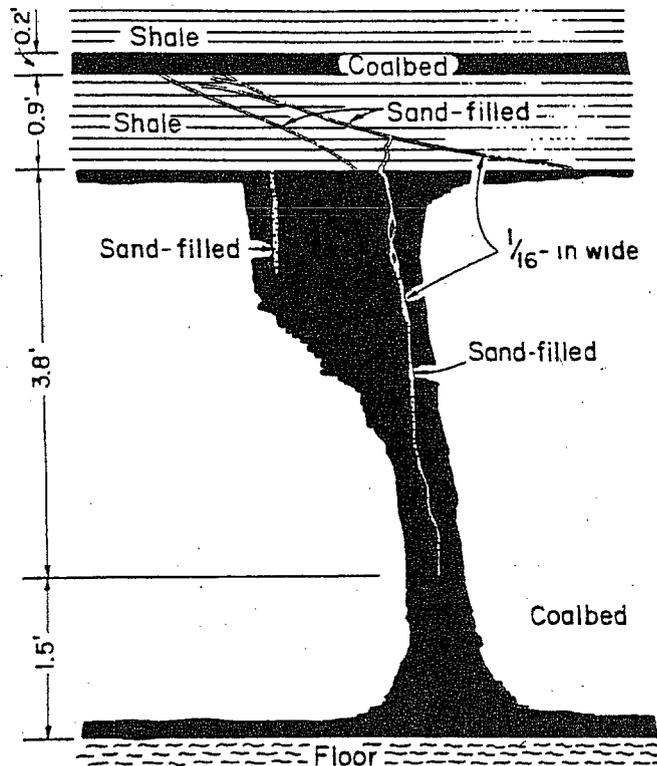
In several cases the strata penetrated above coalbeds have been weak, thin shales below rider coals, and the fractures have been contained within strata that generally were mined along with the main bench of coal throughout the mine to prevent them from deteriorating and later falling (Figure 12).

Figure 12. Cross-section of fractures in rib and shale parting at location 1 near borehole EM-8, Pittsburgh Coalbed, Emerald mine, Greene County, Pennsylvania.

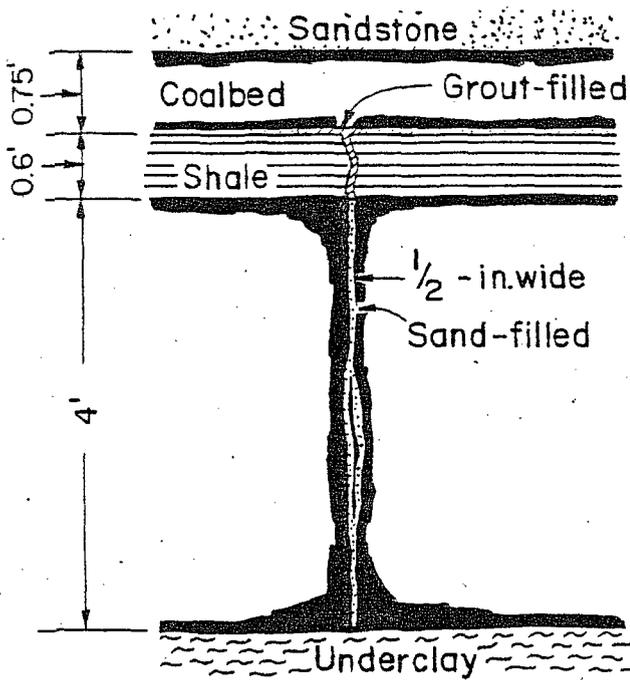
Figure 13. Cross-section of fractures in rib and shale parting at location 7 on the northwest rib near borehole RP-2, Upper Freeport Coalbed, Lucerne No. 6 mine, Indiana County, Pennsylvania. Modified from Murrie and others (1984).

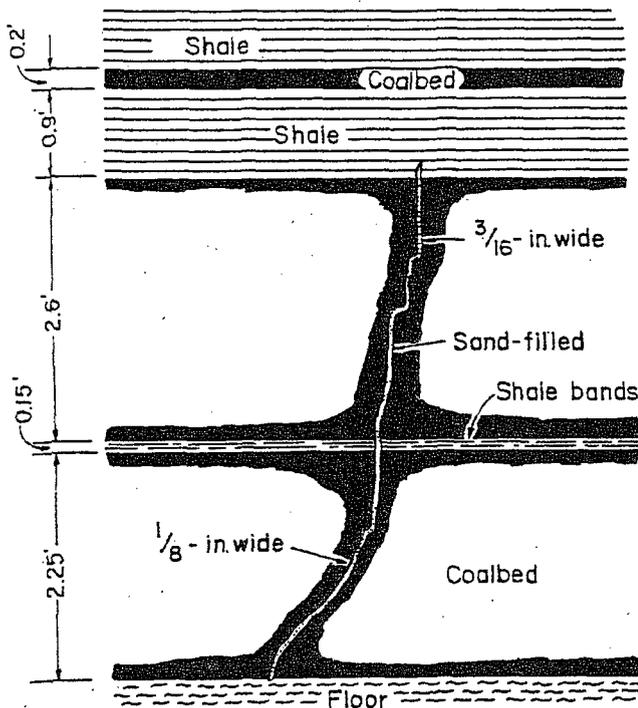
Figure 14. Cross-section of fracture in rib and shale partings at location 4 near borehole EM-8, Pittsburgh Coalbed, Emerald mine, Greene County, Pennsylvania.

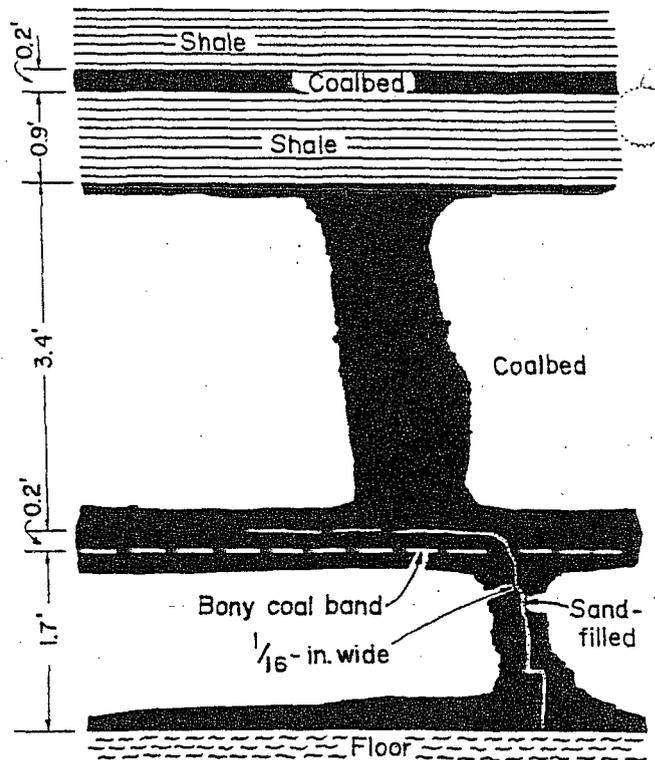
Figure 15. Cross-section of fracture in rib at location 2 near borehole EM-8, Pittsburgh Coalbed, Emerald mine, Greene County, Pennsylvania.
