Inconsistencies regarding reported cement top:

### Main Points Addressing Wellbore Integrity

### NMOCD CASE NO. 15397: OXY-442

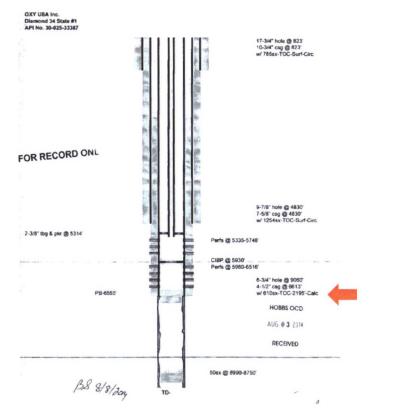
1/20/16: Oxy furnishes cement bond log, dated 8/19/1997, to

Devon (Requested 10/14/2015)
Estimated top of cement at 5165'
TOC is indicated by "good bond indicator" on log

(shaded section in CBL amplitude track).

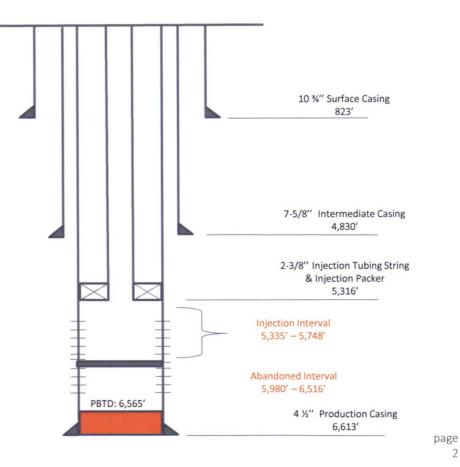
- 7-5/8" intermediate casing set above base of salt
- Bond log indicates presence of free pipe below 5100'
  - Chevron patterns and weak formation arrivals on VDL track indicate absence of cement coverage down to a depth of at least 5,115'
- Free pipe section includes both Base of Salt (5,044) & Top of Bell Canyon formation (5,098')
- Cement coverage does not extend to intermediate casing shoe, cover the top of the permitted injection zone, or cover the base of the salt section

- Lack of cement bond behind production casing establishes conduit for fluid flow between permitted injection zone and base of salt section
- High likelihood of washouts in salt section provides additional path for vertical fluid migration behind intermediate casing

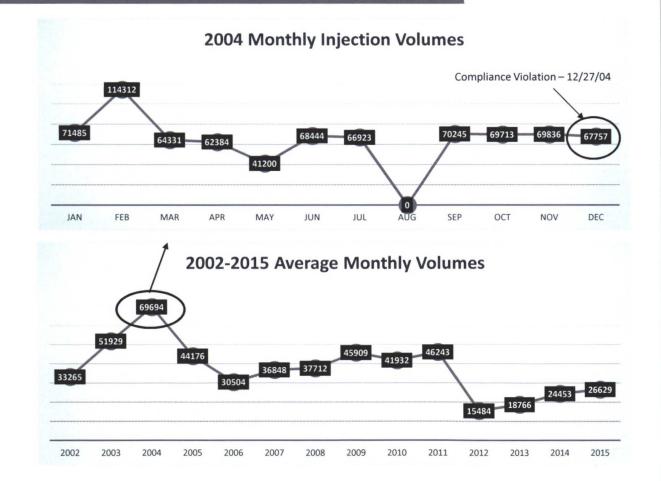
- Overpressure compliance violation cited in December, where reported volumes were similar to average volumes injected throughout the year (NMOCD record)
- Reported monthly injection volumes in 2004 greatly exceeded average injection volumes of any other year since 2002
- As late as September 2015, Oxy continued to inject above permitted pressures (ref: Oxy-257)

- Fracture gradient likely was exceeded, which could have established a vertical path into the production casing annulus
- This far-wellbore path would be unidentifiable by RA-tracer survey data if communication was established beyond the tool's depth of investigation
