CORROSION CONTROL ON ROBINSON #1

FIELD LABORATORY REPORT

WATER ANALYSIS

LABORATORY LOCATION	Midland, Texas	REPORT NUMBER	12612
COMPANY	Sam Boren	WELL	Robinson #1
POOL	Wildcat	LOCATION	
COUNTY	Rossevelt	STATE	Texas
FORMATION	Bough "C"	DEPTH	9644'-9651'
SUBMITTED BY	Krey	TESTS DESIRED	Analysis

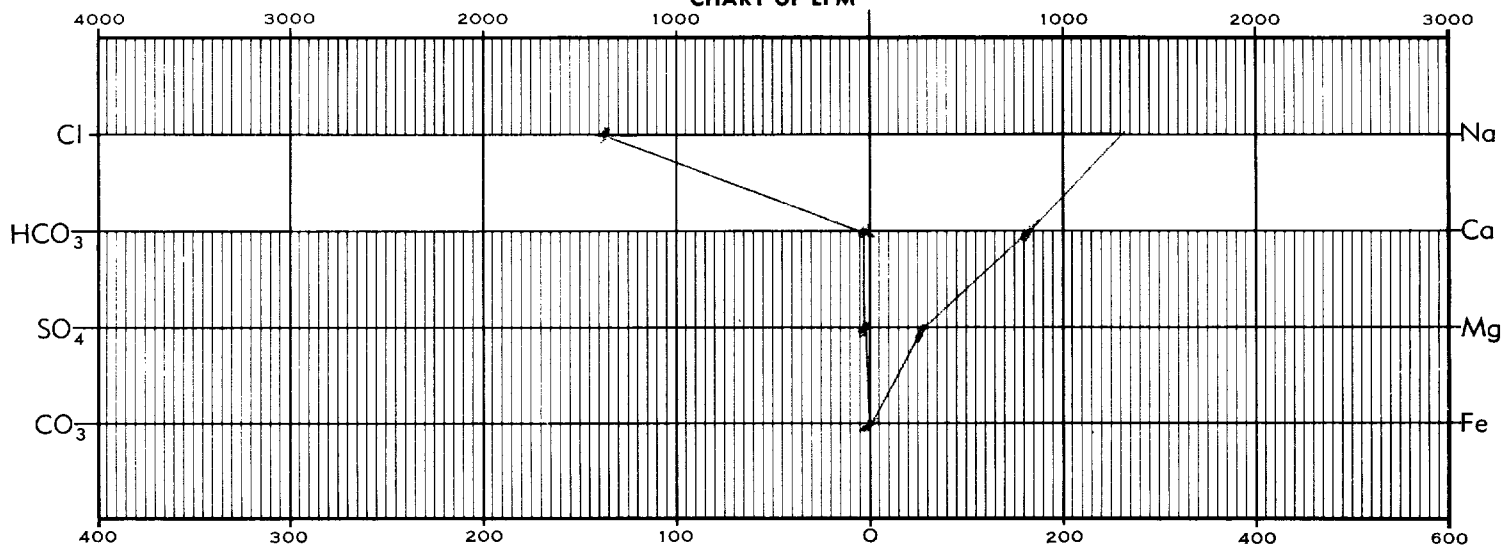
CHART OF EPM

Corrosion tests showed this sample to be corrosive.
