# OXY USA, Inc. West Dollarhide Devonian Unit #101 Delineation Report and Work Plan

Section 33, T24S, R38E Lea County, New Mexico

**September 24, 2014**

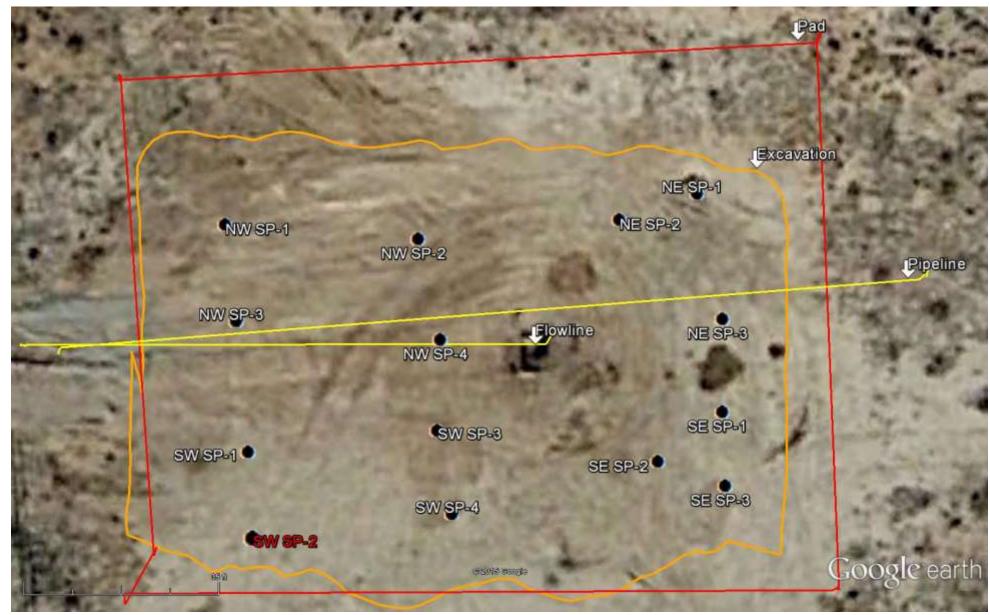
West Dollarhide Devonian Unit 101

On February 20, 2015 excavation began on the site. The site was excavated to a dwpth of approximately 2'. On March 4, 2015 SESI collected 14 field samples, (refer to photo below for sample points). The results of the field samples are presented in the table below:

Northwest	Southwest	Northeast	Southeast
SP-1 152PPM	SP-1 532PPM	SP-1 204PPM	SP-1 204PPM
SP-2 580PPM	SP-2 2444PPM	SP-2 864PPM	SP-2 404PPM
SP-3 532PPM	SP-3 204PPM	SP-3 204PPM	SP-3 864PPM
Sp-4 740PPM	Sp-4 364PPM

- 1. Excavate areas around NW SP-4, SW SP-2, NE SP-2 and SE SP-3 to the depth where the chloride concentrations are in the 500PPM range. Contaminated soil transport to an approved NMOCD facility for disposal. In the event that these areas do not reach the target of 500 PPM within 2' an impermeable liner will be installed in just that area. Otherwise, no liner will be installed for this site.
- 2. The excavated area will be backfilled with caliche and returned to grade.
- 3. A closure report and a final C-141 will be filed upon completion of the above work.
