GW - 203

**Subject: Response Letter: Inspection Report, GW-203
Baker Petrolite Hobbs Facility
Lea County, New Mexico**

Re: Inspection Report, GW-203
Baker Petrolite Hobbs facility
Lea County, New Mexico

**RE: GW-203 Hobbs Facility Inspection
Lea County, New Mexico**

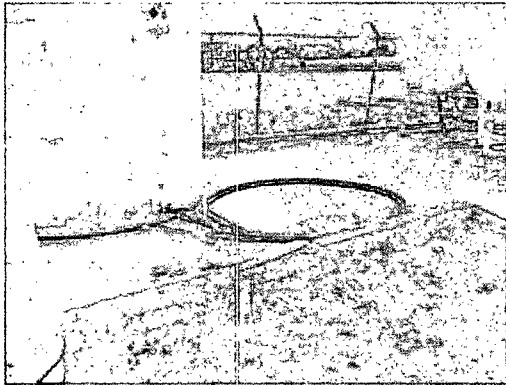
1. **Photo 1, 5 & 7:** A few secondary containment areas appeared to have some wear and tear. **Photo 1** shows cracks near the "berm" portion of the containment. **Photo 5** shows a hole in the containment area. **Photo 7** shows cracks in the floor of containment. These concerns defeat the purpose of a secondary containment. A previous inspection by the OCD was done on 02/10/2005 and that concluded concerns of cracks in the chemical storage secondary containment area. (See Attached 03/04/1995 inspection letter). Baker Petro shall address these concerns and submit to the OCD a plan of action for resolution.

Photo 1: Cemented secondary containment with cracks.

1. Referencing photos 1, 5 and 7. Cracks in concrete containment areas floors and "berms". We have solicited estimates from third party contractors to repair these areas including filling of the cracks and hole mentioned in photo 5. These written estimates will be submitted for approval from Baker Petrolite management and the work will be completed as quickly as possible following approval. The cracks in the floors of the concrete containment were repaired by a third party contractor following the 2-10-05 inspection using an epoxy / silicon product.

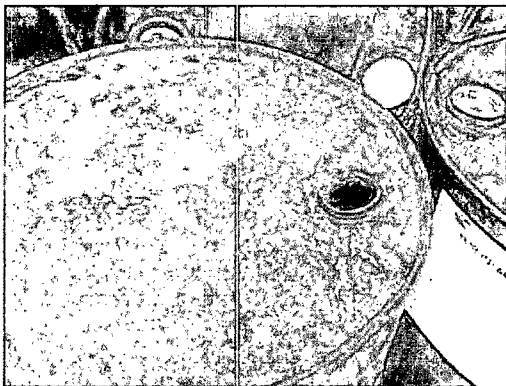
2. **Photo 2:** The majority of containers and barrel storage at the facility are in good condition except for the missing bung on this barrel. The permit requires that all barrels and containers are stored and cared for properly. Baker Petro shall abide by all conditions of their permit.

Photo 2: Bung missing on barrel.

2. Referencing Photo 2. The drum missing the 2 inch bung has been corrected. Baker Petrolite will abide by all conditions of the permit.
3. Referencing photos 3 and 4. The diesel tank described was out of service at the time of inspection and was labeled as such using an "out of service" tag seen in photo 4. However, we will remove this tank from this area and place it inside the containment as suggested to remain compliant with our permit.

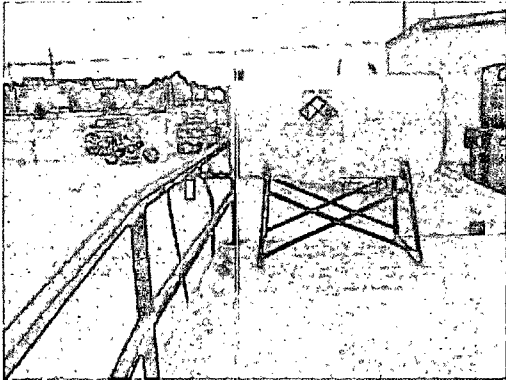
3. **Photo 3 & 4:** A saddle diesel tank was situated without secondary containment and not properly situated. At the time of inspection it was noted to the OCD that this was a temporary set up. The OCD understands working conditions but stresses the fact that knowingly and willing incidences of discharge or potential discharge is a violation of the facilities discharge plan permit. Baker Petro shall always adhere to its permit conditions.

Photo 3: Saddle tank without proper containment on ramp.

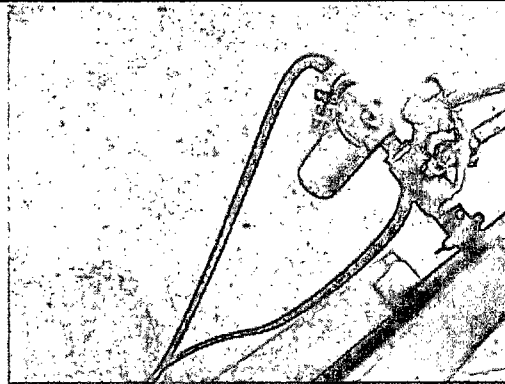
Photo 4: View of diesel saddle tank over edge.

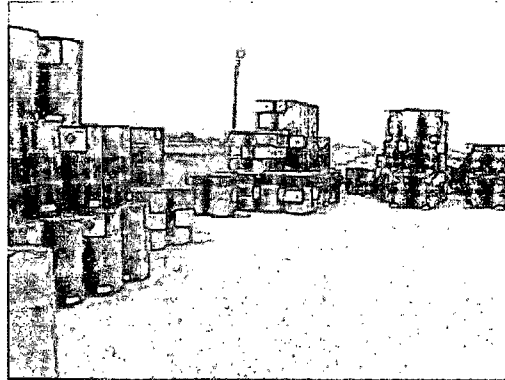
Photo 6: Large amount of chemicals located on secondary containment area.

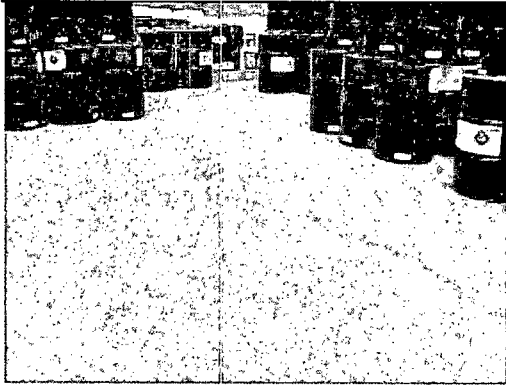
Photo 7: Cracks noted in cemented area of containment area.

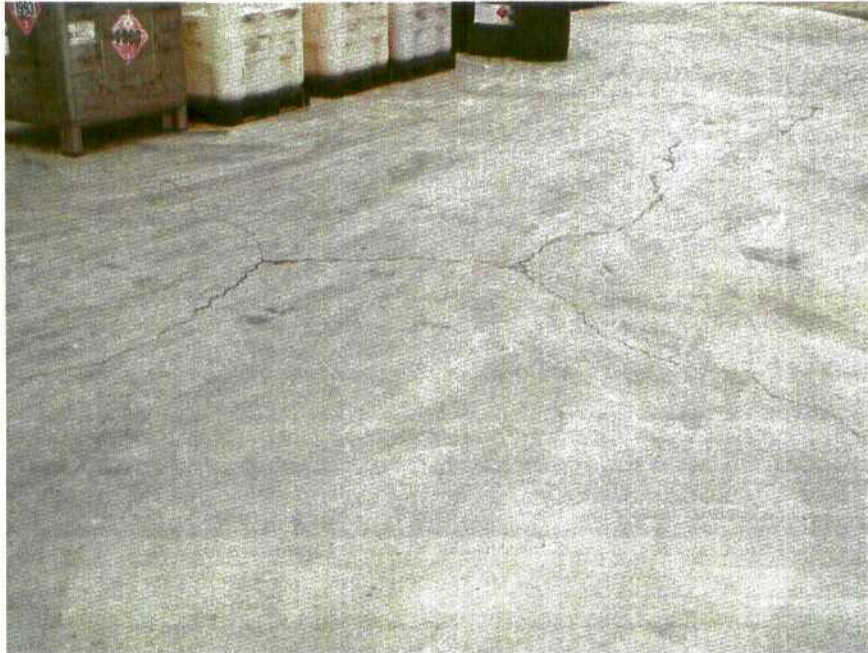
1. The raised concrete containment area contains numerous cracks that could allow chemicals stored in the containment area to escape to the ground surface thereby creating a potential adverse impact to the environment. See attached pictures. It is recommended that attention be given to replacement of the containment area or sealing of the concrete to prevent a potential discharge to the ground surface.

Concrete failure

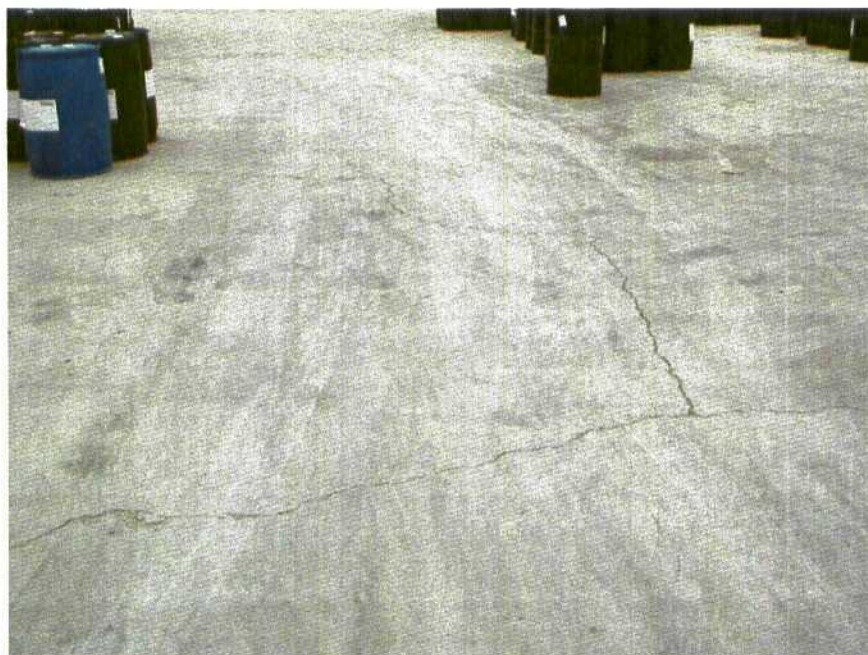
Concrete failure

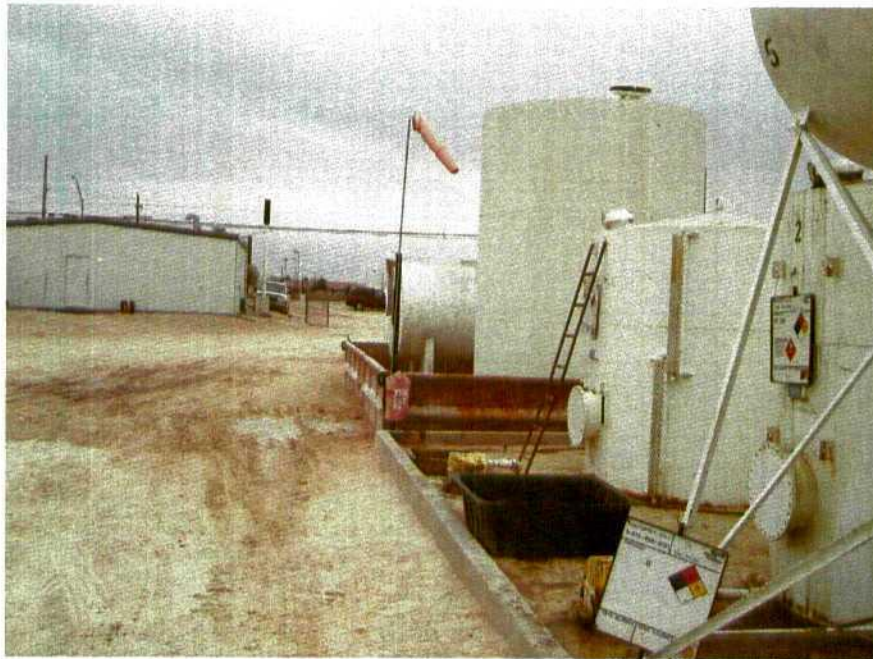
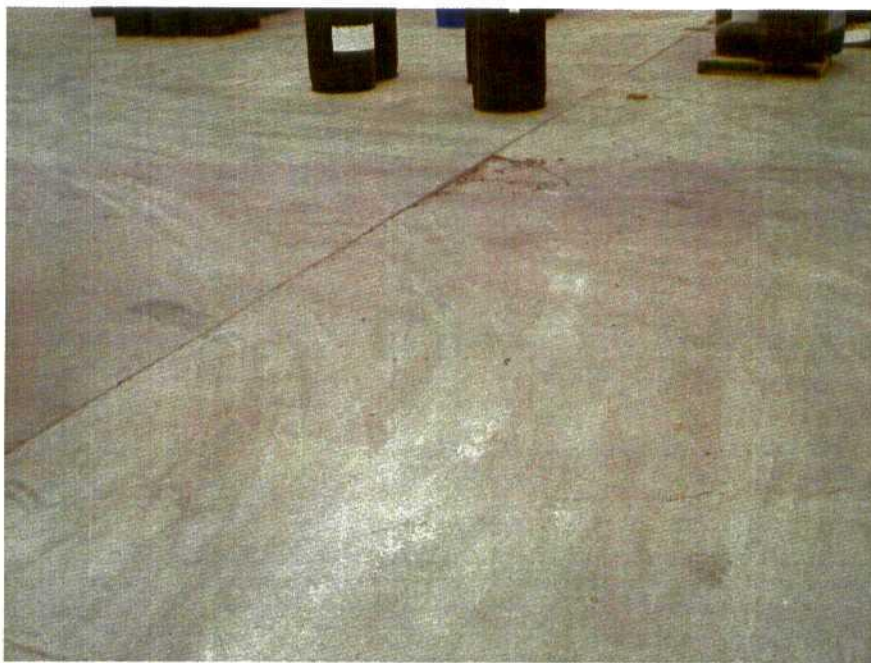
Concrete failure

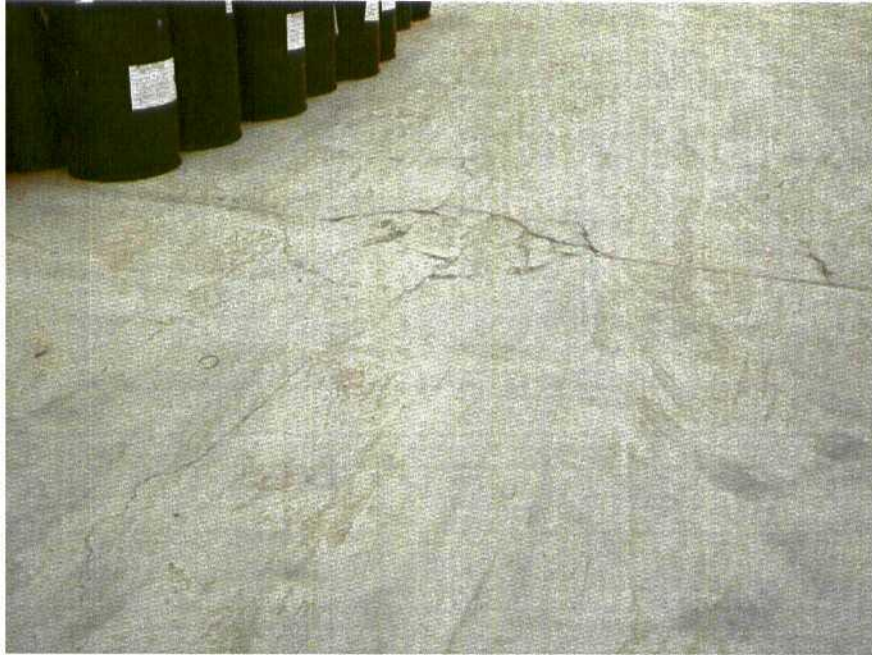
Concrete failure

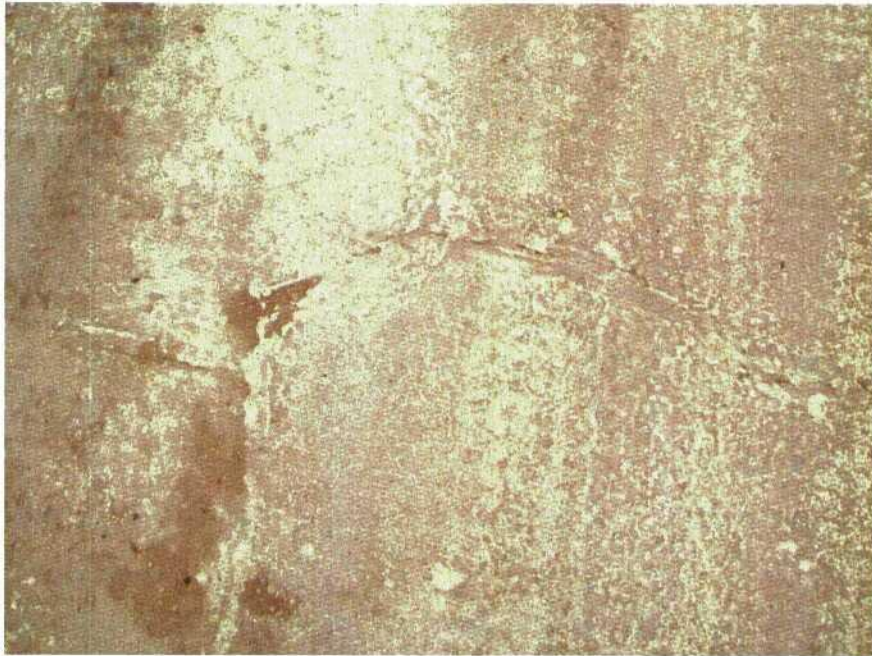
Concrete failure

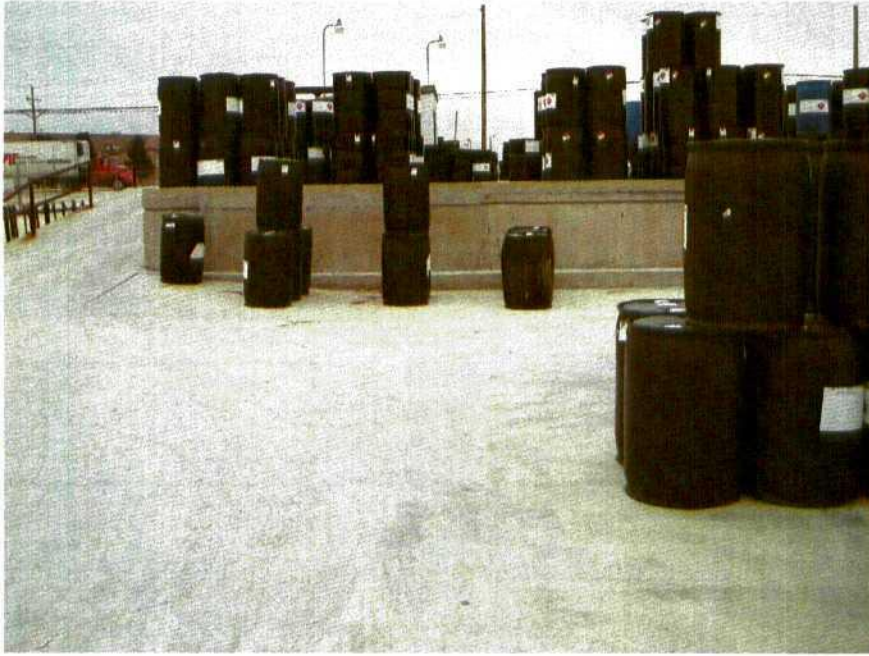
Drum storage on concrete containment area
