Highlander Environmental Corp.

September 15, 2005

RE: **INVESTIGATION & CHARACTERIZATION WORK PLAN
K-4 LEAK, BD SWD SYSTEM
UNIT "K", SEC. 4, T22S, R37E**

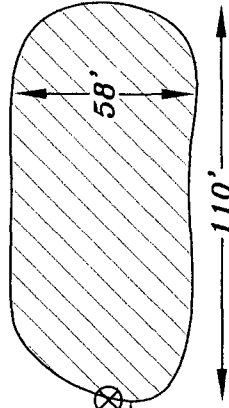
FIGURE NO. 2

LEAK

34'

SPILL AREA
