Release Notification

Chaco 2308 4P 149H Narrative

Enduring Resources, LLC Chaco 2308 4P 149H Photo Page

NRM2019555862

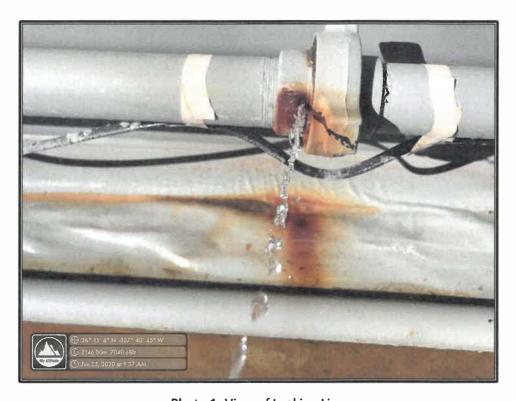
A waterline leak was discovered at the Chaco 2308 4P 149H wellsite. The line leak was due to internal corrosion on the above ground water dump line, leaking 7 bbls of produced water onto the lined secondary containment for this well facility. The leak was stopped and the line repaired.

Photo 1: View of Leaking Line

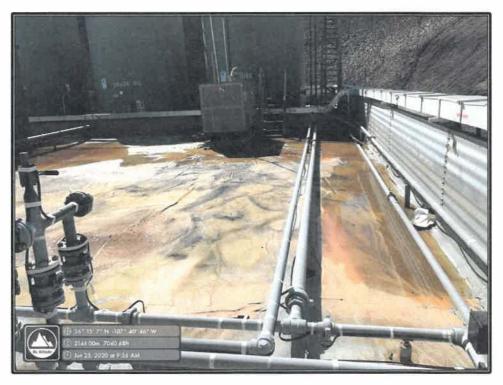
A water truck was on-site to recover the spilled water. 7 bbls of produced water was recovered off of the liner. Notification was submitted to Cory Smith, NMOCD, of the release, and to inform the NMOCD of the liner inspection that would take place on July 1, 2020.

Photo 2: View of Water on Liner

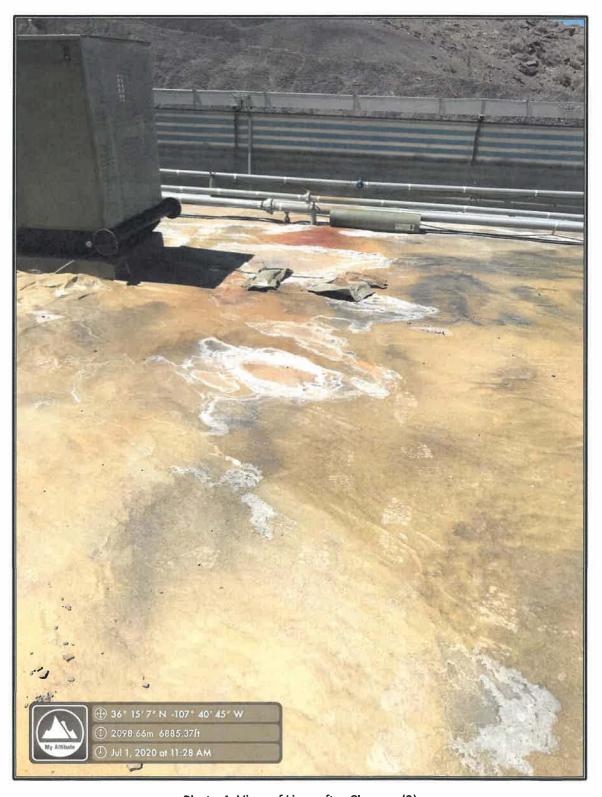
The Enduring HSE Supervisor was on-site at 11:30 AM to perform the liner inspection. A representative from the NMOCD was not present. The liner was inspected, and no evidence of a liner integrity issue was found during the inspection. Pictures were taken of the liner during inspection and are attached to the closure report for reference.

Photo 4: View of Liner after Cleanup (2)

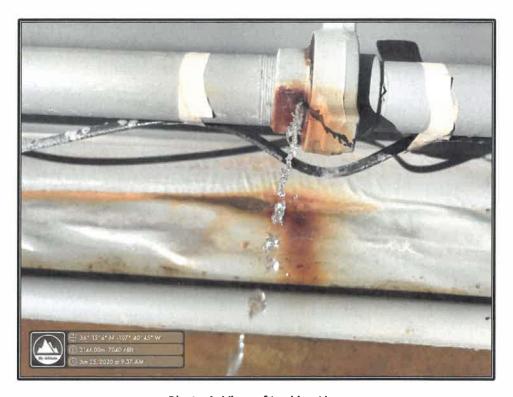
Photo 1: View of Leaking Line

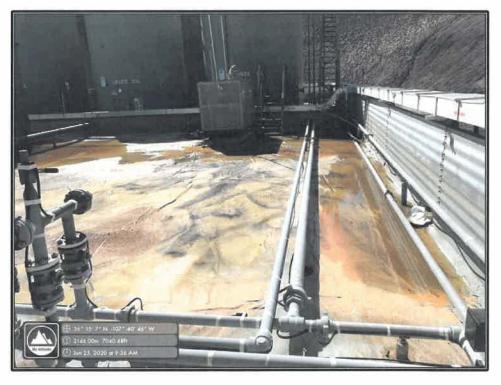
Photo 2: View of Water on Liner

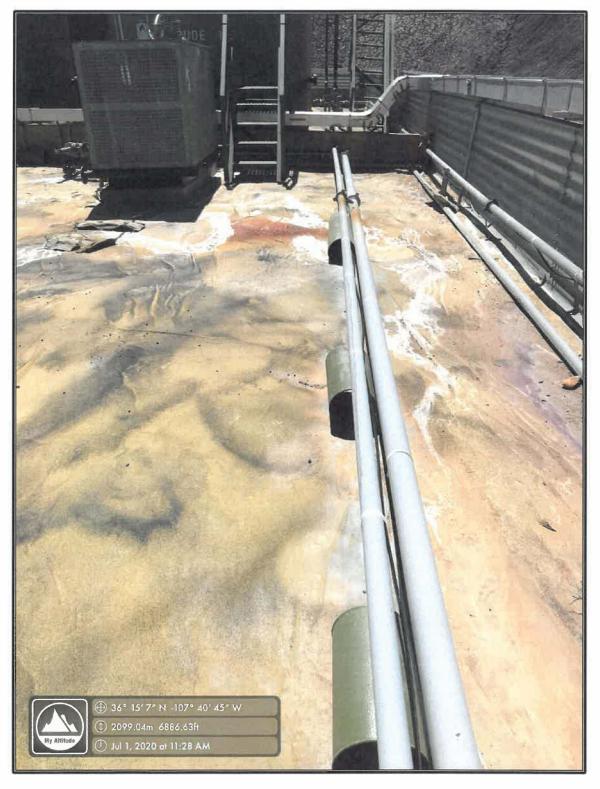
Photo 3: View of Liner after Cleanup

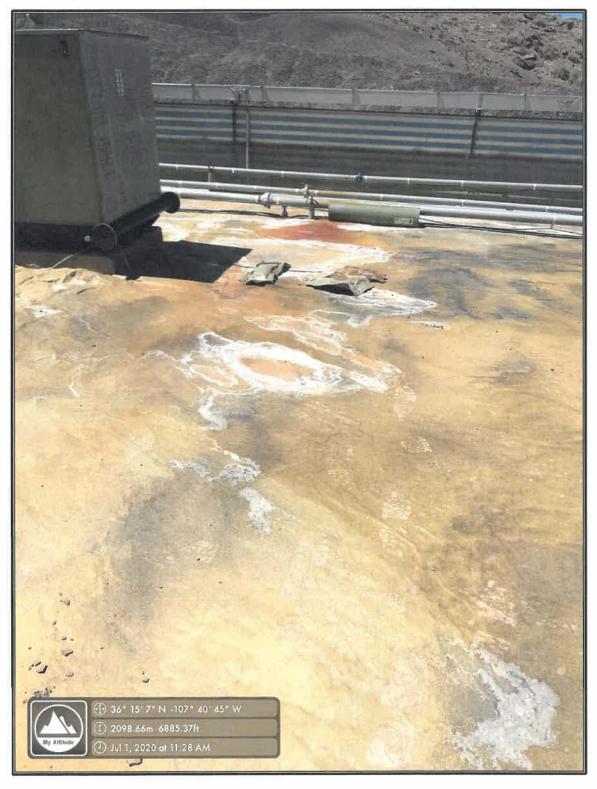
Photo 4: View of Liner after Cleanup (2)
