#### SITE CHARACTERIZATION AND CLOSURE REPORT

ARMSTRONG ENERGY CORPORATION DORA DEAN 24 # 1 SWD ROOSEVELT COUNTY, NEW MEXICO UNIT LETTER "B", SECTION 24, TOWNSHIP 5 SOUTH, RANGE 33 EAST LATITUDE 33.86264° N, LONGITUDE 103.42913° W API NUMBER: 30-041-20938

SEPTEMBER 2019

ARMSTRONG ENERGY CORPORATION

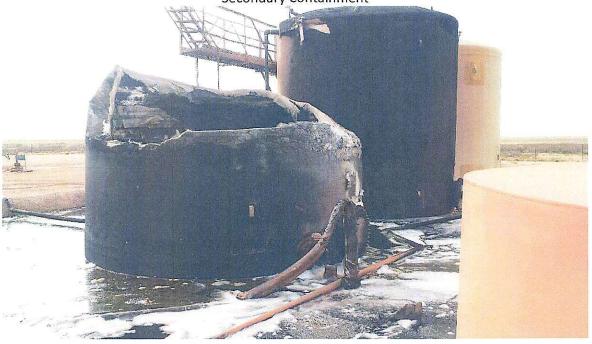
Photograph 1: Burned Production Water Storage Tanks and Standing Water in Lined, Bermed Secondary Containment

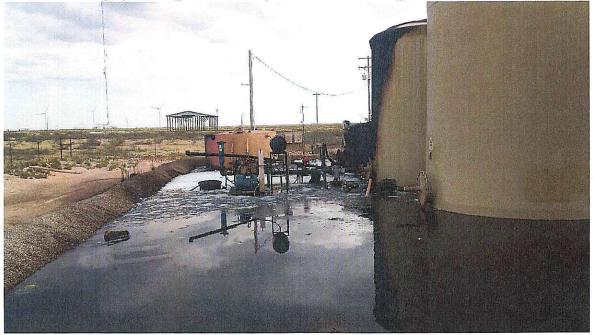
Photograph 2: Original Secondary Containment Holding All Released Liquids

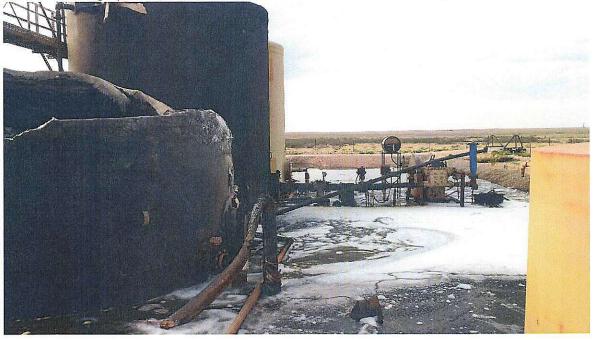
Photograph 3: Produced Water Release Contained in Secondary Containment

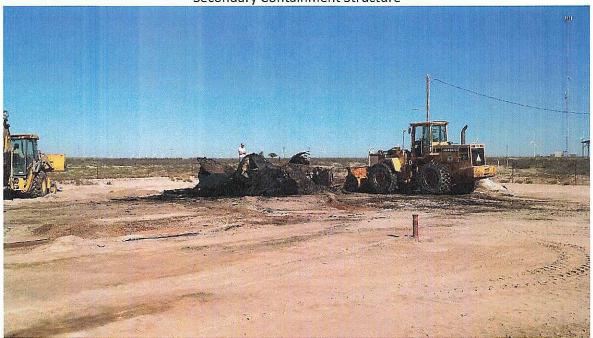
Photograph 5: Removal of Secondary Containment Liner and Berm to Make Way for New Secondary Containment Structure

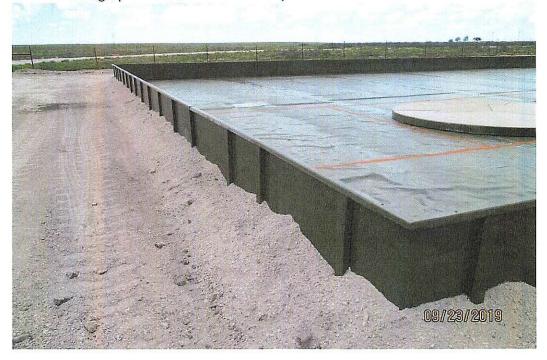
Photograph 7: Brand New Secondary Containment Structure Installed

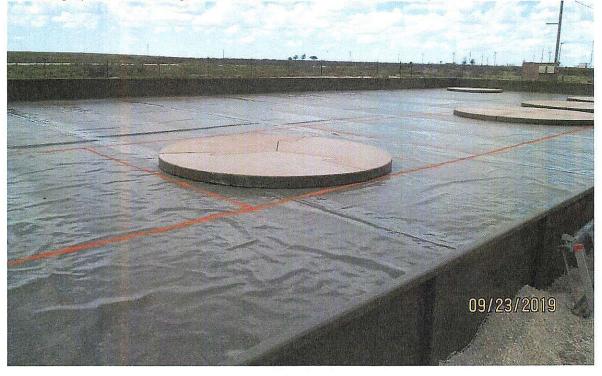
Photograph 8: New Storage Tank Bases Installed in New Secondary Containment Structure
