LINER INSPECTION AND CLOSURE REPORT REPORTABLE RELEASE

Spur Energy Partners

Seacrest ET AL #1
Incident ID: NAPP2118846106
API #30-015-22321
Eddy County, NM

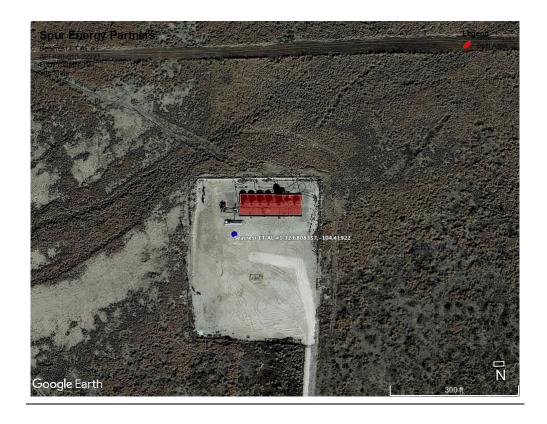
On July 13, 2022, Paragon went to the Seacrest and conducted an initial assessment. There were obvious staining on the liner from the spill. There were no signs outside the containment that the liner had been breached. Therefore, no samples were taken. See the site map below showing the affected area.

On July 14, 2022, Paragon returned to the site with equipment and personnel to conduct cleanup activities. We initially sprayed the affected area with surface cleaner. We then power washed and squeegeed the runoff to where the vacuum truck could capture the fluids.

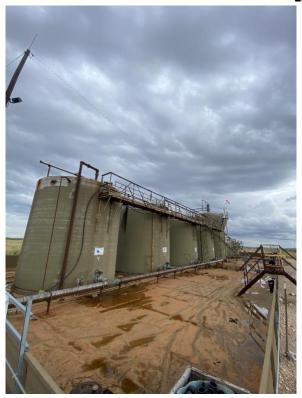
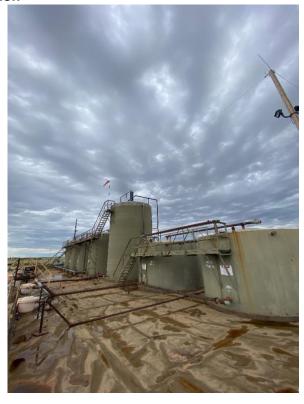
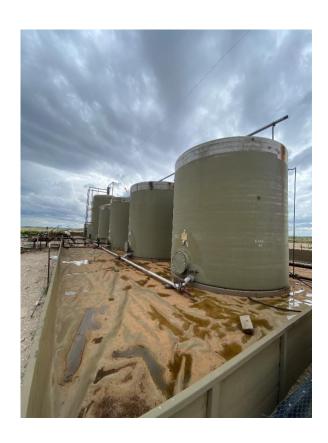
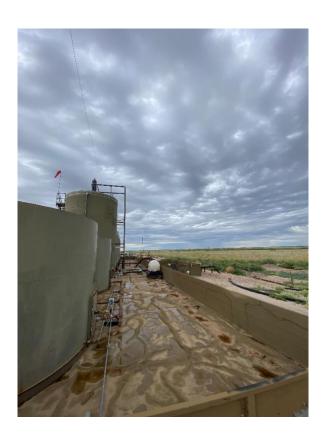
Photographic Documentation Liner Inspection

On July 20, 2022, Paragon returned to the site to conduct a liner inspection. A 48-hour notification was sent out to the NMOCD on July 18, 2022. The liner inspection concluded that the liner was all intact and in good condition. The integrity of the liner appears to have the ability to contain spills. See Appendix D for the email notification and liner report.

Visualization	Yes	No	Comments		
Is there a tear in the liner?		X			
Are there holes in the liner?		X			
Is the liner retaining any fluids?		X			
Does the liner have integrity to contain a leak?	X
