LINER INSPECTION AND CLOSURE REPORT REPORTABLE RELEASE

Spur Energy Partners

Tarpan 33 Fee #4H Incident ID: NAPP2129837754 API #30-015-41662 Eddy County, NM

Paragon Environmental LLC 1601 N. TURNER ST. STE.500 Hobbs, NM 88240 575-964-7814

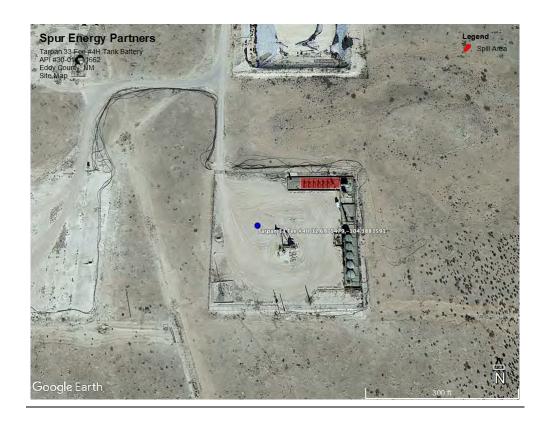
On July 13, 2022, Paragon went to the Tarpan and conducted an initial assessment. There was obvious staining on the liner from the spill. There were no signs outside the containment showing no signs that the liner had been breached. Therefore, no samples were taken. See the site map below showing the affected area.

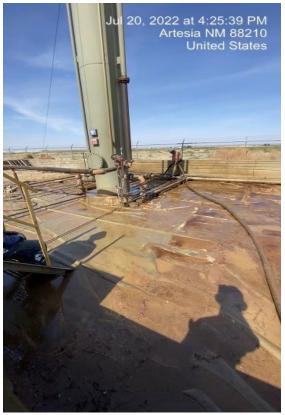
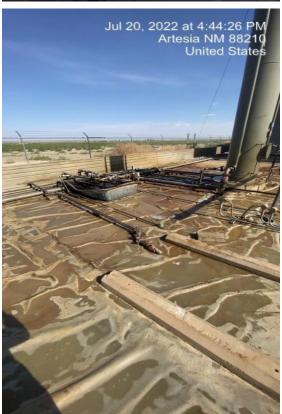
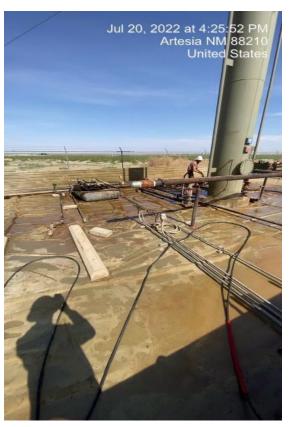
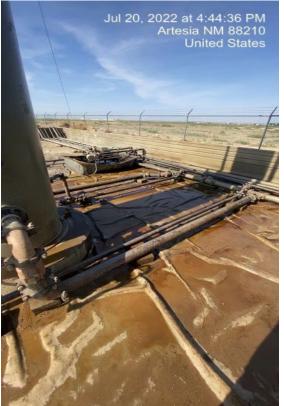
Completed

On August 3, 2022, Paragon returned to the site to conduct a liner inspection. A 48-hour notification was sent out to the NMOCD on August 6, 2022. The liner inspection concluded that the liner was all intact and in good condition. The integrity of the liner appears to have the ability to contain spills. See Appendix D for the email notification and liner report.
