MicroBind Case Study – Osage County, OK

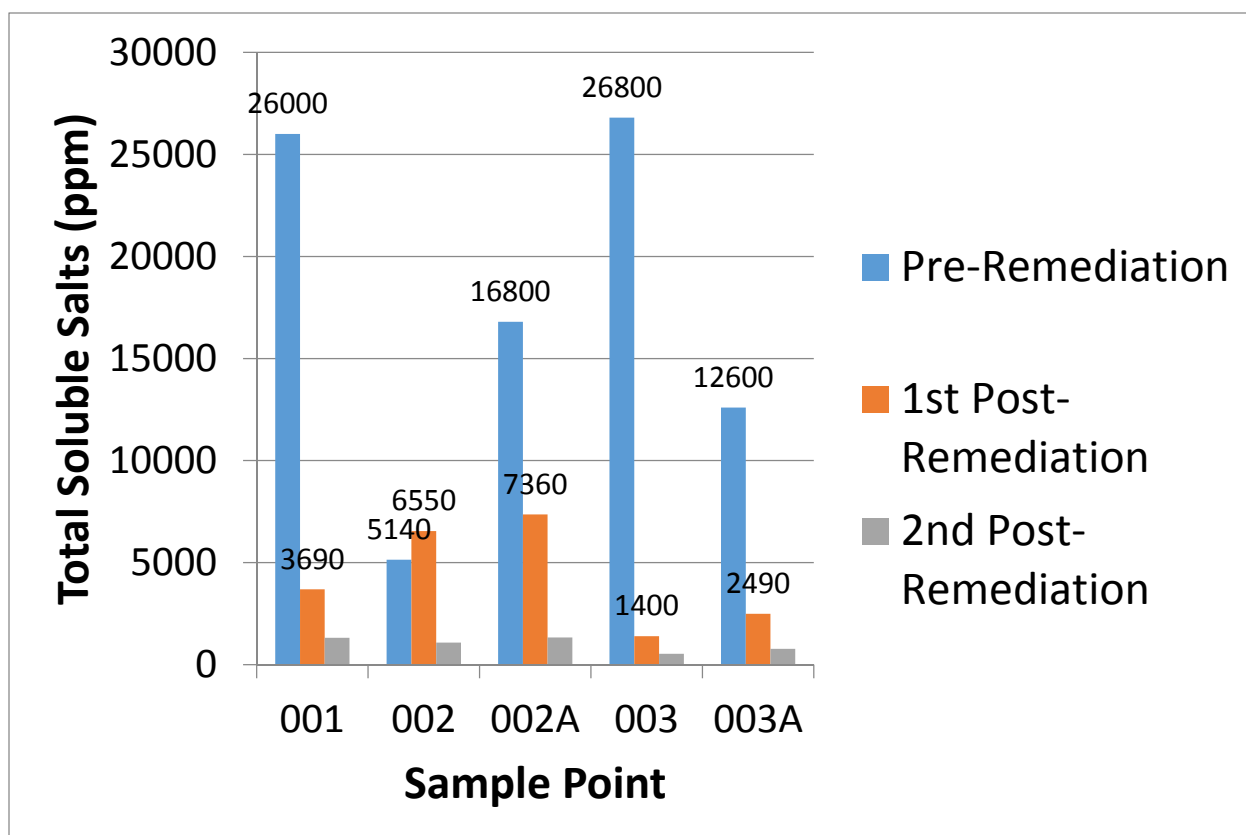
Figure 1: Comparison Graph of Pre and Post Remediation TSS Results

Analytical results indicated significant reductions in TSS in all samples collected. Final analytical results indicated TSS results below the OCC's action level in all sample locations. In addition, the site had full vegetative growth at the time of sampling.

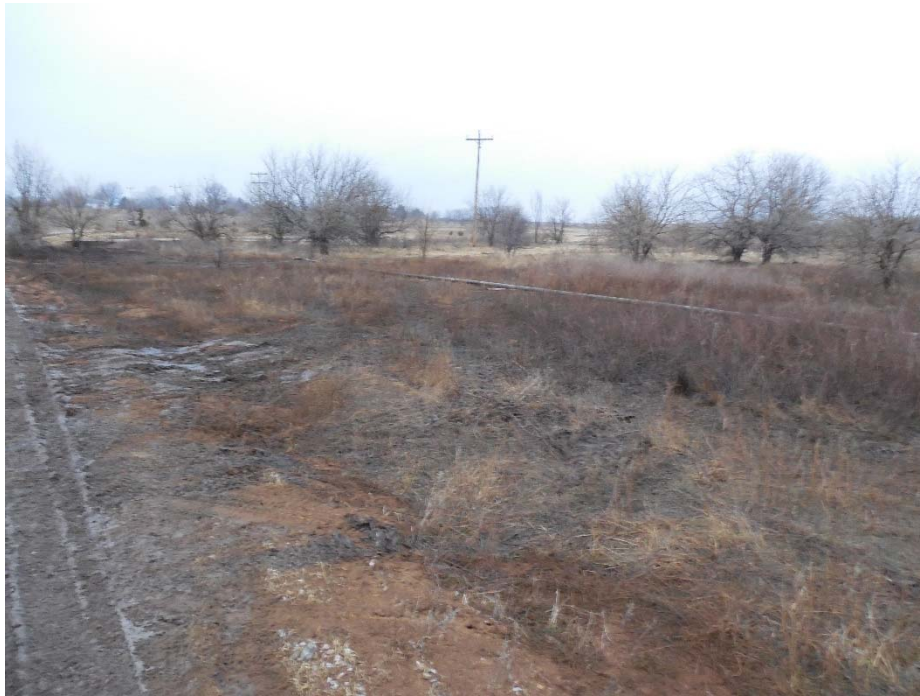
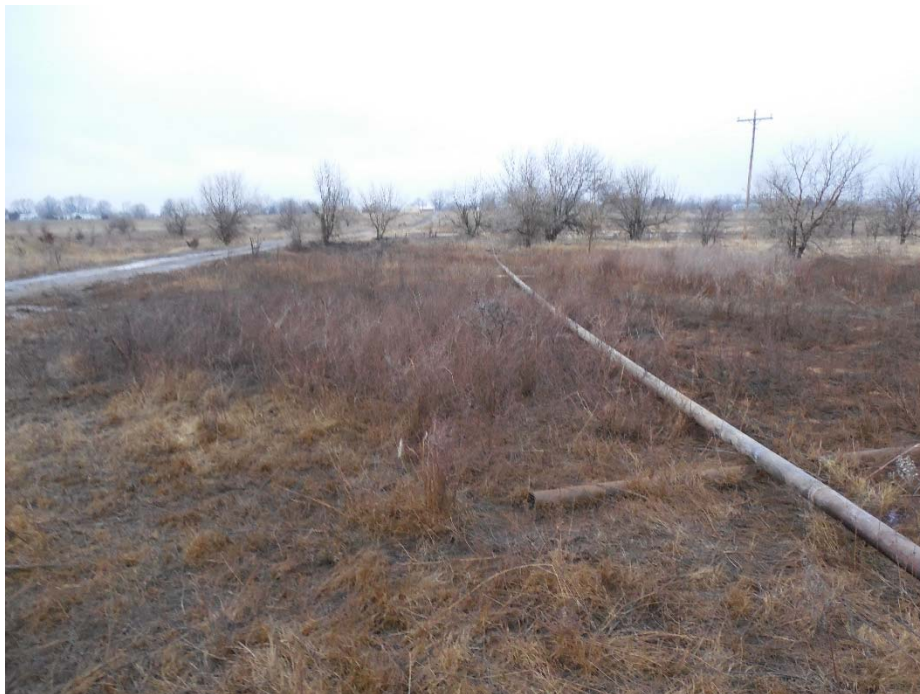
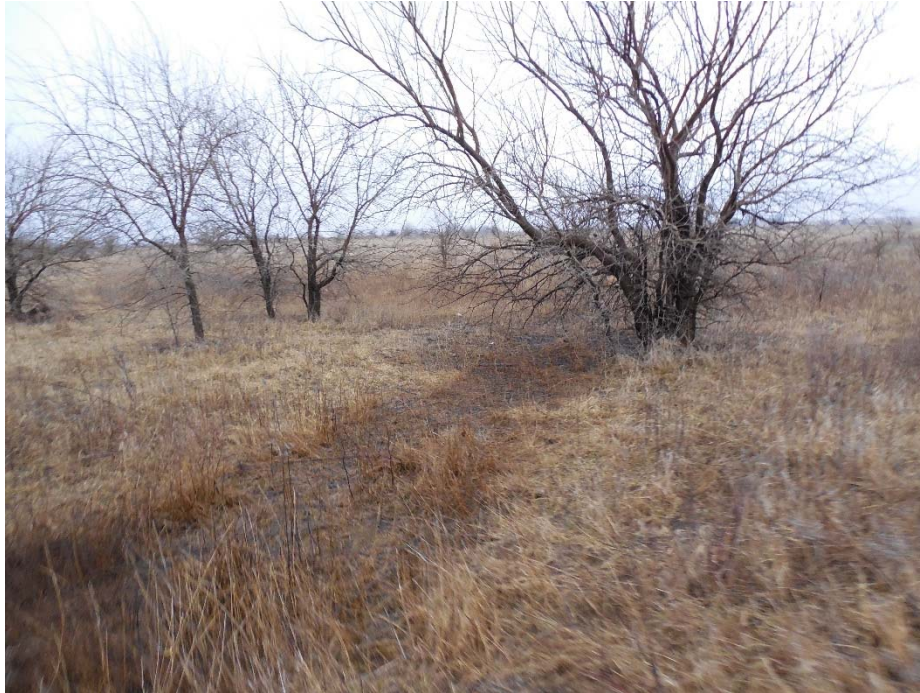
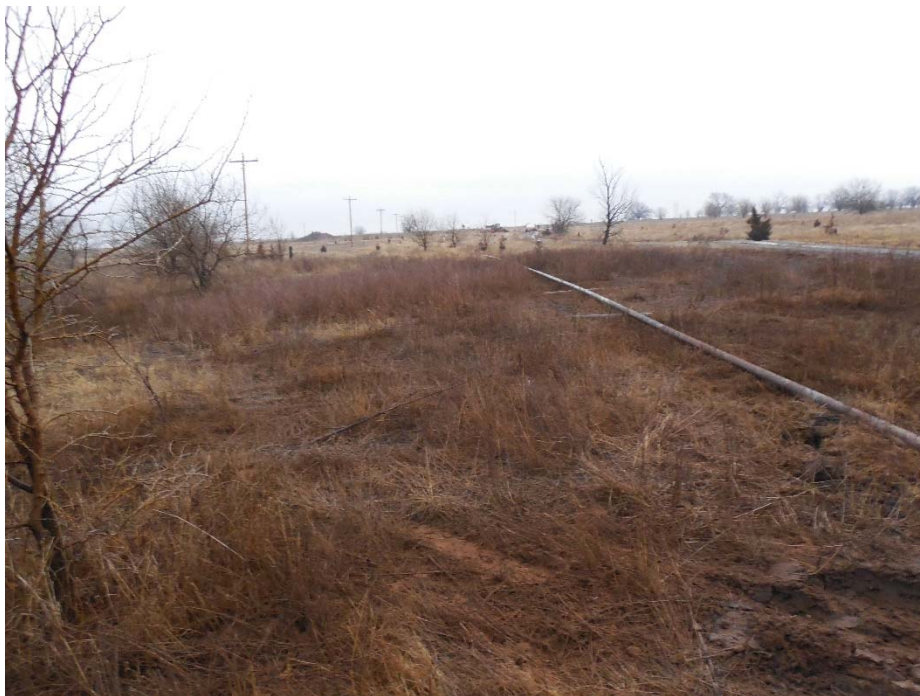
Results indicated Total Soluble Salts (TSS) levels above the Oklahoma Corporation Commission (OCC's) action level of 2,640 ppm in Sample IDs 001, 002, 002A, 003, and 003A.

Photograph 1: Pre-Remediation Impacted Area

Photograph 2: Pre-Remediation Impacted Area

Photograph 3: Pre-Remediation Impacted Area

Photograph 4: Pre-Remediation Impacted Area

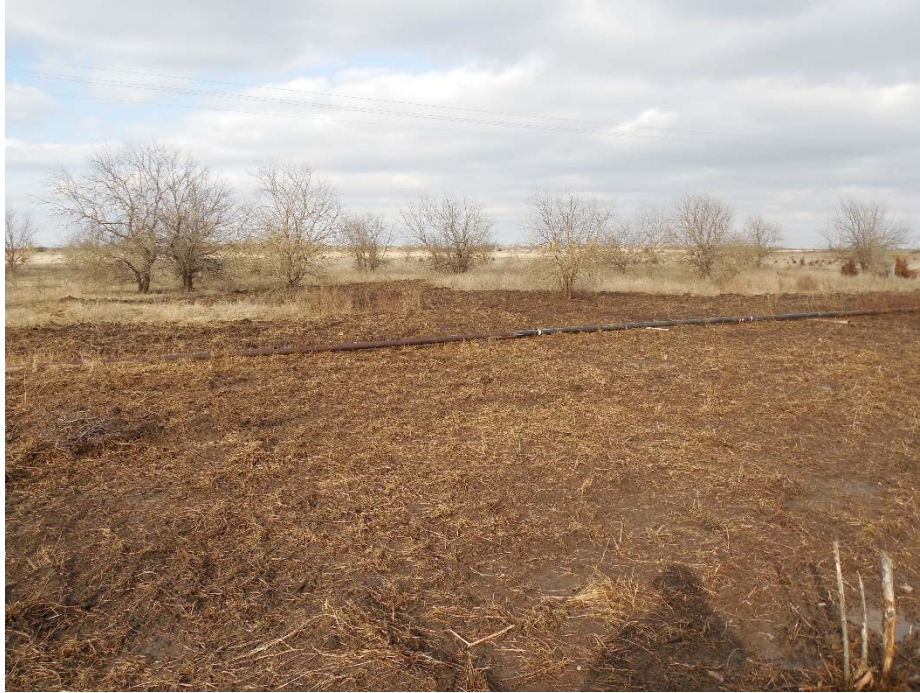
Photograph 9: Post-Treatment

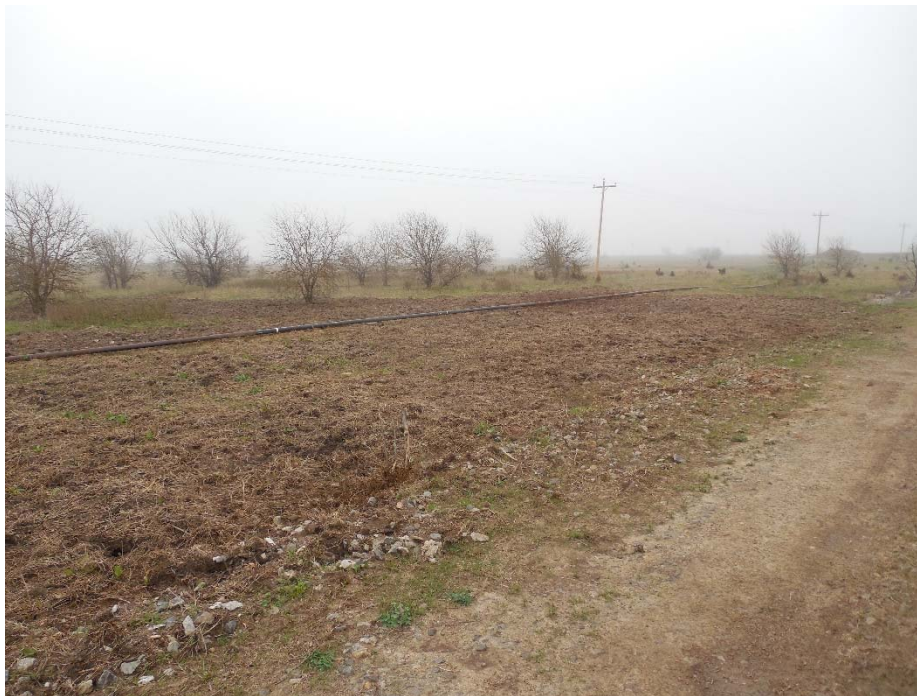
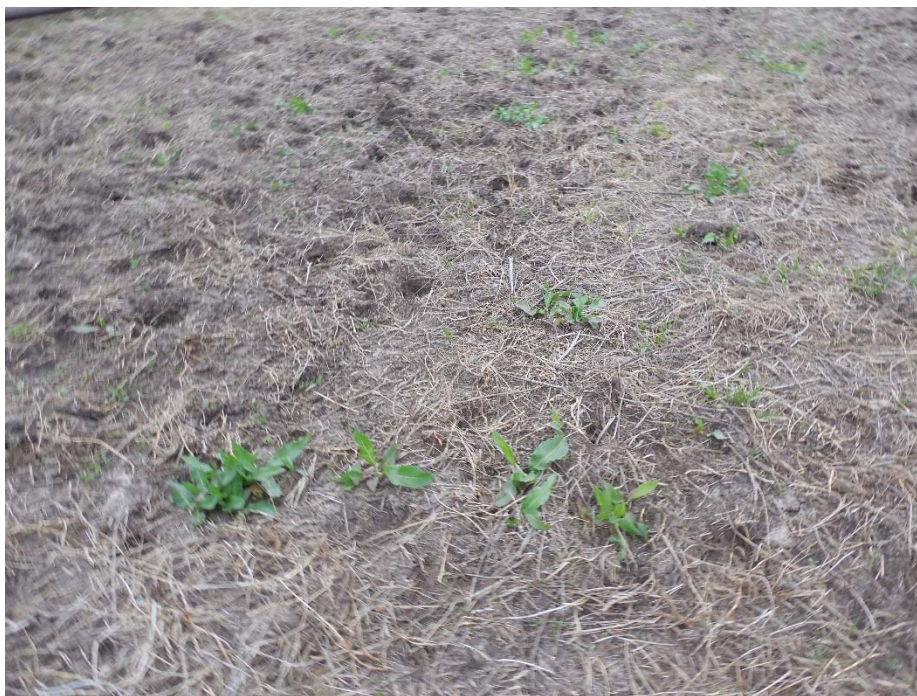
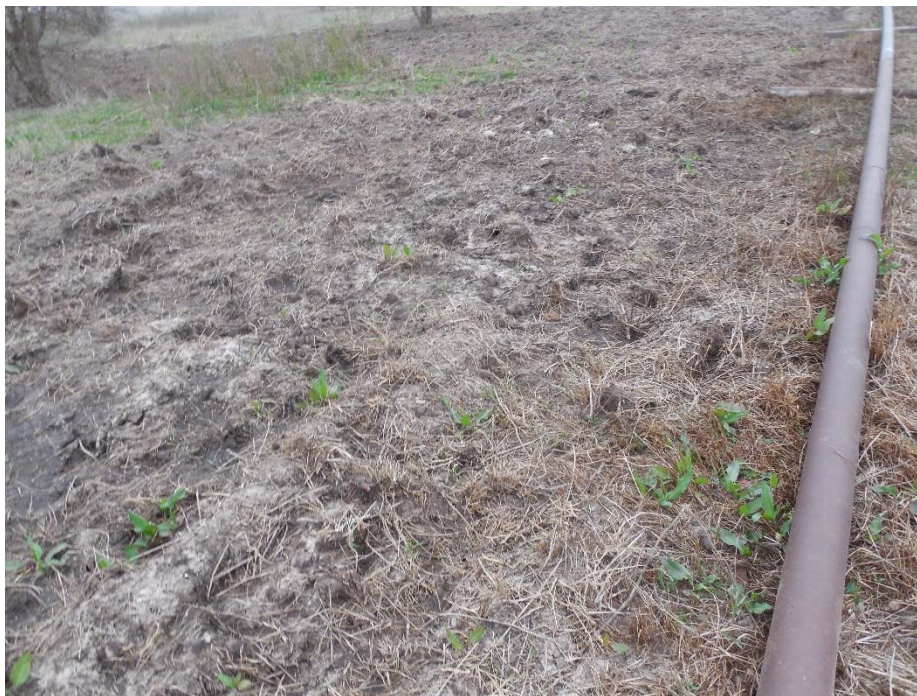
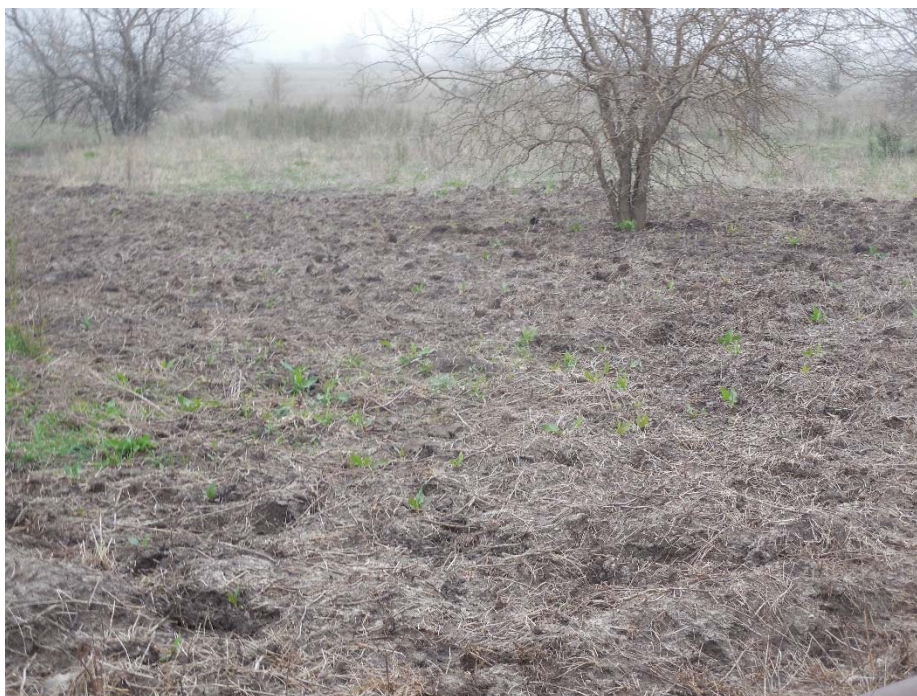
Analytical results indicated significant reductions in TSS in all samples collected, except for Sample ID 002, which had a slight increase in TSS. Slight vegetative growth was noted at the time of sampling.

Photograph 10: Site 3 Months Post-Remediation

Photograph 11: Site 3 Months Post-Remediation

Photograph 12: Site 3 Months Post-Remediation

Photograph 13: Site 3 Months Post-Remediation

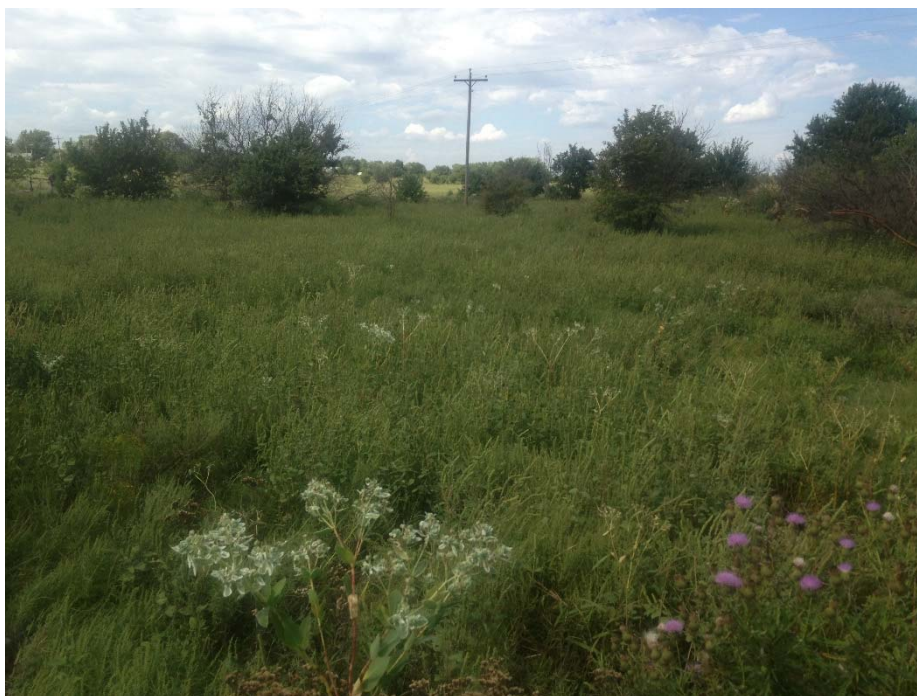
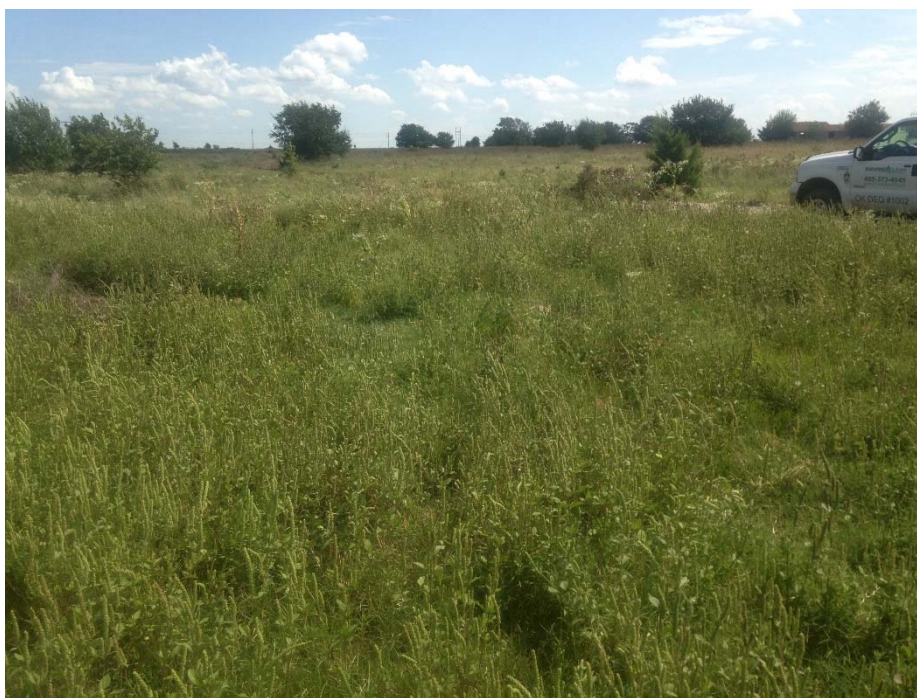
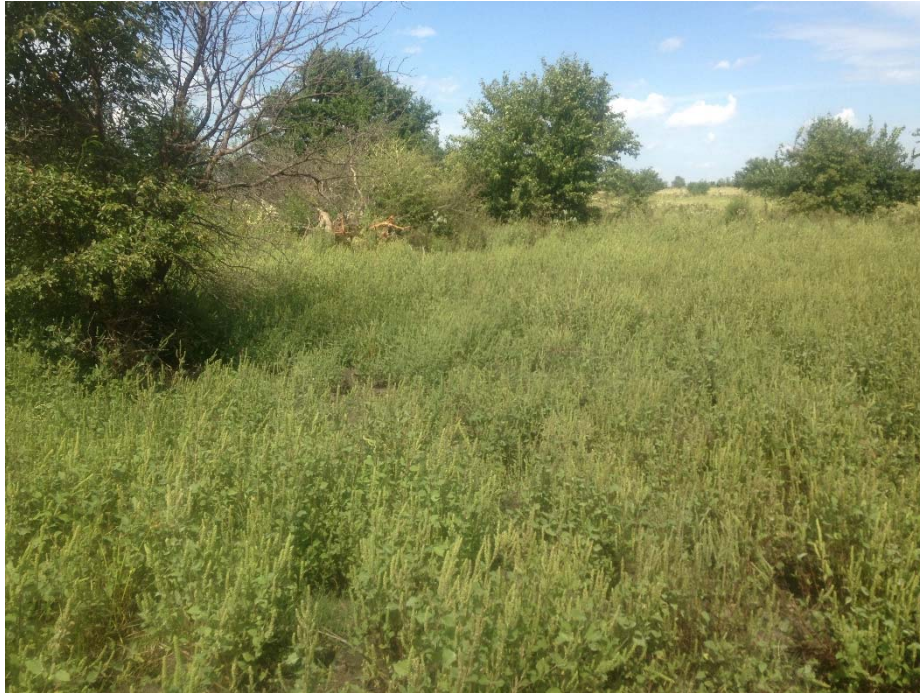
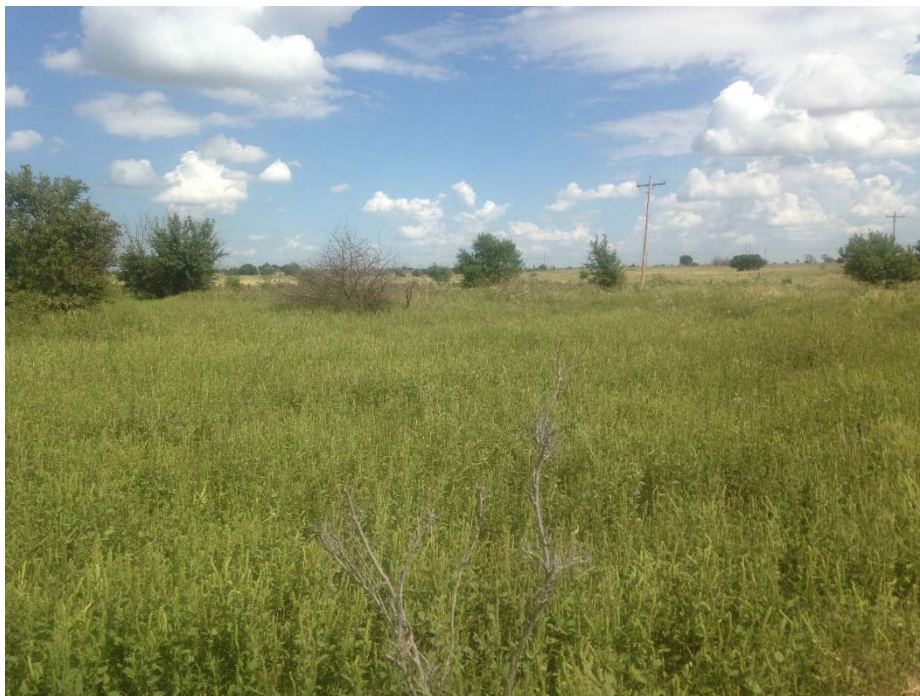
Photograph 14: Site 8 Months Post-Remediation

Photograph 15: Site 8 Months Post-Remediation

Photograph 16: Site 8 Months Post-Remediation

Photograph 17: Site 8 Months Post-Remediation
