MicroBind Case Study – Osage County, OK

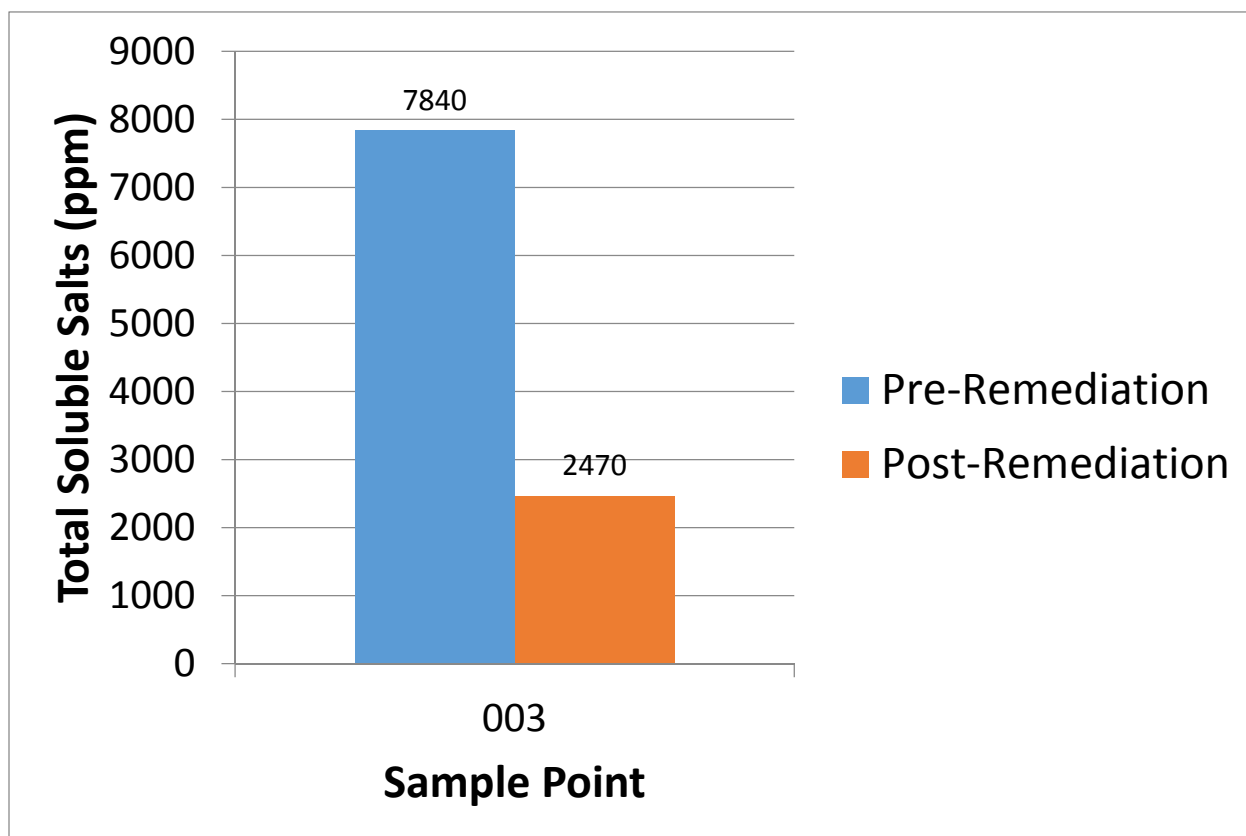
Figure 1: Comparison Graph of Pre and Post Remediation TSS Results

Analytical results indicated significant reductions in sample location 003. Full vegetative growth was noted at the time of sampling.

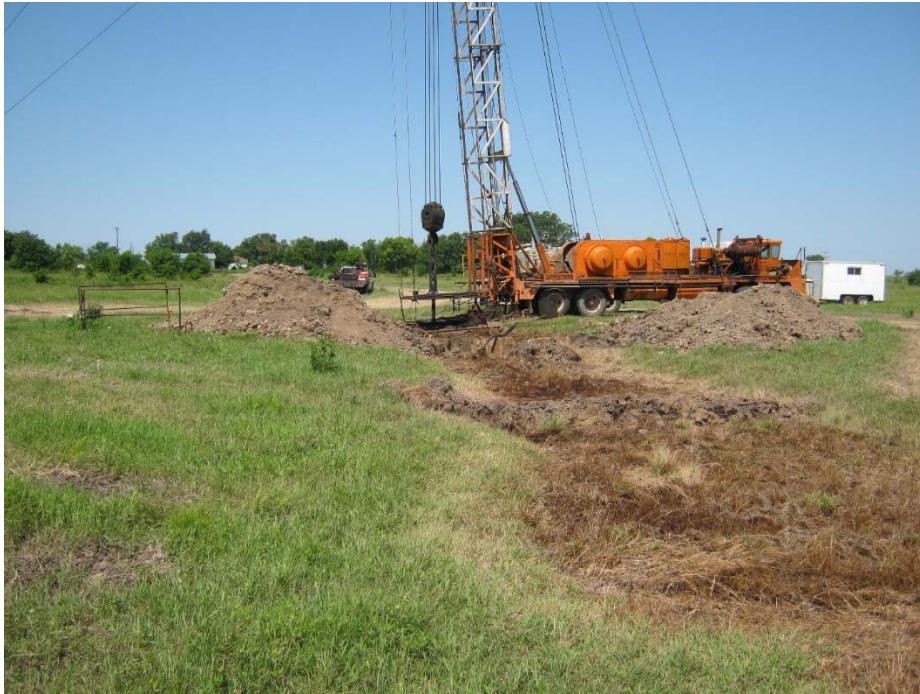
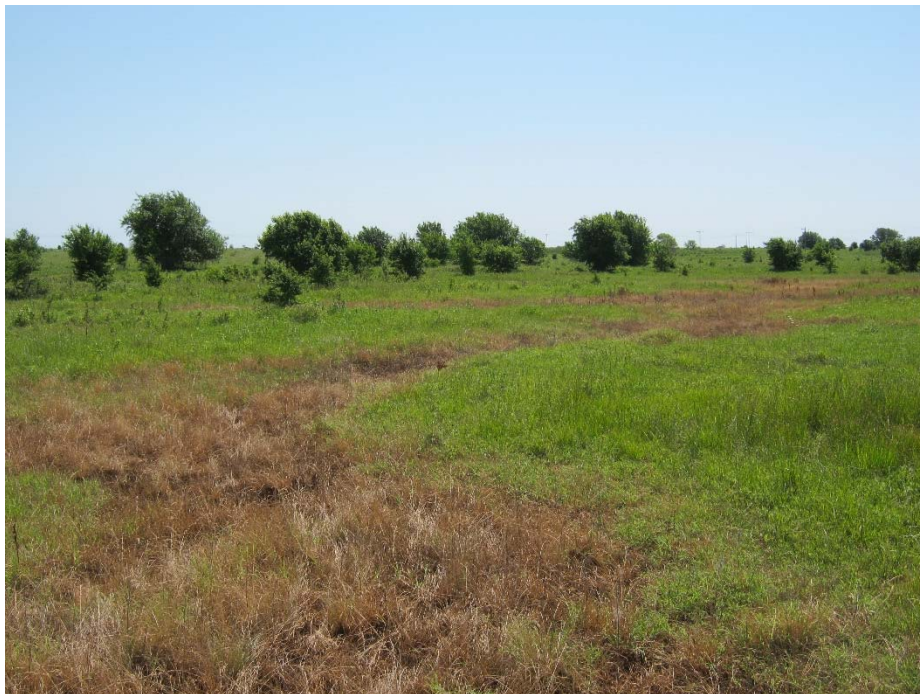
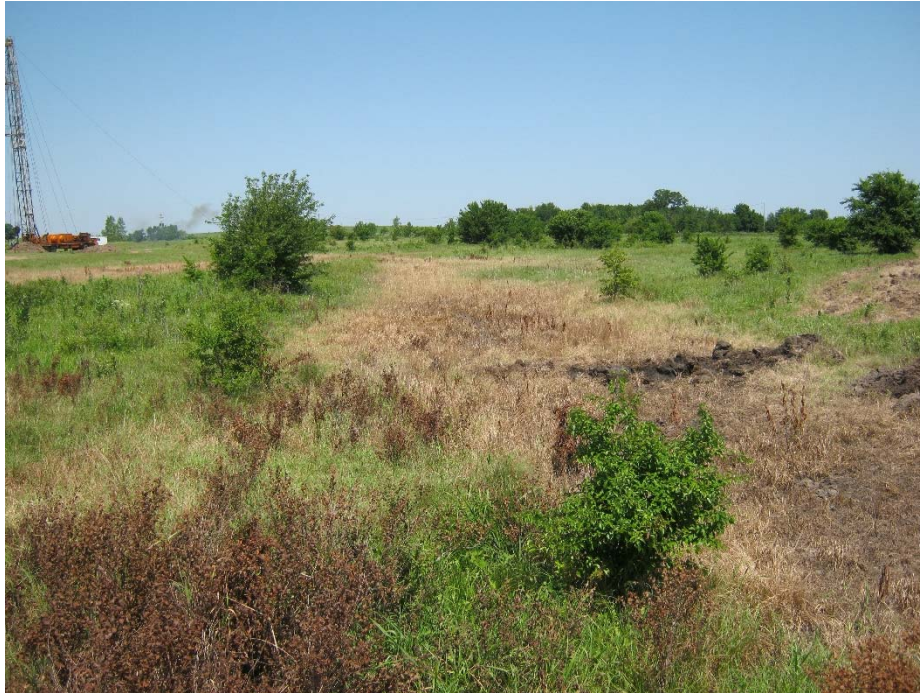
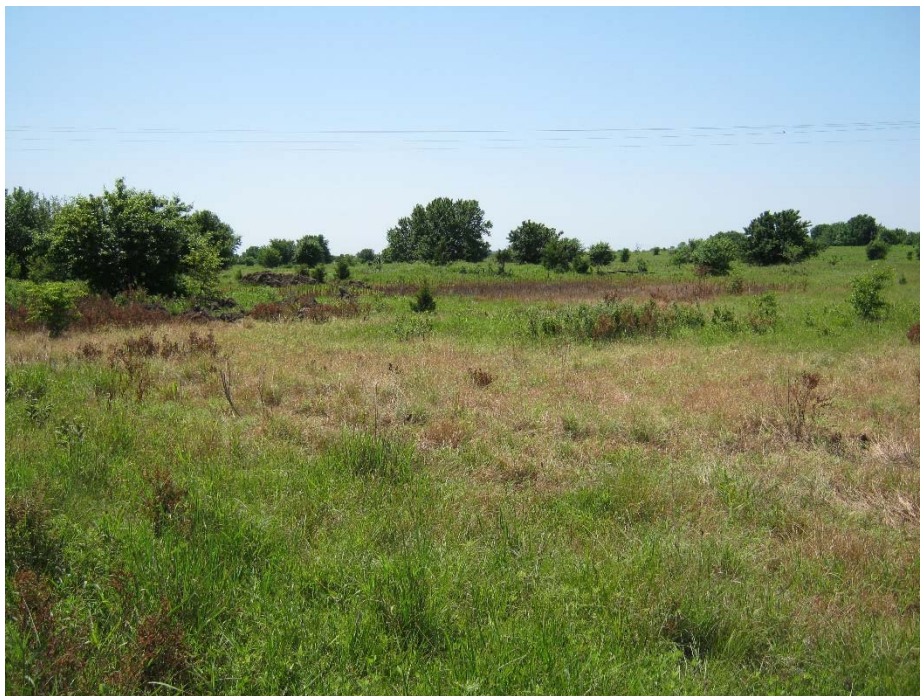
Results indicated Total Soluble Salts (TSS) levels above the Oklahoma Corporation Commission (OCC's) action level of 2,640 ppm in Sample IDs 001, 001B, 002, 003, and 004.

Photograph 1: Pre-Remediation Impacted Area

Photograph 2: Pre-Remediation Impacted Area

Photograph 3: Pre-Remediation Impacted Area

Photograph 4: Pre-Remediation Impacted Area

- Till the impacted area
- Incorporate gypsum and manure into the surface of the impacted area
- Seed the impacted area
- Treat the impacted area with a MicroBind solution

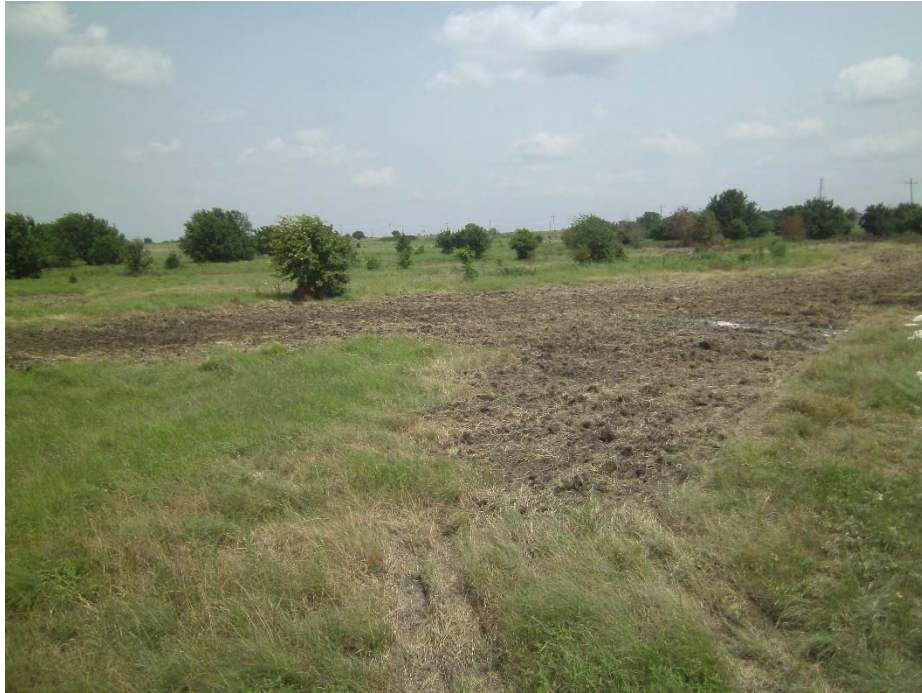
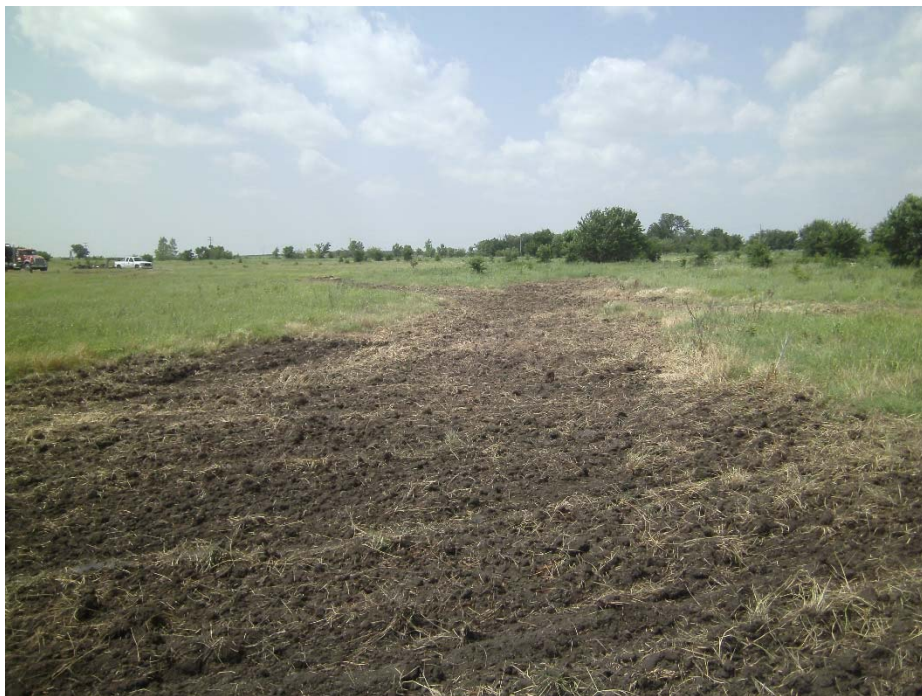
Photograph 5: Impacted area after incorporation of manure

Photograph 6: Impacted area after incorporation of manure

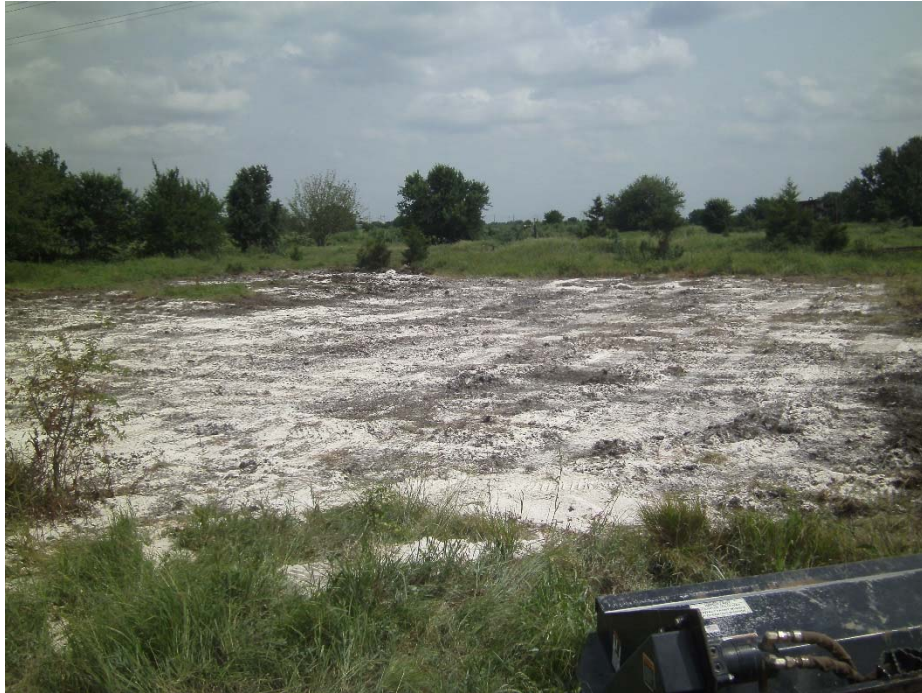
Photograph 7: Impacted area after incorporation of gypsum

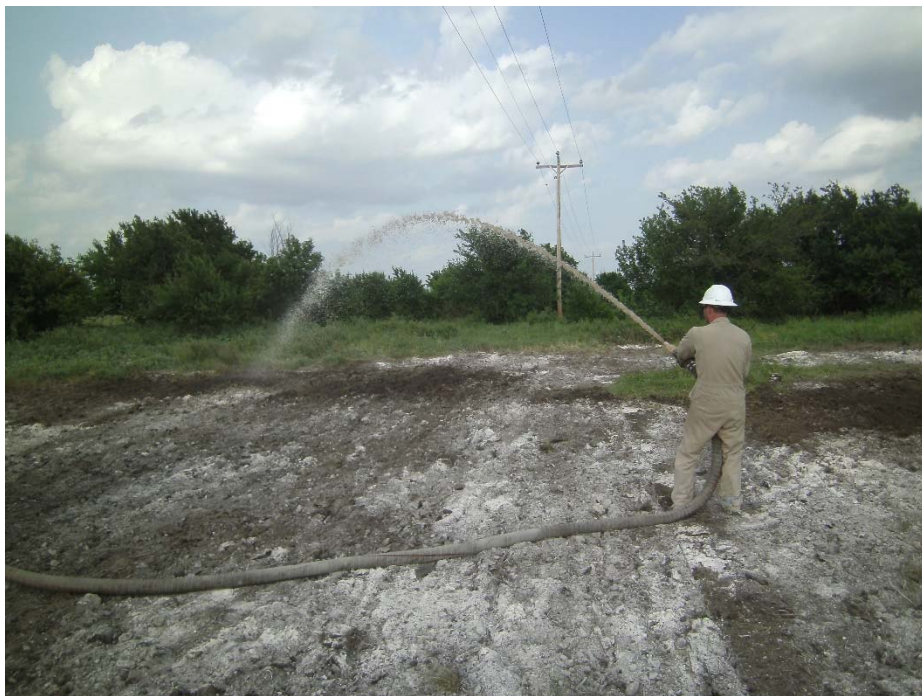
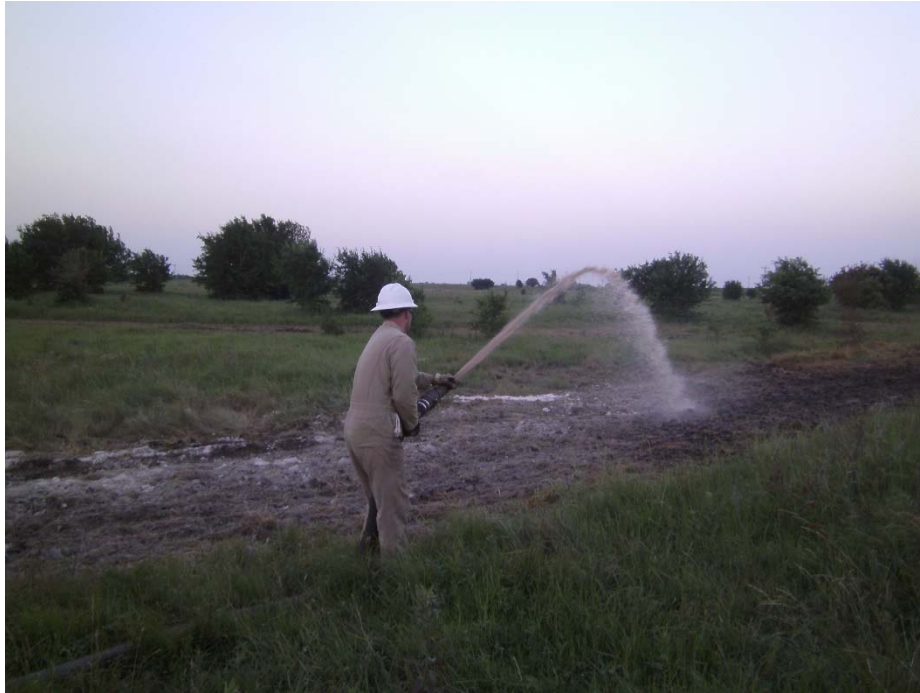
Photograph 8: Treating the impacted area with a MicroBind solution

Photograph 9: Treating the impacted area with a MicroBind solution

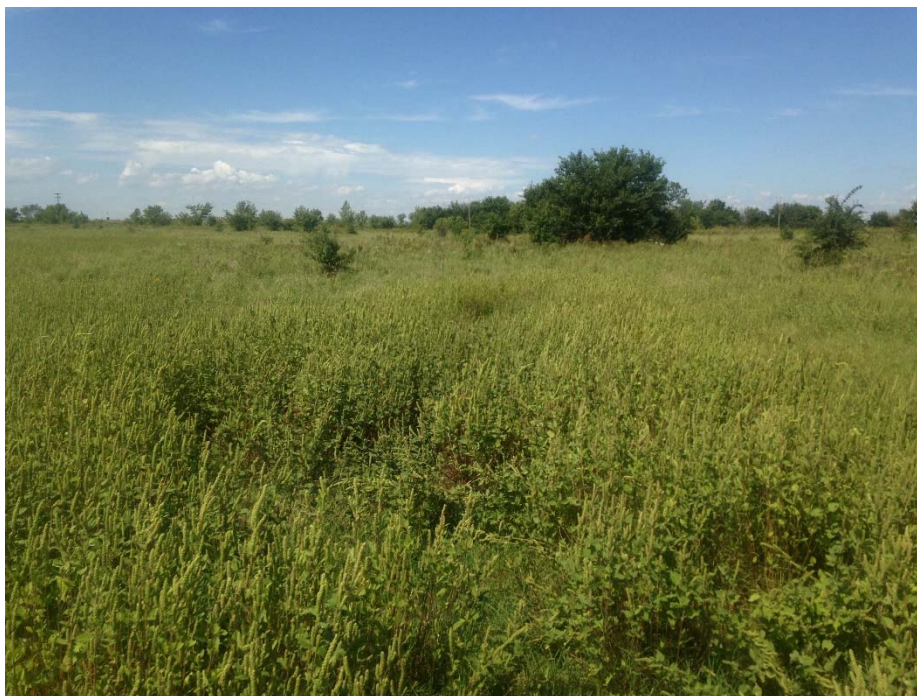
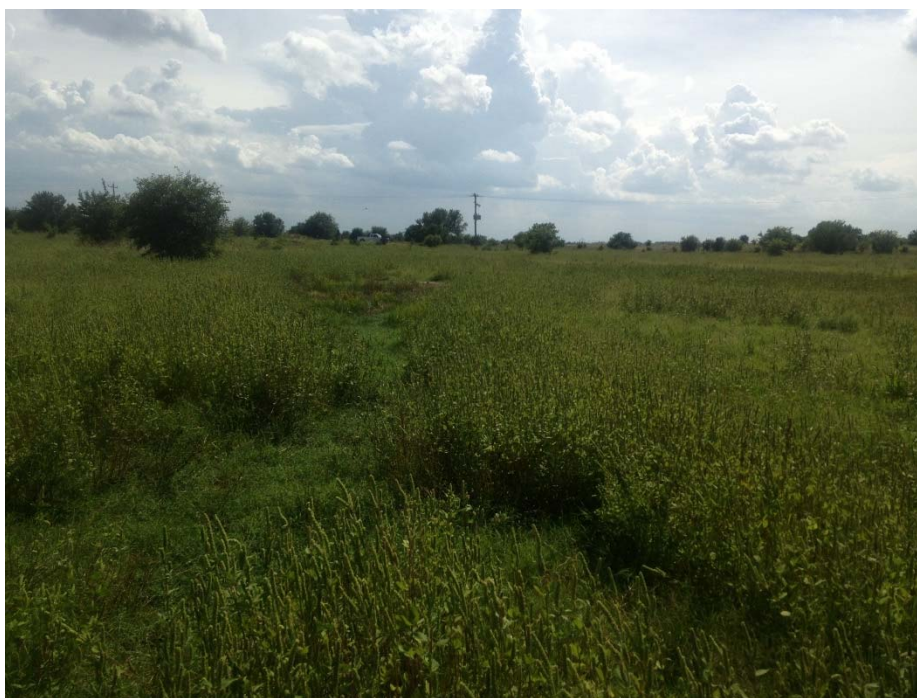
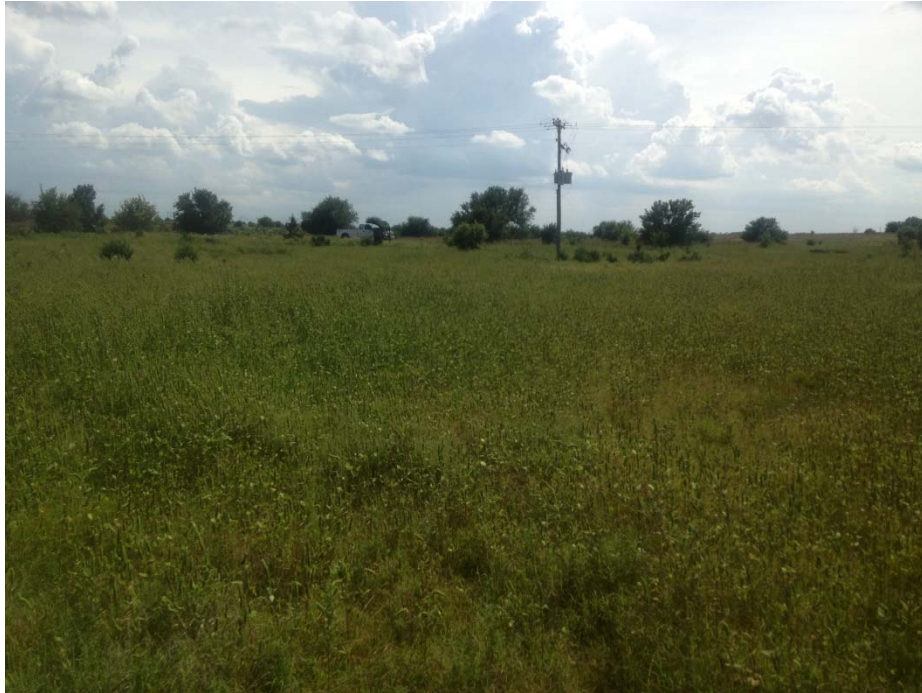
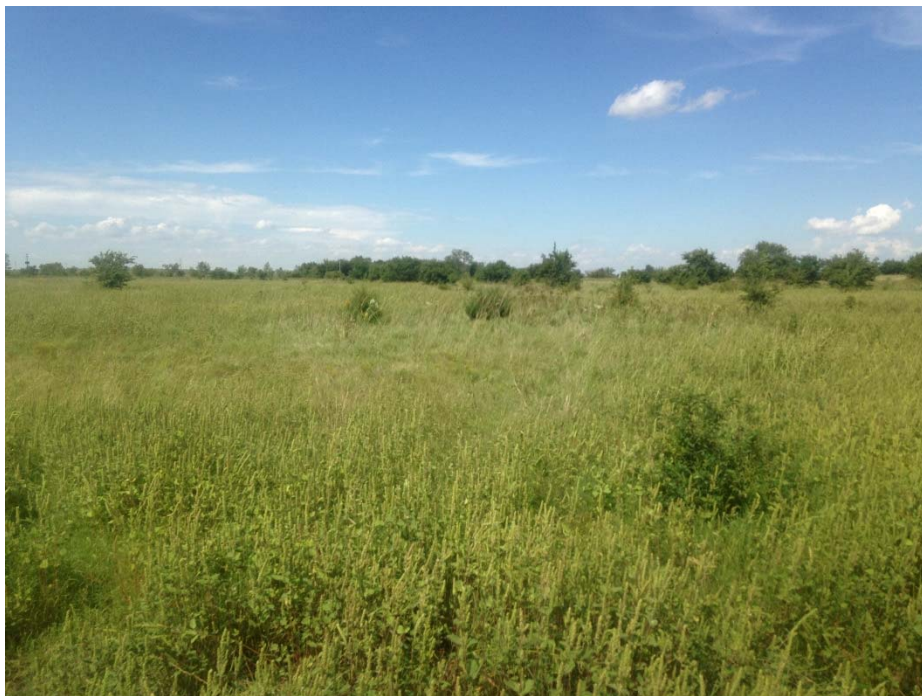
Photograph 10: Site 16 Months Post-Remediation

Photograph 11: Site 16 Months Post-Remediation

Photograph 12: Site 16 Months Post-Remediation

Photograph 13: Site 16 Months Post-Remediation
