**Remediation and Closure Report
Devon Energy: Ross Ranch 10 Federal No. 1 SWD
30-015-296056 *2RP-3427***

March 21, 2016

Subject: **Remediation and Closure Report**
 Devon Energy
 Ross Ranch 10 Federal #001 SWD (30-015-29605) *2RP-3427*

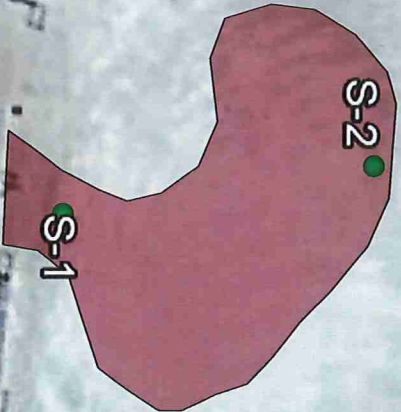
SITE MAP

Talon mobilized personnel and equipment to perform remediation activities in accordance with the approved work plan. The impacted area in the vicinity of sample location S-2 was excavated to a depth of 0.5-feet and all of the excavated material was hauled to Lea Land, LLC disposal facility. The excavated area was backfilled with clean caliche and contoured to match the surrounding location.
