## **Closure Report**

West Redlake Water Station #1 Battery  
Talon Project No. 701307.082.01

Subject:       **Remediation and Closure Report**  
                  Lime Rock Resources II-A, L.P.  
                  West Redlake Water Station #1 Battery

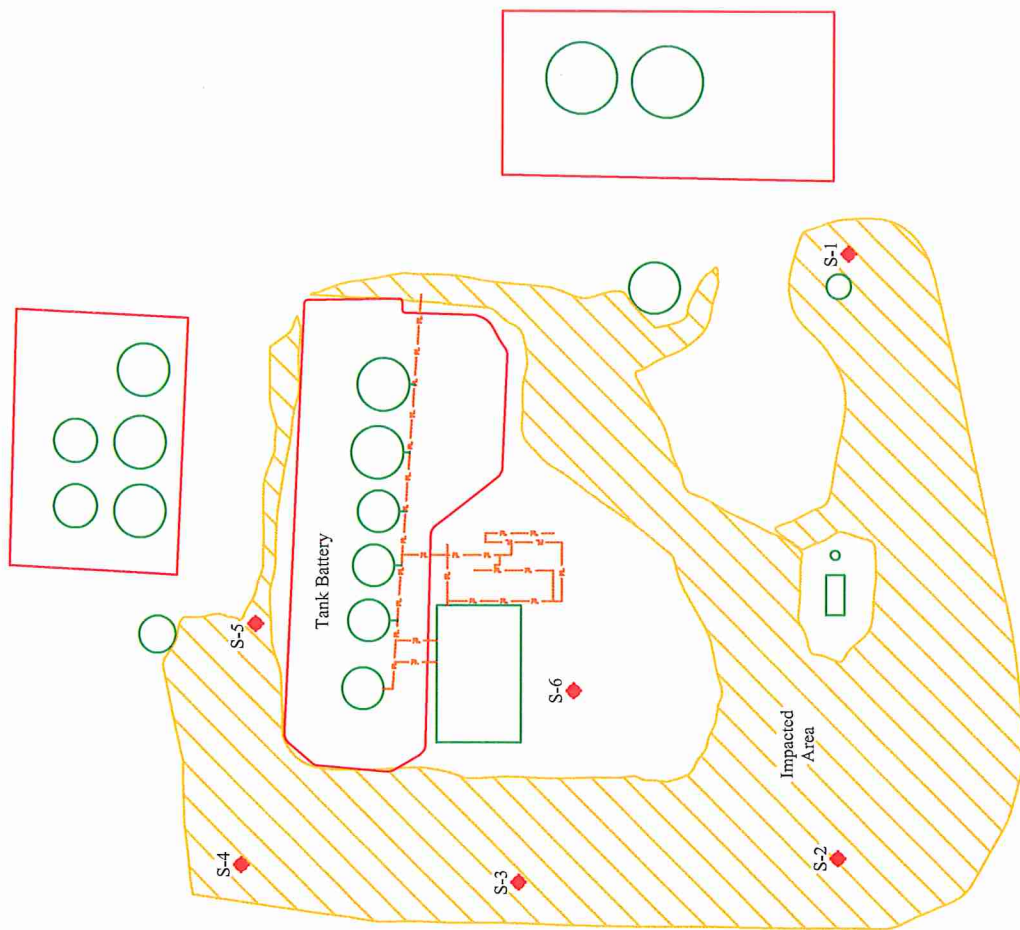
West Red Lake Station #1  
Lime Rock Resources  
Eddy County, New Mexico  
Figure 1 - Site Plan

The impacted areas in the vicinity of sample location S-1, S-2, S-5 and S-6 were excavated to a depth of 2-feet deep.

The impacted area around sample location S-3 was excavated to a depth of 1-foot deep and the area in the vicinity of sample location S-4 was excavated to a depth of 0.5-feet deep.
