Remediation Closure Report

Grandi 22-3 * 30-015-33922 * **2RP-3647**

Talon Project No. 700794.186.01

June 27, 2016

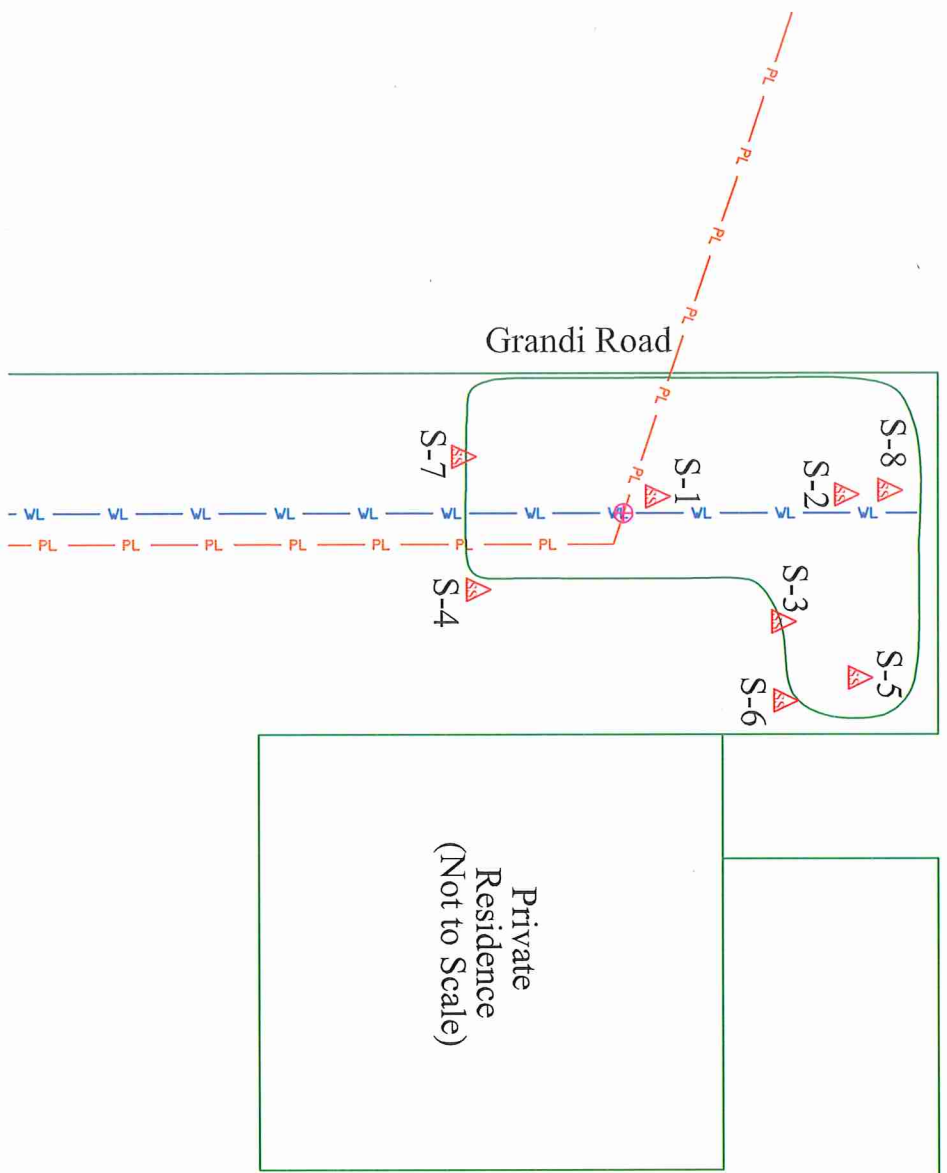
Grandi 22-3 Line
Devon Energy Corporation
Eddy County, New Mexico
Site Plan

On July 2, 2015 Blue Wally Construction submitted a OneCall ticket for installing a sprinkler system for a private home owner. Devon Energy's line locating department responded with a positive response by flagging the line and requesting in the notes that the construction company was to contact Devon so that a representative could be present at the time of the installation of the sprinklers. Blue Wally Construction failed to contact Devon Energy as requested and installed the sprinkler system. In March 2016, the home owner contacted Devon Energy believing that the line had developed a leak due to staining in his yard. Devon pressured the line on March 18, 2016 to identify exactly where the leak was located. On March 21, 2016 Devon excavated a small area around the line to identify how the line had failed. A cut into the Devon line was identified right underneath the sprinkler system line that was routed over the top of the Devon line. The coordinates are 32.383947, -104.168534. A site plan is presented in [Appendix I](#) which illustrates the impacted areas.
