## **Remediation and Closure Report**

Cotton Draw Unit No. 65 \* 30-015-35915 \*

Subject:       **Remediation and Closure Report**  
Cotton Draw Unit # 65 \* 30-015-10843

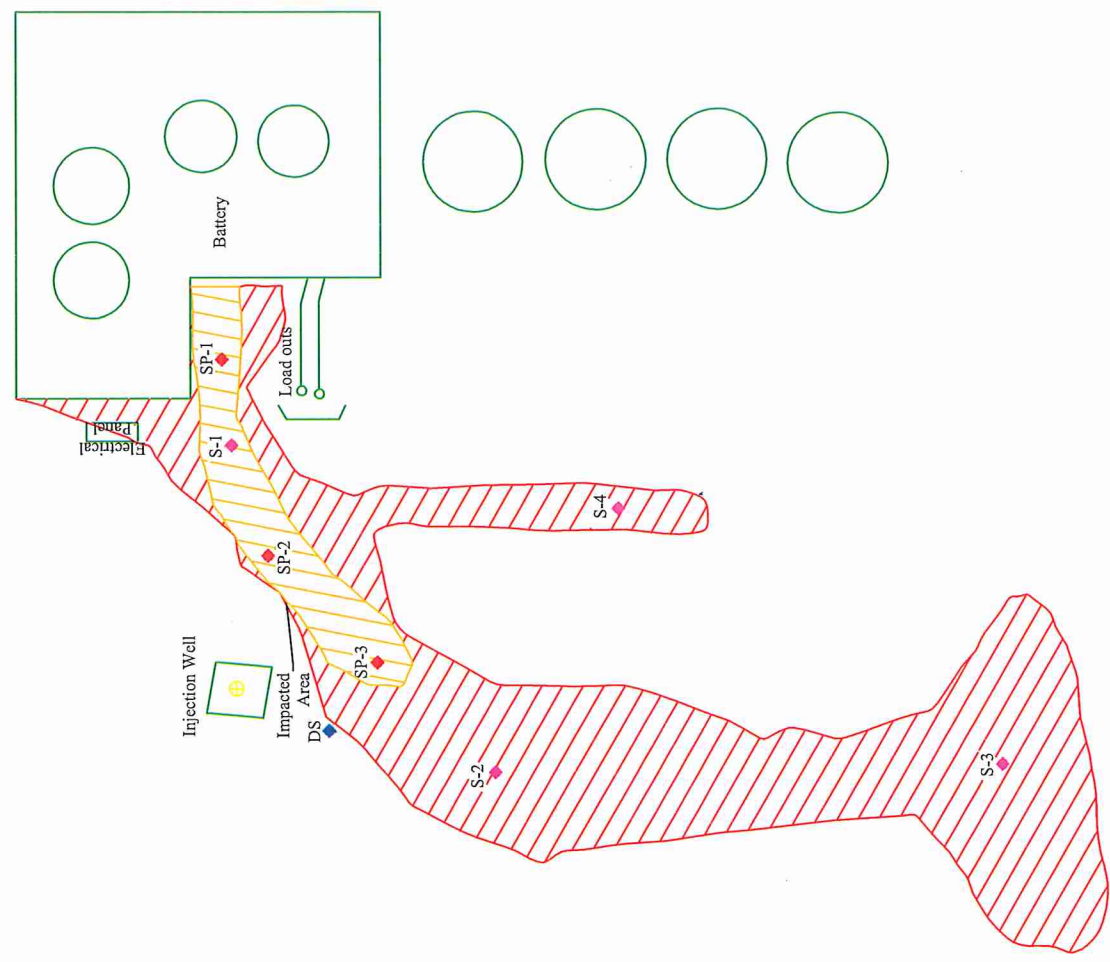
Cotton Draw #65  
 Devon Energy Corporation  
 Eddy County, New Mexico  
 Figure 1 - Site Plan

The hydrocarbon impacted soil within the flow path from S-1 through S-3 was excavated to a depth of 0.5-feet deep. The 2 barrel overspray on the lease road east of the location was also scraped 0.5-feet while excavating in the vicinity of S-3.

The impacted area within the S-4 flow path was excavated to the depth of 1-foot deep.

All contaminated soil was transported to Lea Land, LLC, an approved disposal facility.

The excavated areas on location and lease road were backfilled with new caliche, machine compacted and re-contoured to match the surrounding location.
