LT Environmental, Inc.
3300 North A Street, Building 1, #103
Midland, Texas 79705
T 432.704.5178

December 23, 2019

**RE: Containment Liner Inspection
2RP-5681
Tucker Draw 9 4 Federal Com #001H
Eddy County, New Mexico**

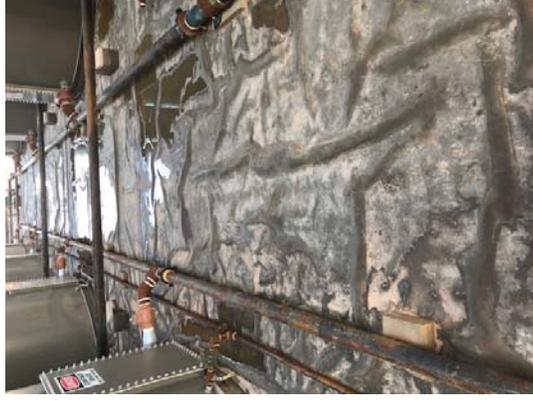
Photograph 4: Cleaned liner.
