Release Notification **VHX23-200312-C-1410**

Site Name: Regulator 29 SWD #001	Site Type SWD
Date Release Discovered 1/27/2020	API# (if applicable) 30-015-41034

Liner Integrity Inspection – Photos attached

Liner Inspection Photos – Regulator 29 SWD #1

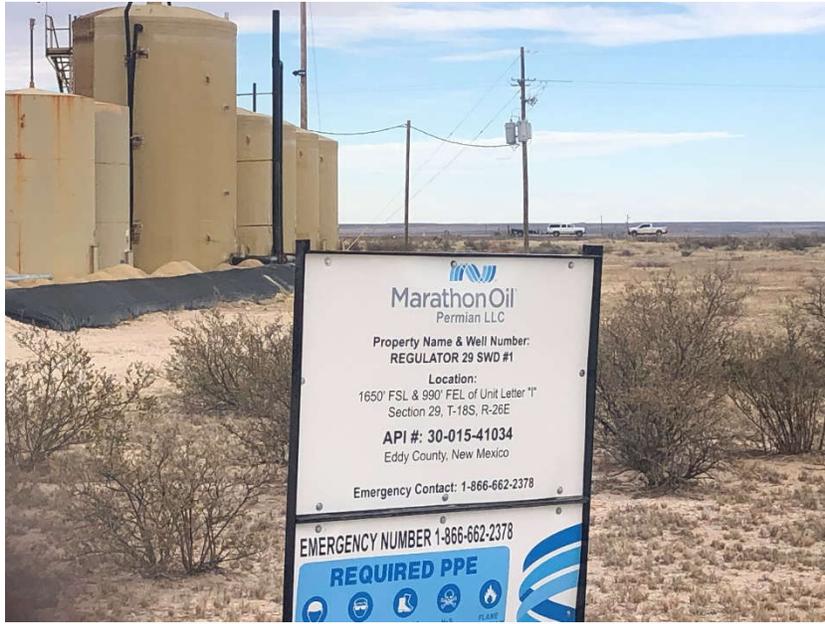
Photo 1. Site Signage

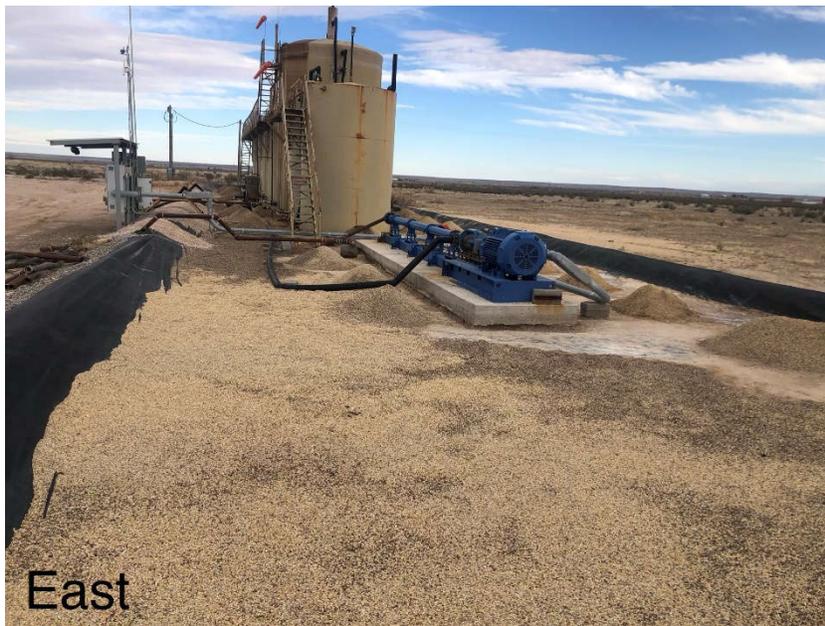
Photo 2. Entire containment

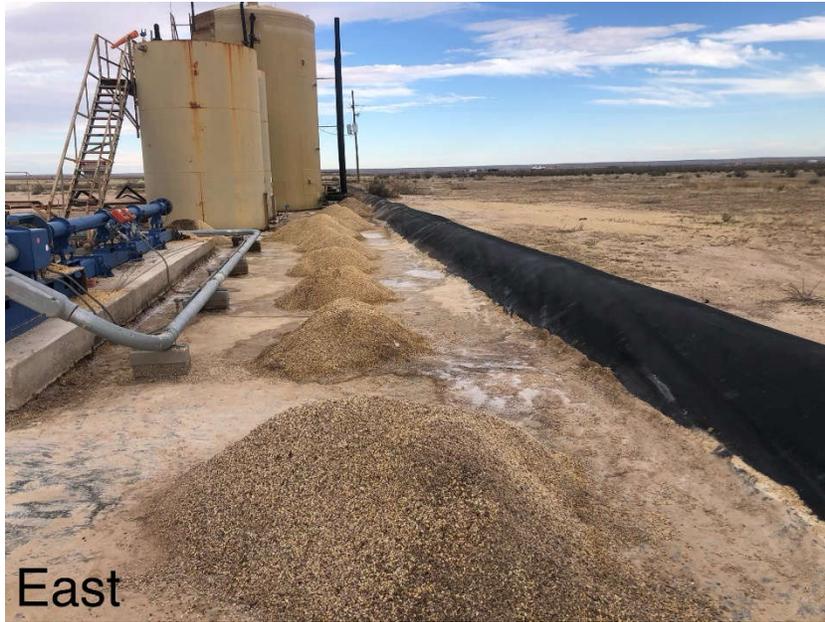
Photo 3. Entire containment

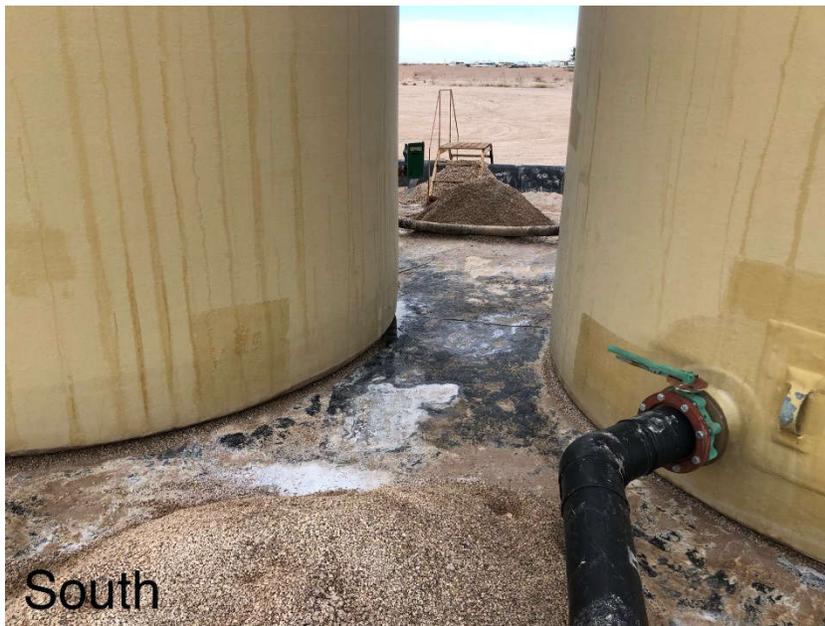
Photo 4. Mid-containment

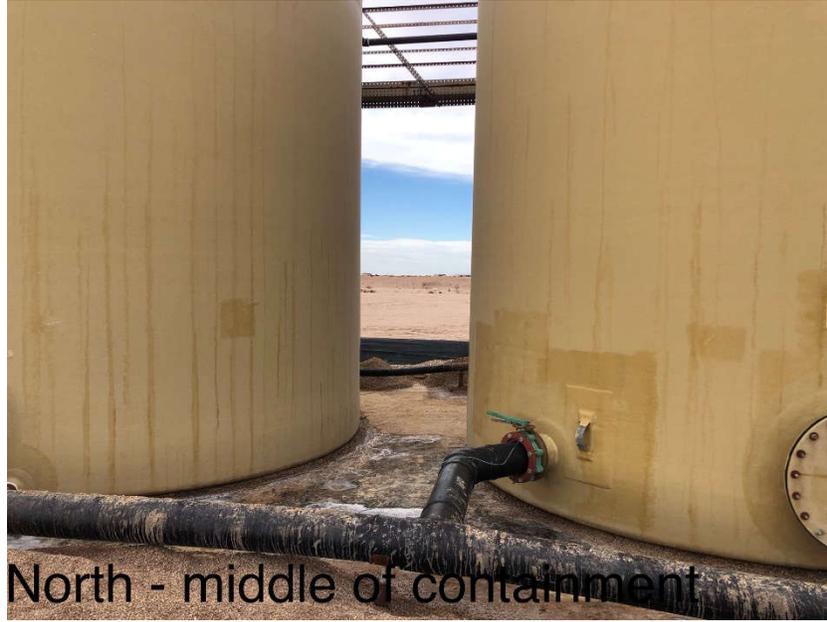
Photo 5. Mid-containment

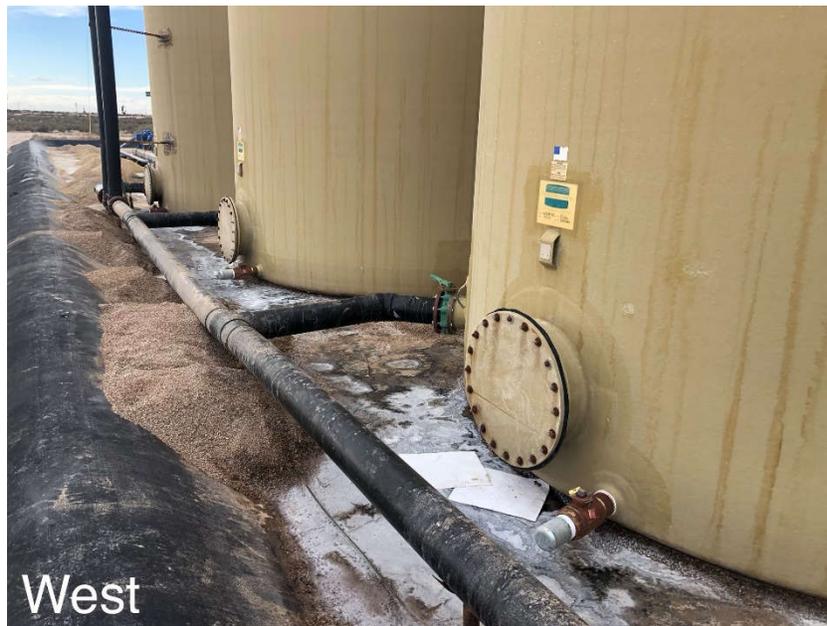
Photo 6. South edge of containment

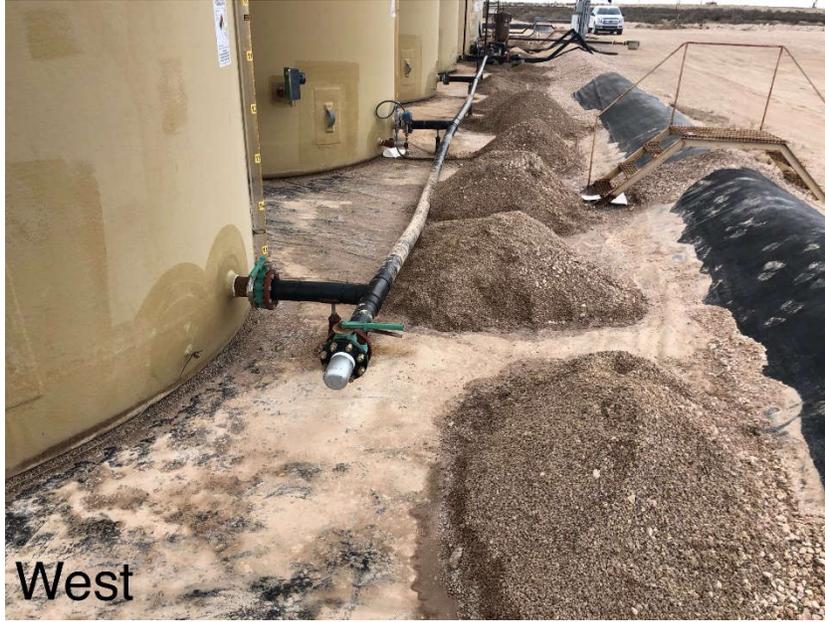
Photo 7. North edge of containment

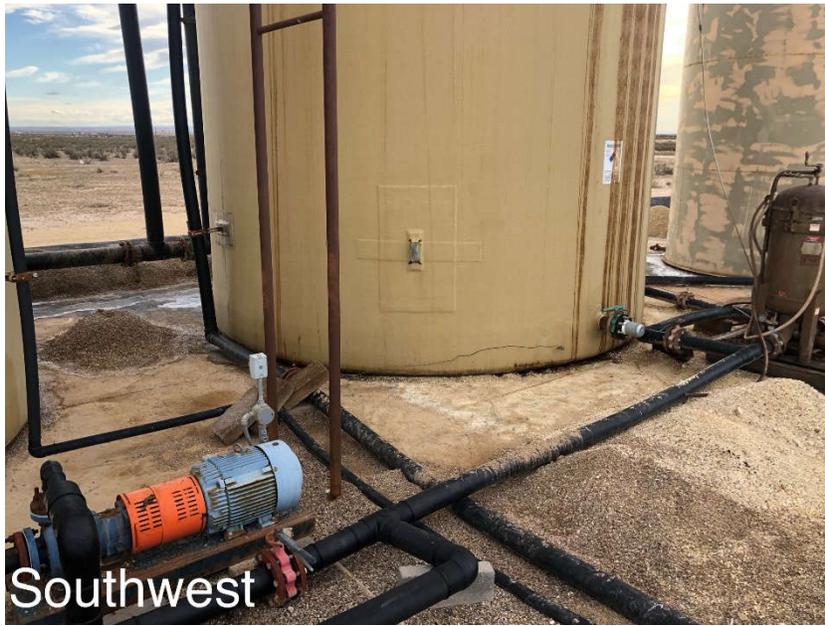
Photo 8. Mid-containment

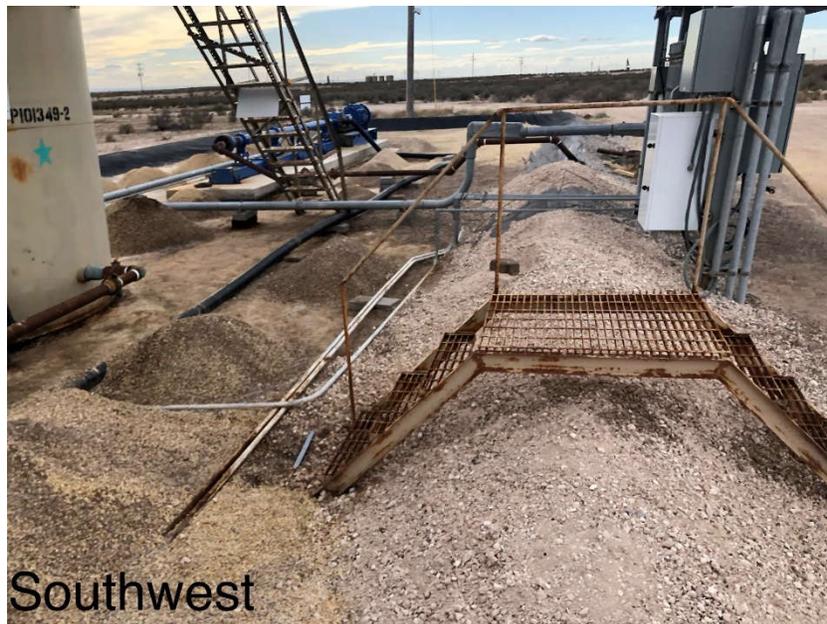
Photo 9. North edge of containment

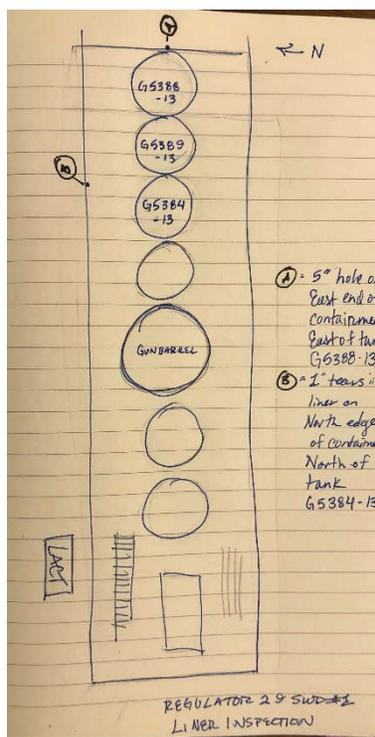
- East edge of containment liner - east of tank G5388-13 - see photos 10 through 13
approximately 5 inch square area

Photo 10. Diagram of site and repairs needed

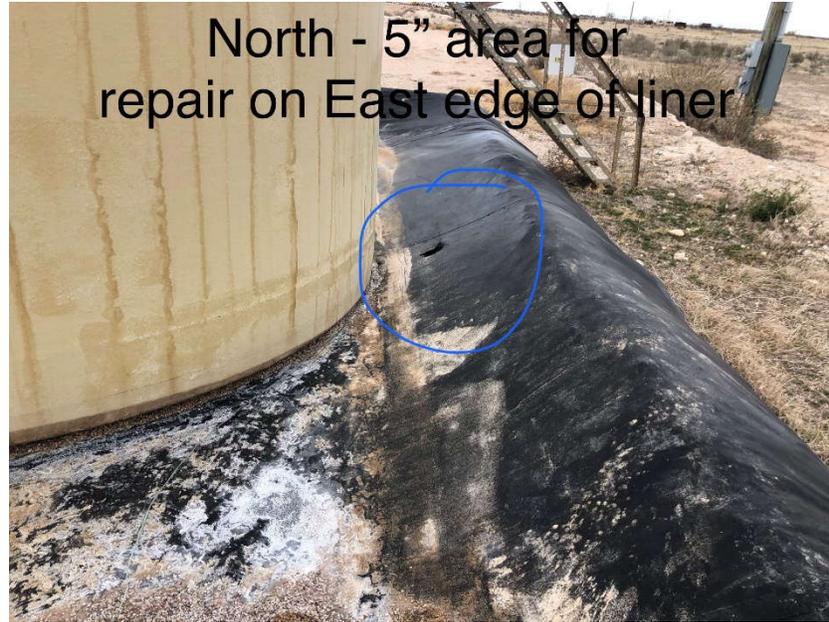
North - 5" area for
repair on East edge of liner

Photo 11. Location of 5-inch hole in liner on East edge of liner

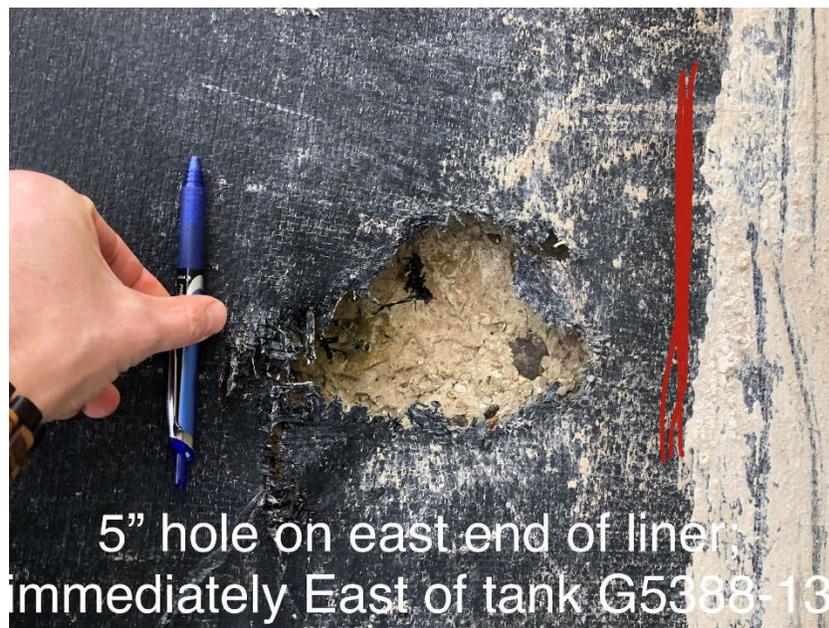
*5 inch hole is near water line of release in question but from evidence shown in attached
photos, the hole did not compromise the liner's ability to contain the leak in question.

5" hole on east end of liner;
immediately East of tank G5388-13

Photo 12. Size of 5-inch hole in liner on East edge of liner;
Red line is waterline.

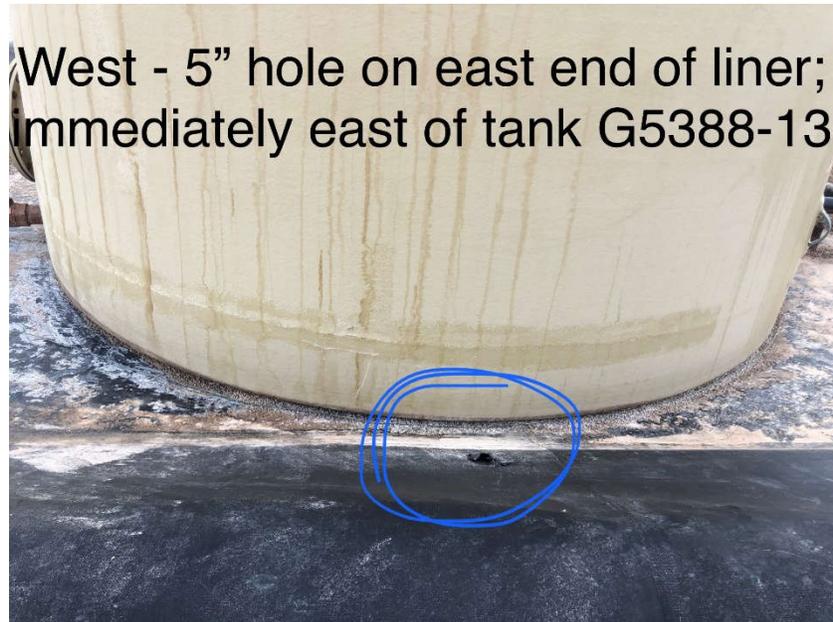
West - 5" hole on east end of liner;
immediately east of tank G5388-13

Photo 13. Location of 5-inch hole in liner on East edge of liner

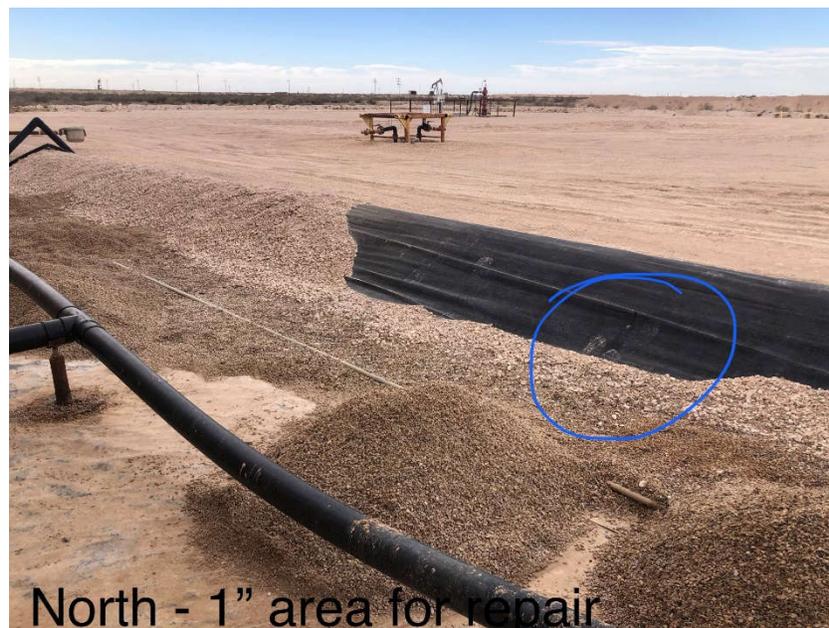
- North edge of containment liner - North of tanks G5384-13 - See photos 14 through 17
approximately 1 inch circular area and 1 inch tear in liner

*1 inch tears on the North edge did not compromise the liners ability to hold the leak.

North - 1" area for repair

Photo 14. Location of 1-inch tears in liner on North edge of liner

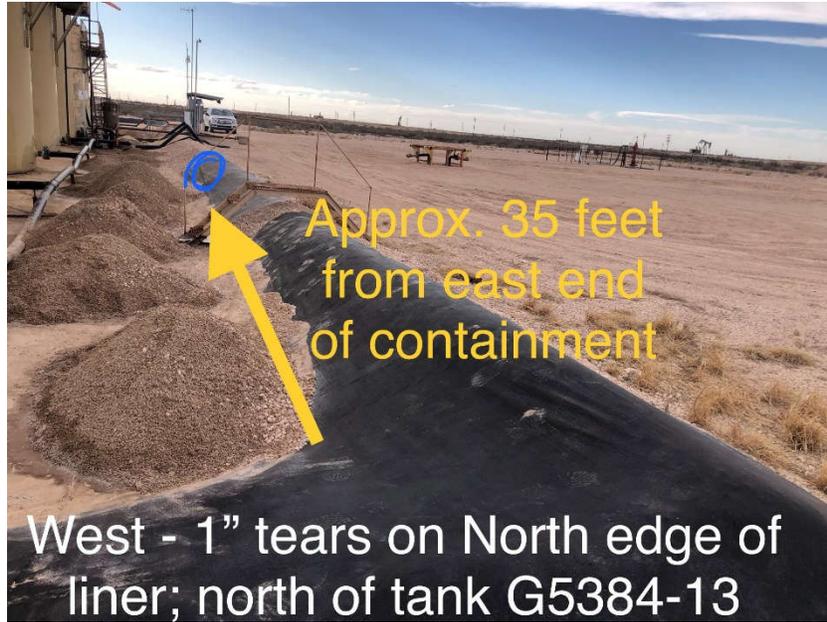
Photo 15. Location of 1-inch tears in liner on North edge of liner

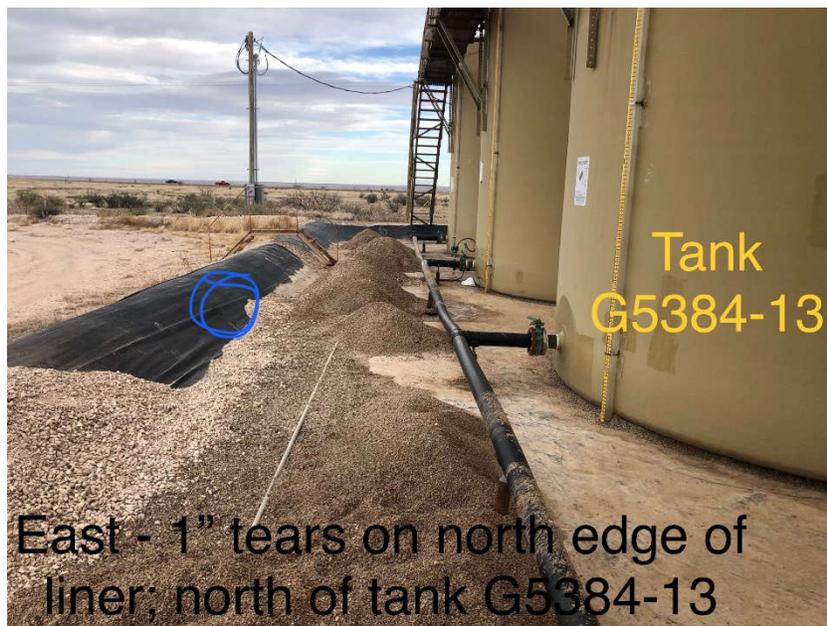
Photo 16. Location of 1-inch tears in liner on North edge of liner

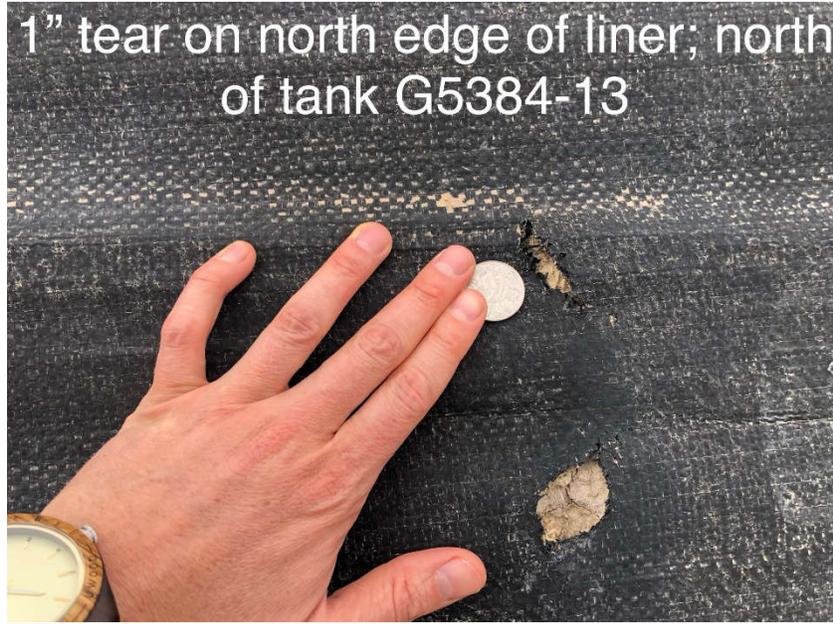
Photo 17. Size of 1-inch tears in liner on North edge of liner

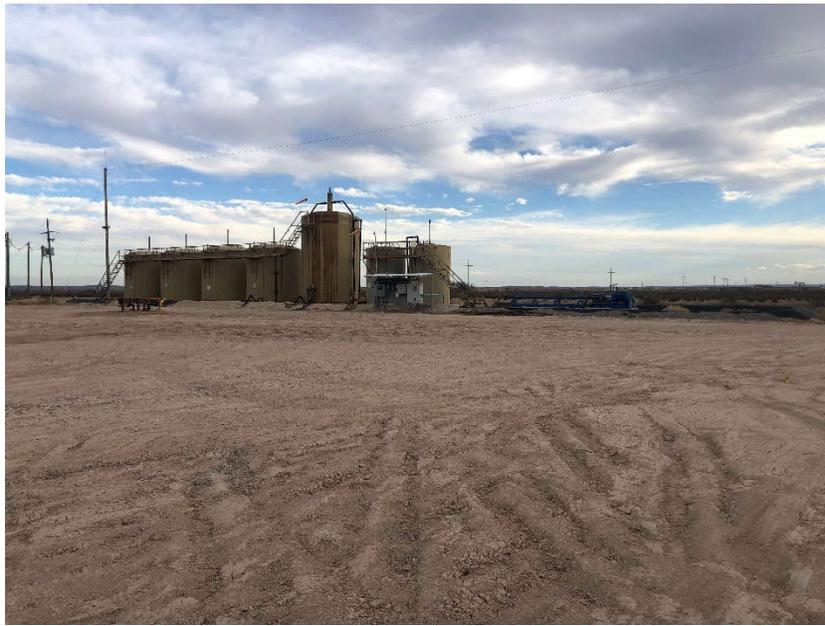
Photo 18. Photo of entire site
