SMA #5E29133, BG4

**RE: LINER INSPECTION REPORT  
BOOMSLANG 14 23 FEDERAL #003H (NOY1736032564)**

Devon Energy Production Company  
Boomslang 14 23 Federal #003H (NOY1736032564)

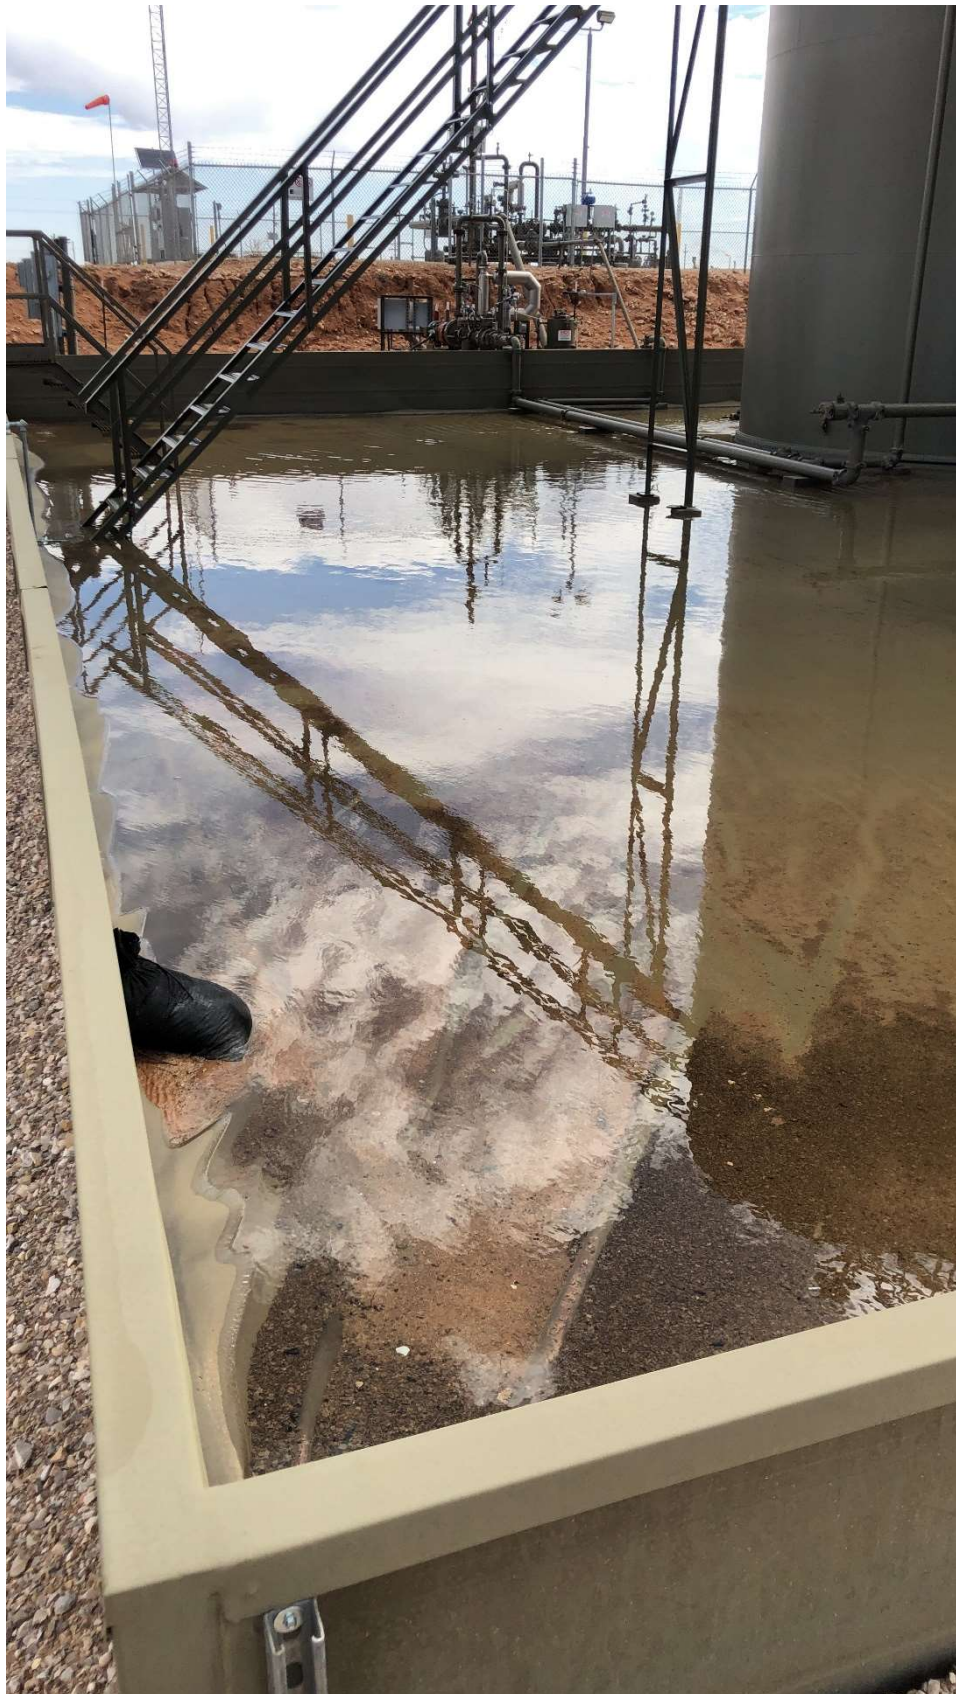
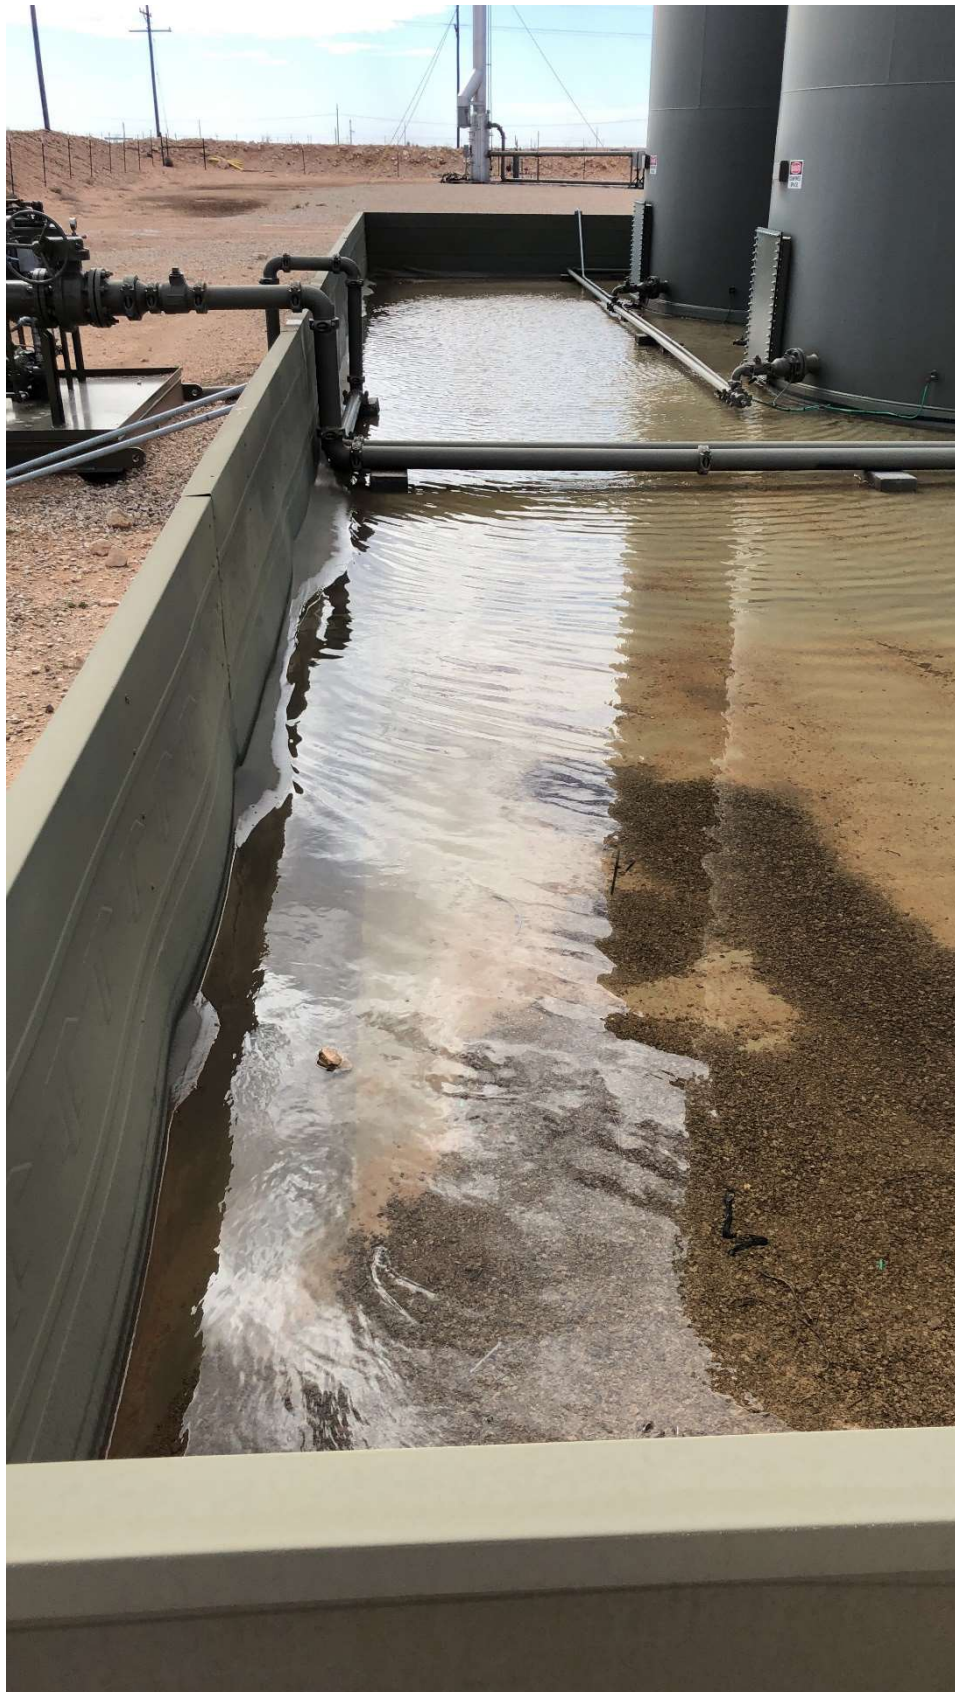
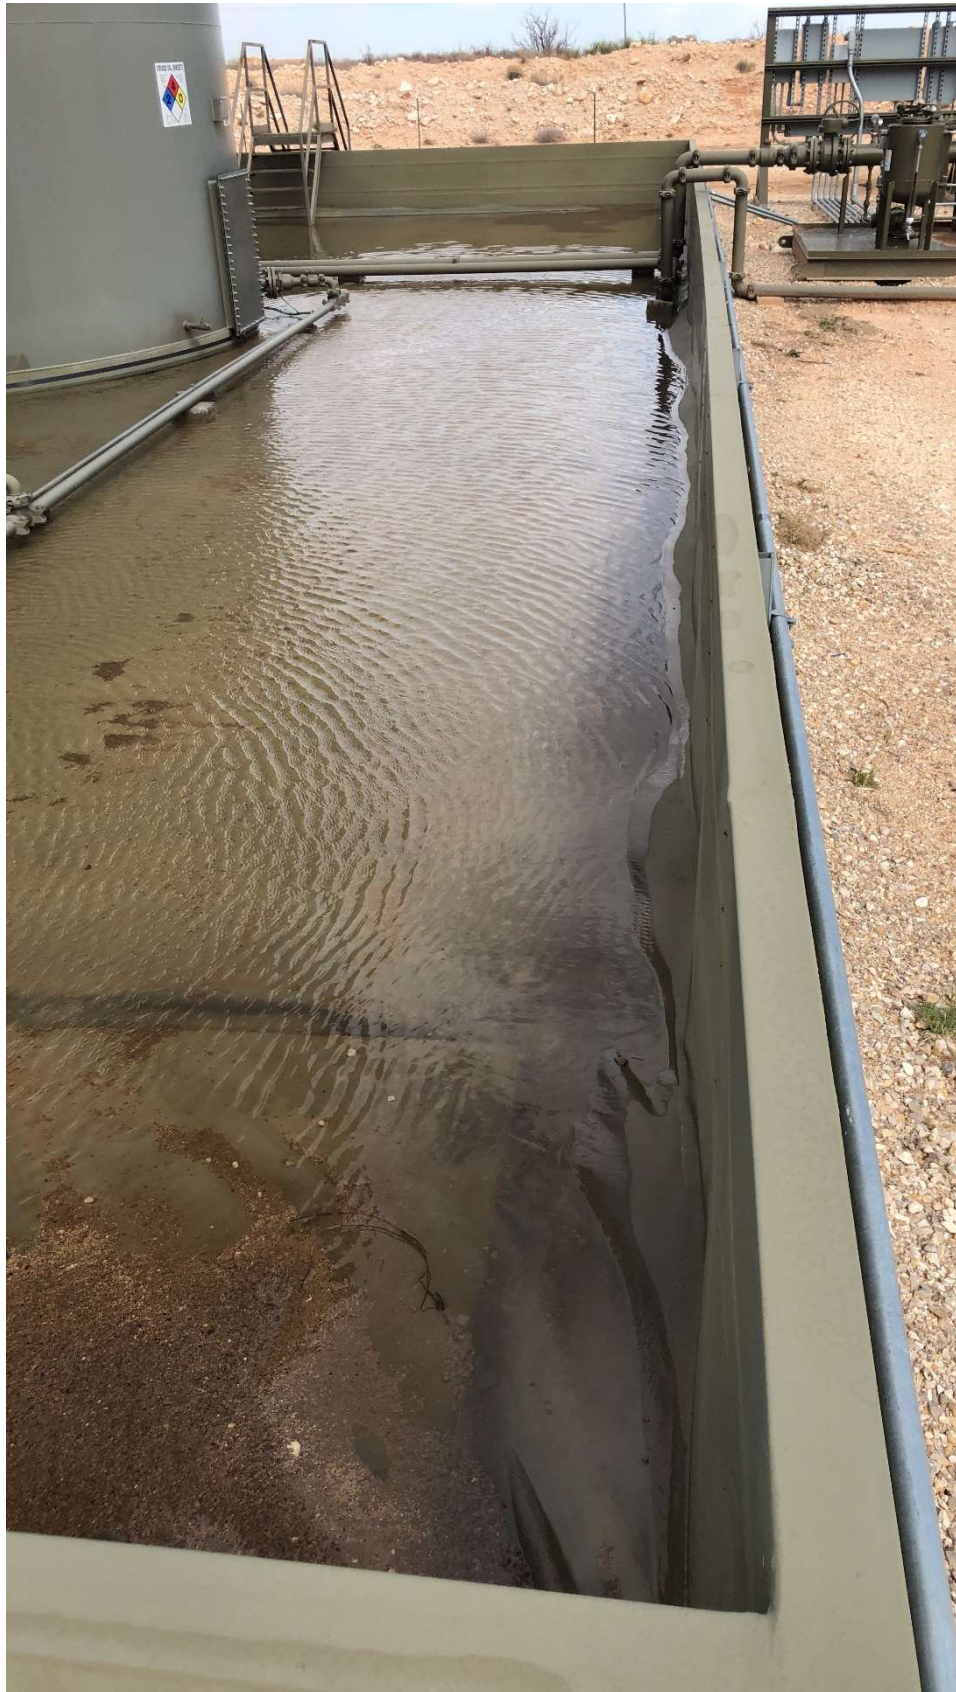
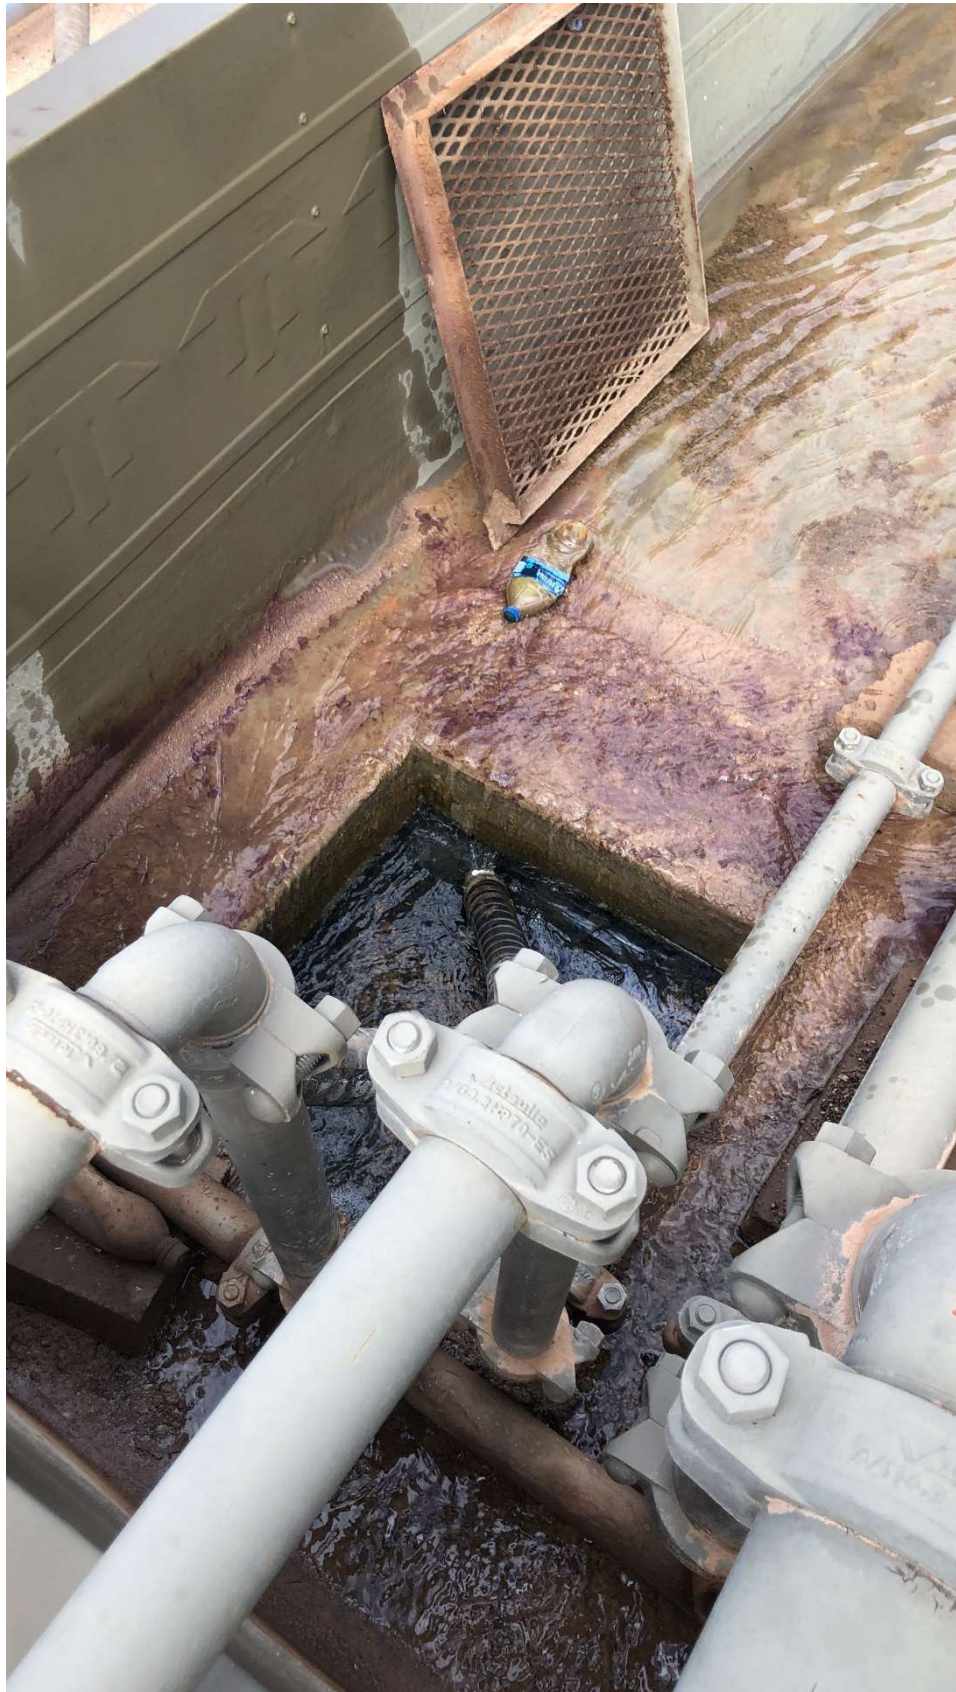
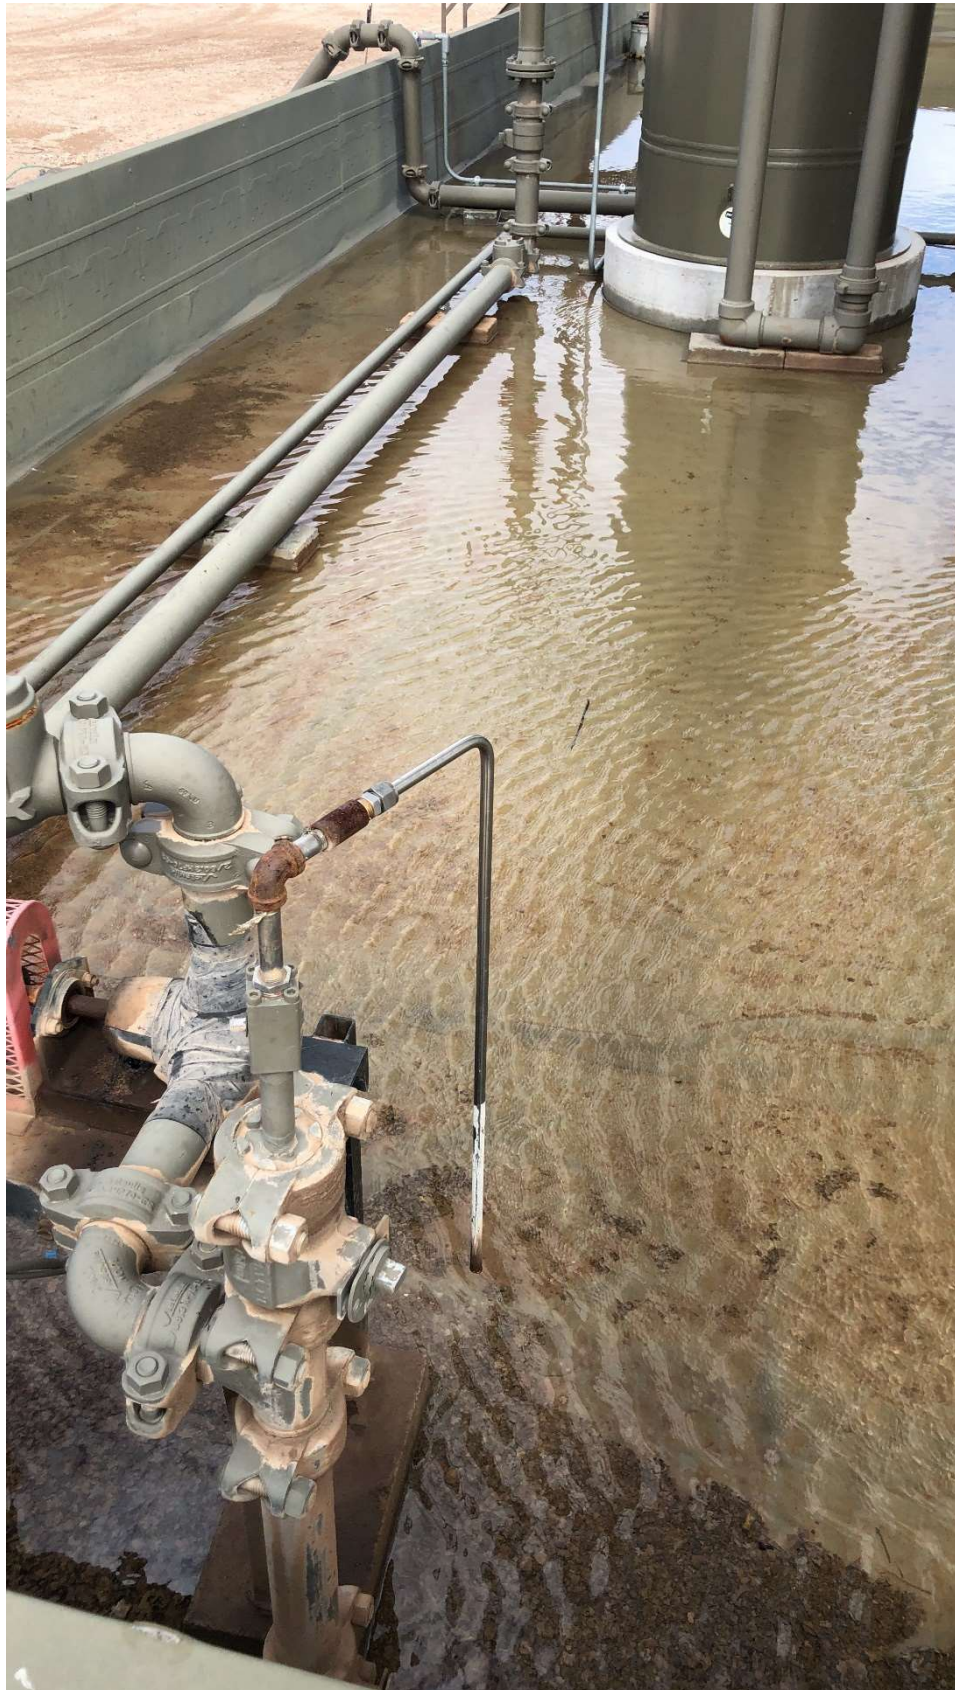
**Appendix A**  
**PHOTO LOG & FIELD NOTES**

At the request of Devon Energy, on May 26, 2020, SMA conducted a liner integrity inspection per the requirements of 19.15.29.11.A(5)(a) NMAC. NMOCD was notified on May 24, 2020 that the liner inspection was to occur. After a thorough visual inspection of the liner for the tank battery containment, SMA concluded that the liner appeared to be intact and had the ability to contain the leak in question. The bolts from the manway from which the release occurred was identified, and SMA verified that the release did not occur outside of the lined containment. A photo log and field notes of the inspection is included in Appendix A.

SMA recommends no further action for this release.
