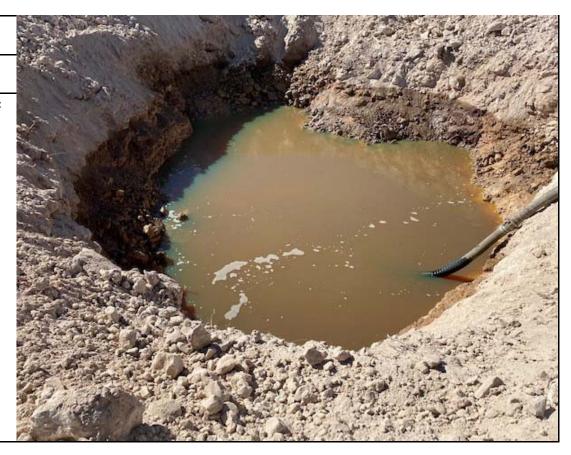
1

View of the Initial Release.

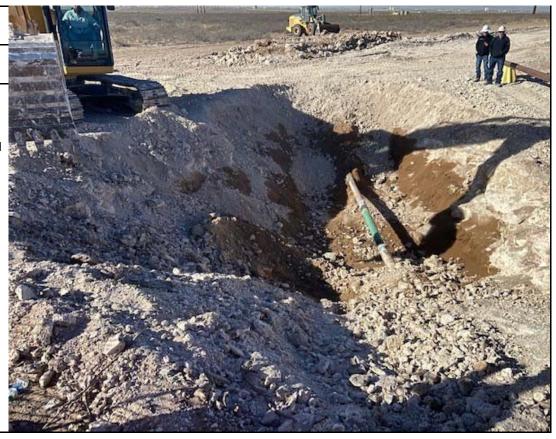
2

View of the affected pipeline and surface staining from the initial release.

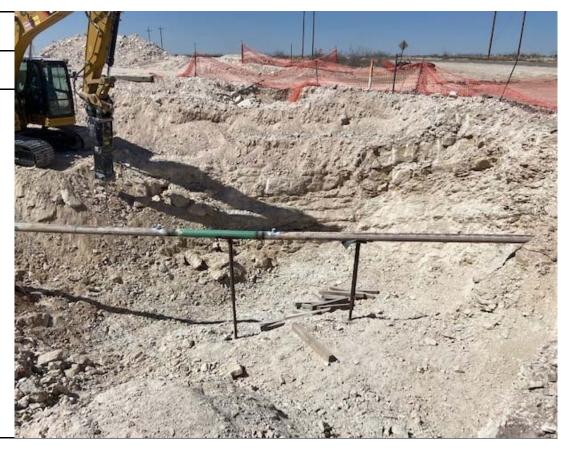
3

View of Excavation Activities.

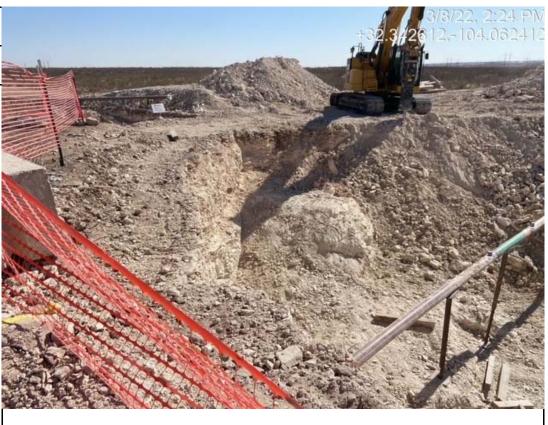
4

View of Excavation Activities.

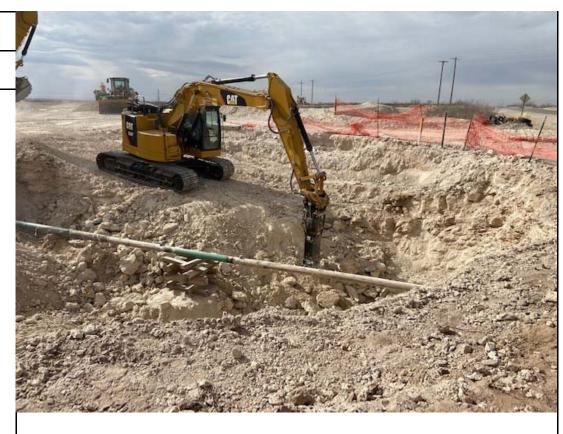
5

View of Excavation Activities.

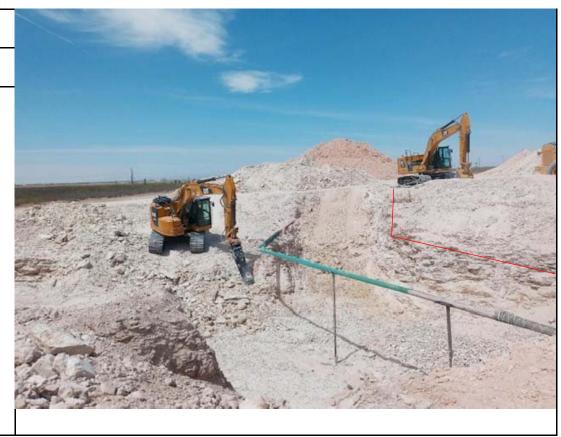
6

View of Excavation Activities.

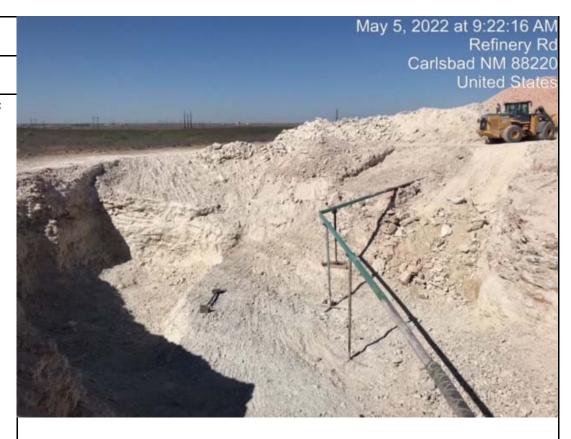
7

View of Excavation Activities.

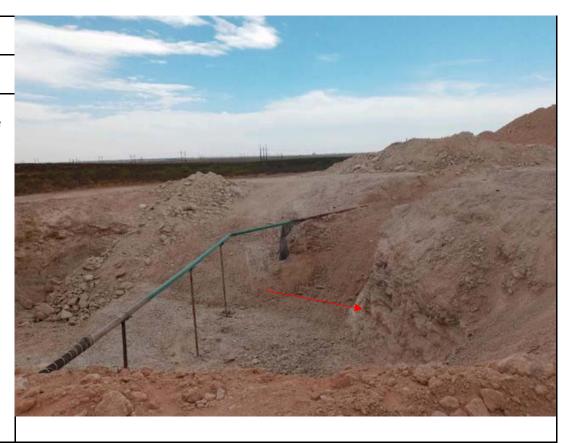
8

View of portion of the excavated area and impacts remaining insitu beneath High Pressure Buried Pipeline.
