RE: Form C-103 Subsequent Report of Remedial Work
Big Eddy Unit #44 Battery #1
Unit Letter H, Section 16, T21S, R30E

This is a summary of activities during the final reclamation of the BEU #44 Battery #1, and a request for approval of the associated NMOCD Form C-103. Bopco retained Merrymen Construction to reclaim the site located within the Maroon Cliffs of Eddy County, south of highway 62/180 east of Carlsbad, NM.

Photo Documentation
Big Eddy Unit #44 Battery #1
Unit Letter H, Section 16, T21S, R30E

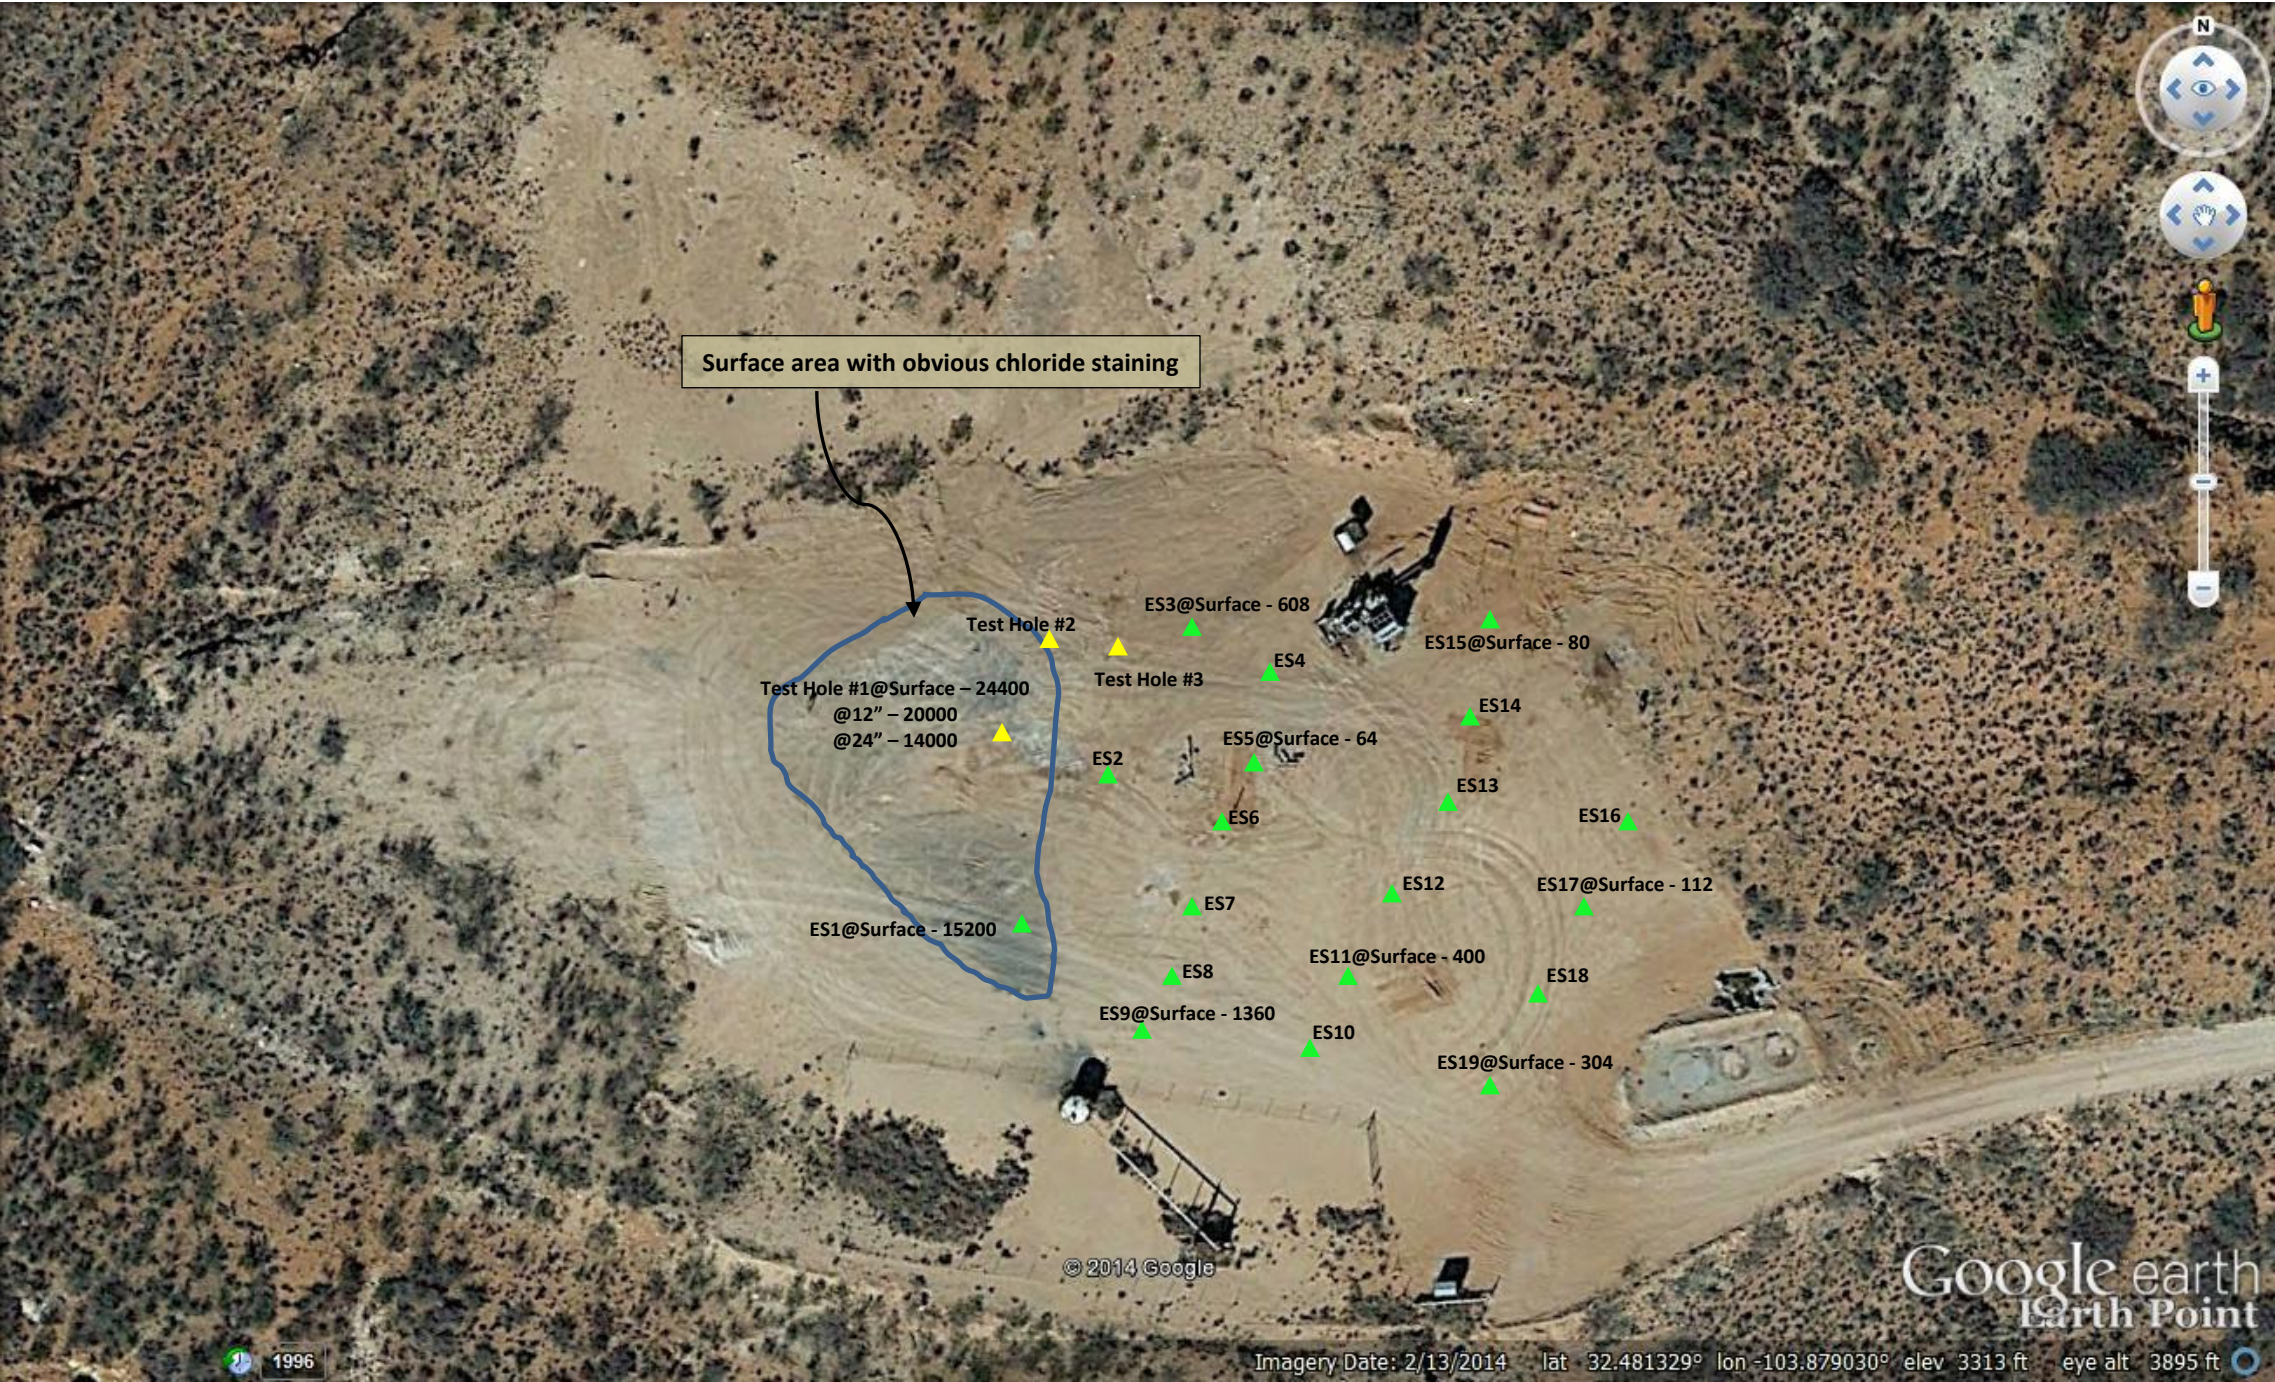
FIGURE 1: Big Eddy Unit 44 Battery #1 Initial Sampling – April 14, 2014
Unit Letter H, Section 16, Township 21S, Range 30E

On April 14, 2014, surface samples were collected from throughout the location to confirm areas of chloride impact following P&A activities at the site. The samples were field screened for chloride. A representative range of these samples was submitted to a commercial laboratory for chloride analysis. Chloride was concentrated in the center west area of the pad (Figure 1).

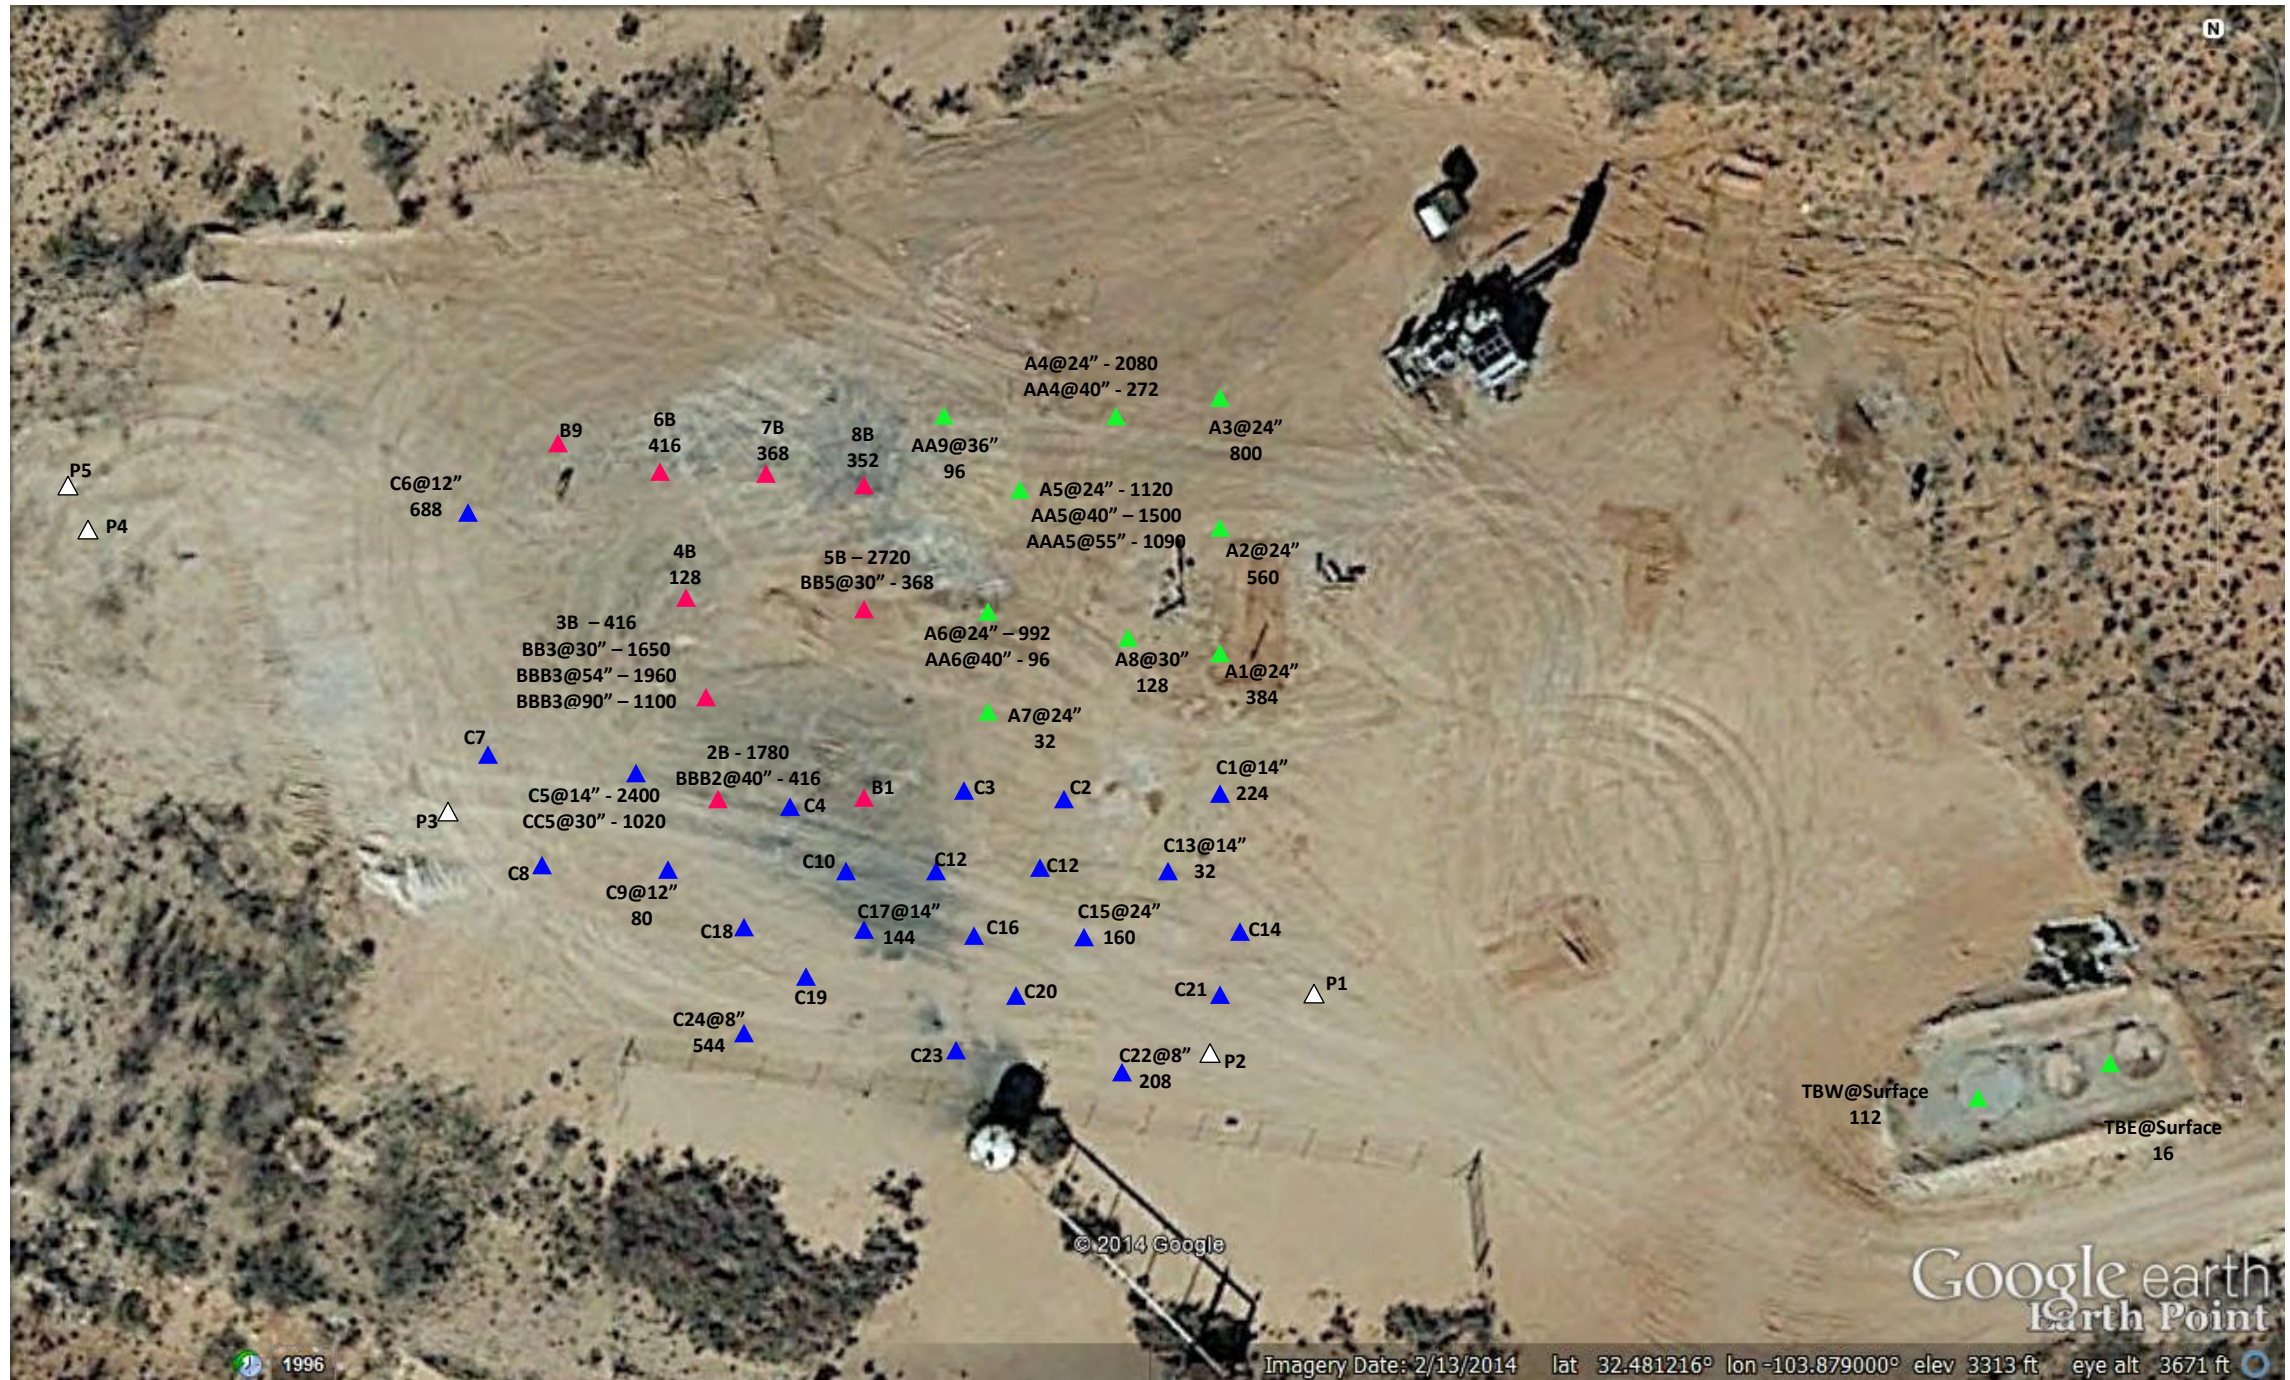
FIGURE 2: Big Eddy Unit 44 Battery #1 Final Reclamation Chloride Results

On May 12, 2014, removal of the well pad began. As excavation progressed, the soils were field screened for chloride and samples were submitted to a laboratory for analysis. Chloride impacted soils were removed to a NMOCD approved disposal facility. Remaining soils contained not more than 1100 mg/kg chloride (Figure 2).

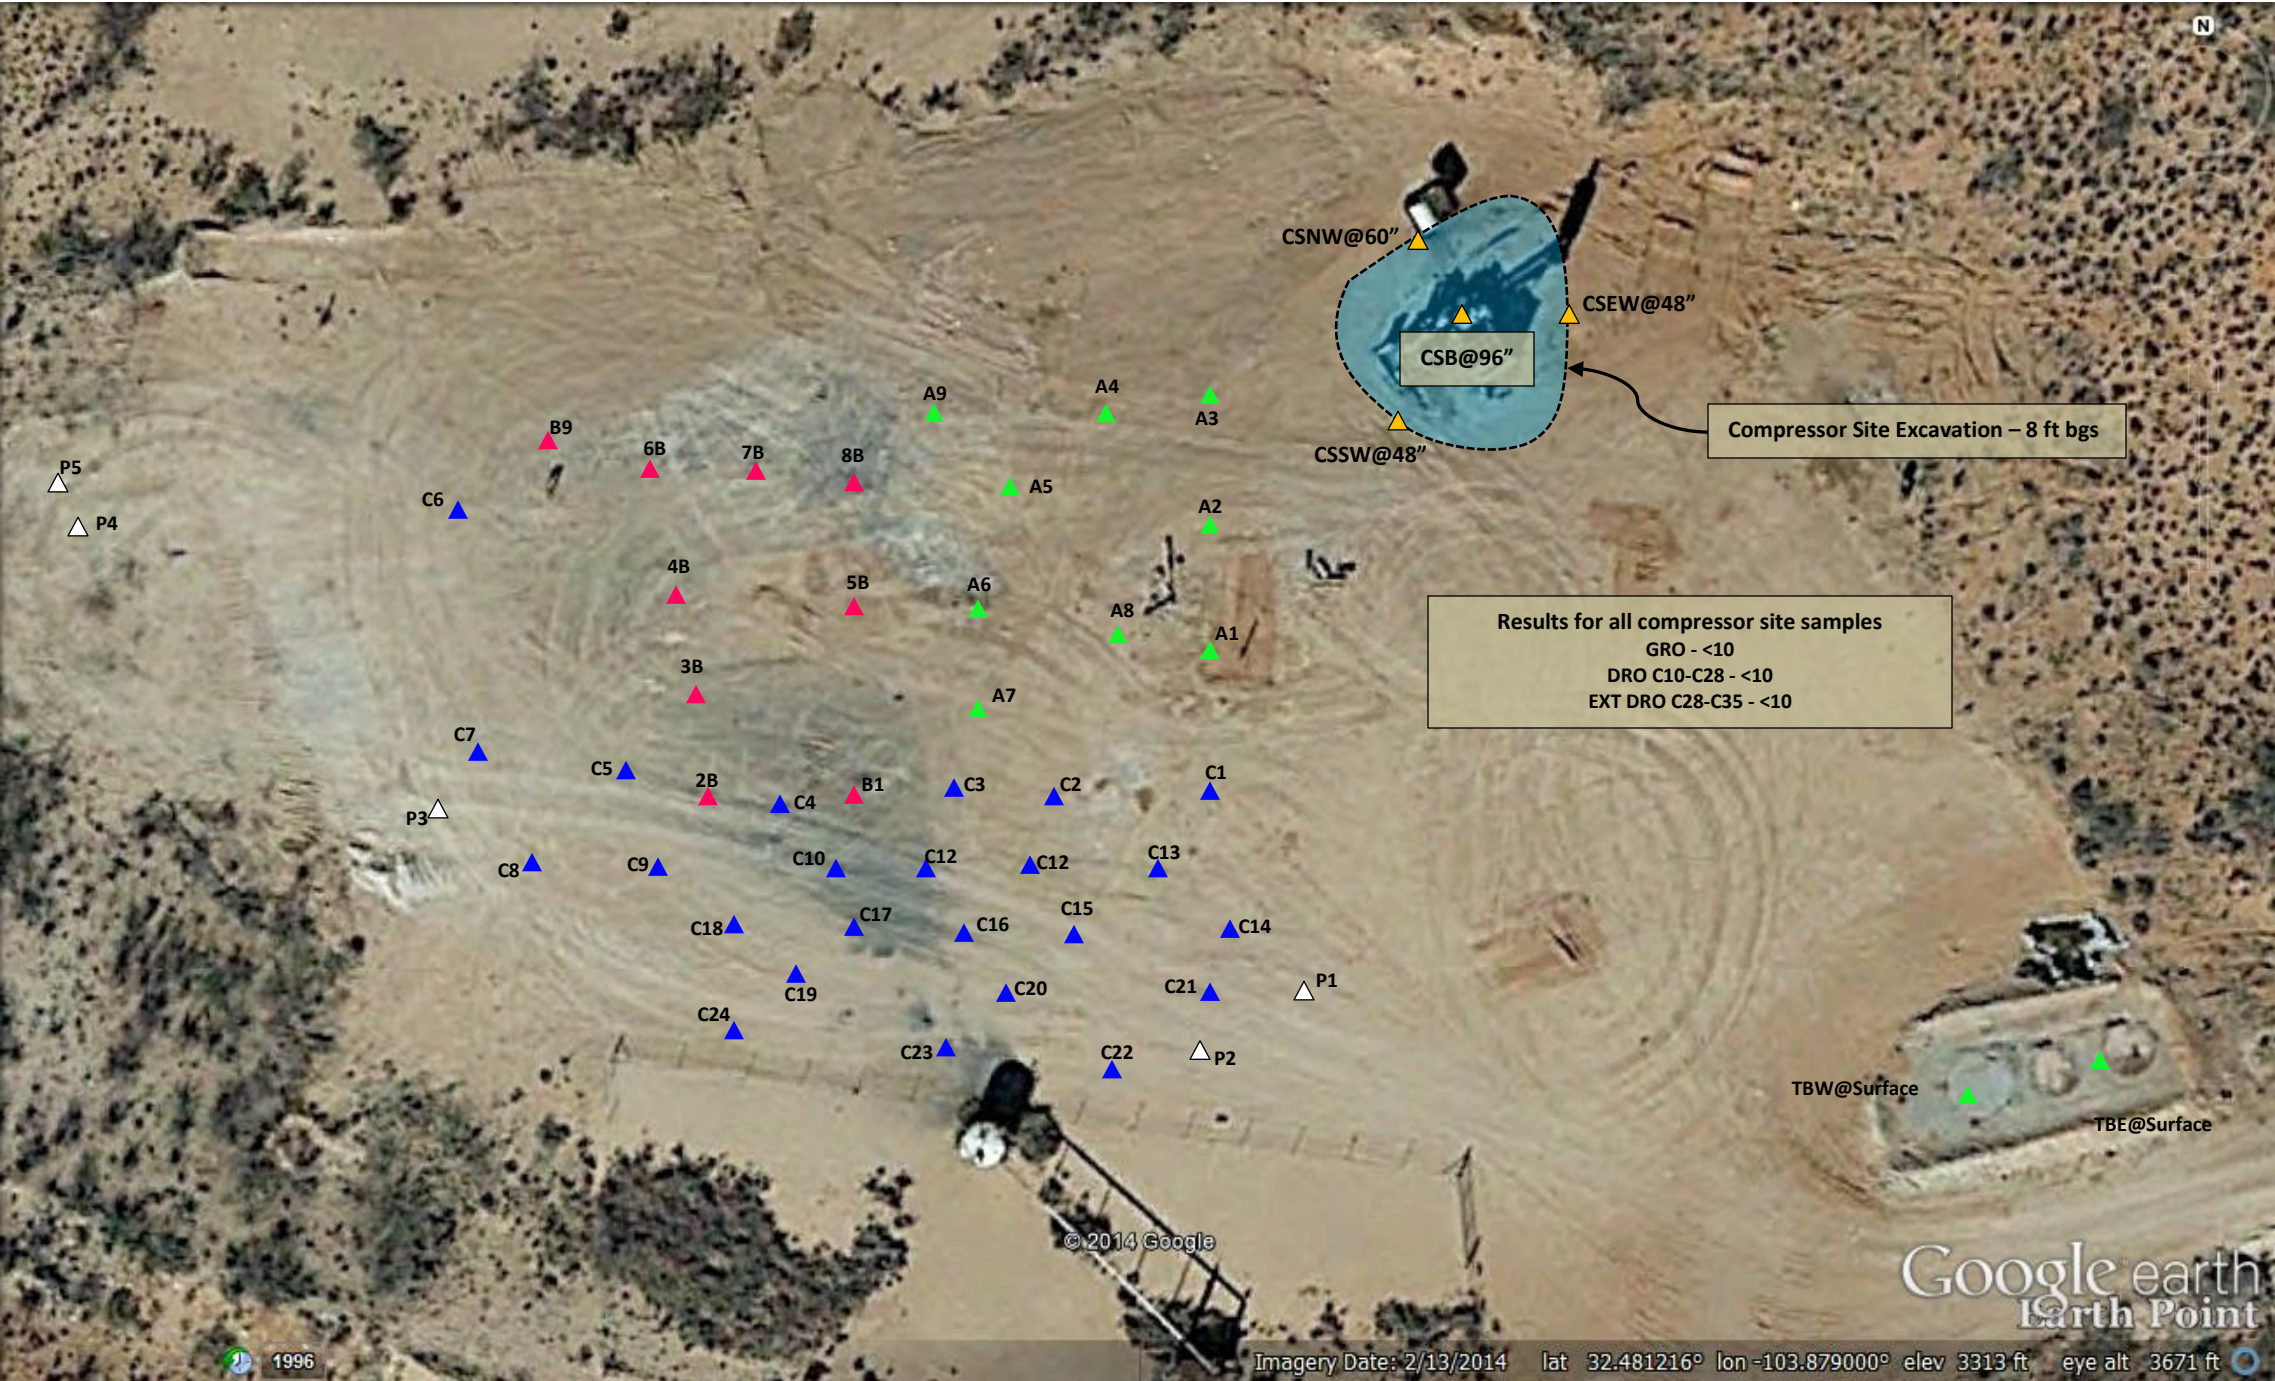
FIGURE 3: Big Eddy Unit 44 Battery #1 Compressor Site
Unit Letter H, Section 16, Township 21S, Range 30E

A small area of oil stain was also discovered in the northeast corner of the site in the former location of a compressor (Figure 3). A sample trench was excavated in the center, and a composite sample was collected from the excavated stockpile. The composite sample was submitted to a laboratory for waste characterization with the purpose of verifying that the material could be removed to Lea Land disposal facility. A sample from the trench was collected at 6 ft below ground surface (bgs) and another at 10 ft bgs. These samples were submitted to the lab for Total Petroleum Hydrocarbon (TPH) analyses to verify the depth of impact at this site. The 10 ft sample was below the method minimum detection level, and the area was excavated to 10 ft bgs. Side wall samples of the excavation were submitted to a laboratory for TPH analyses, and these samples were also below the minimum detection level. Upon laboratory confirmation, impacted soils in this area were removed to Lea Land disposal facility. Surface caliche removed from the east side of the well pad and not impacted by chloride was used to backfill a portion of the compressor site excavation.

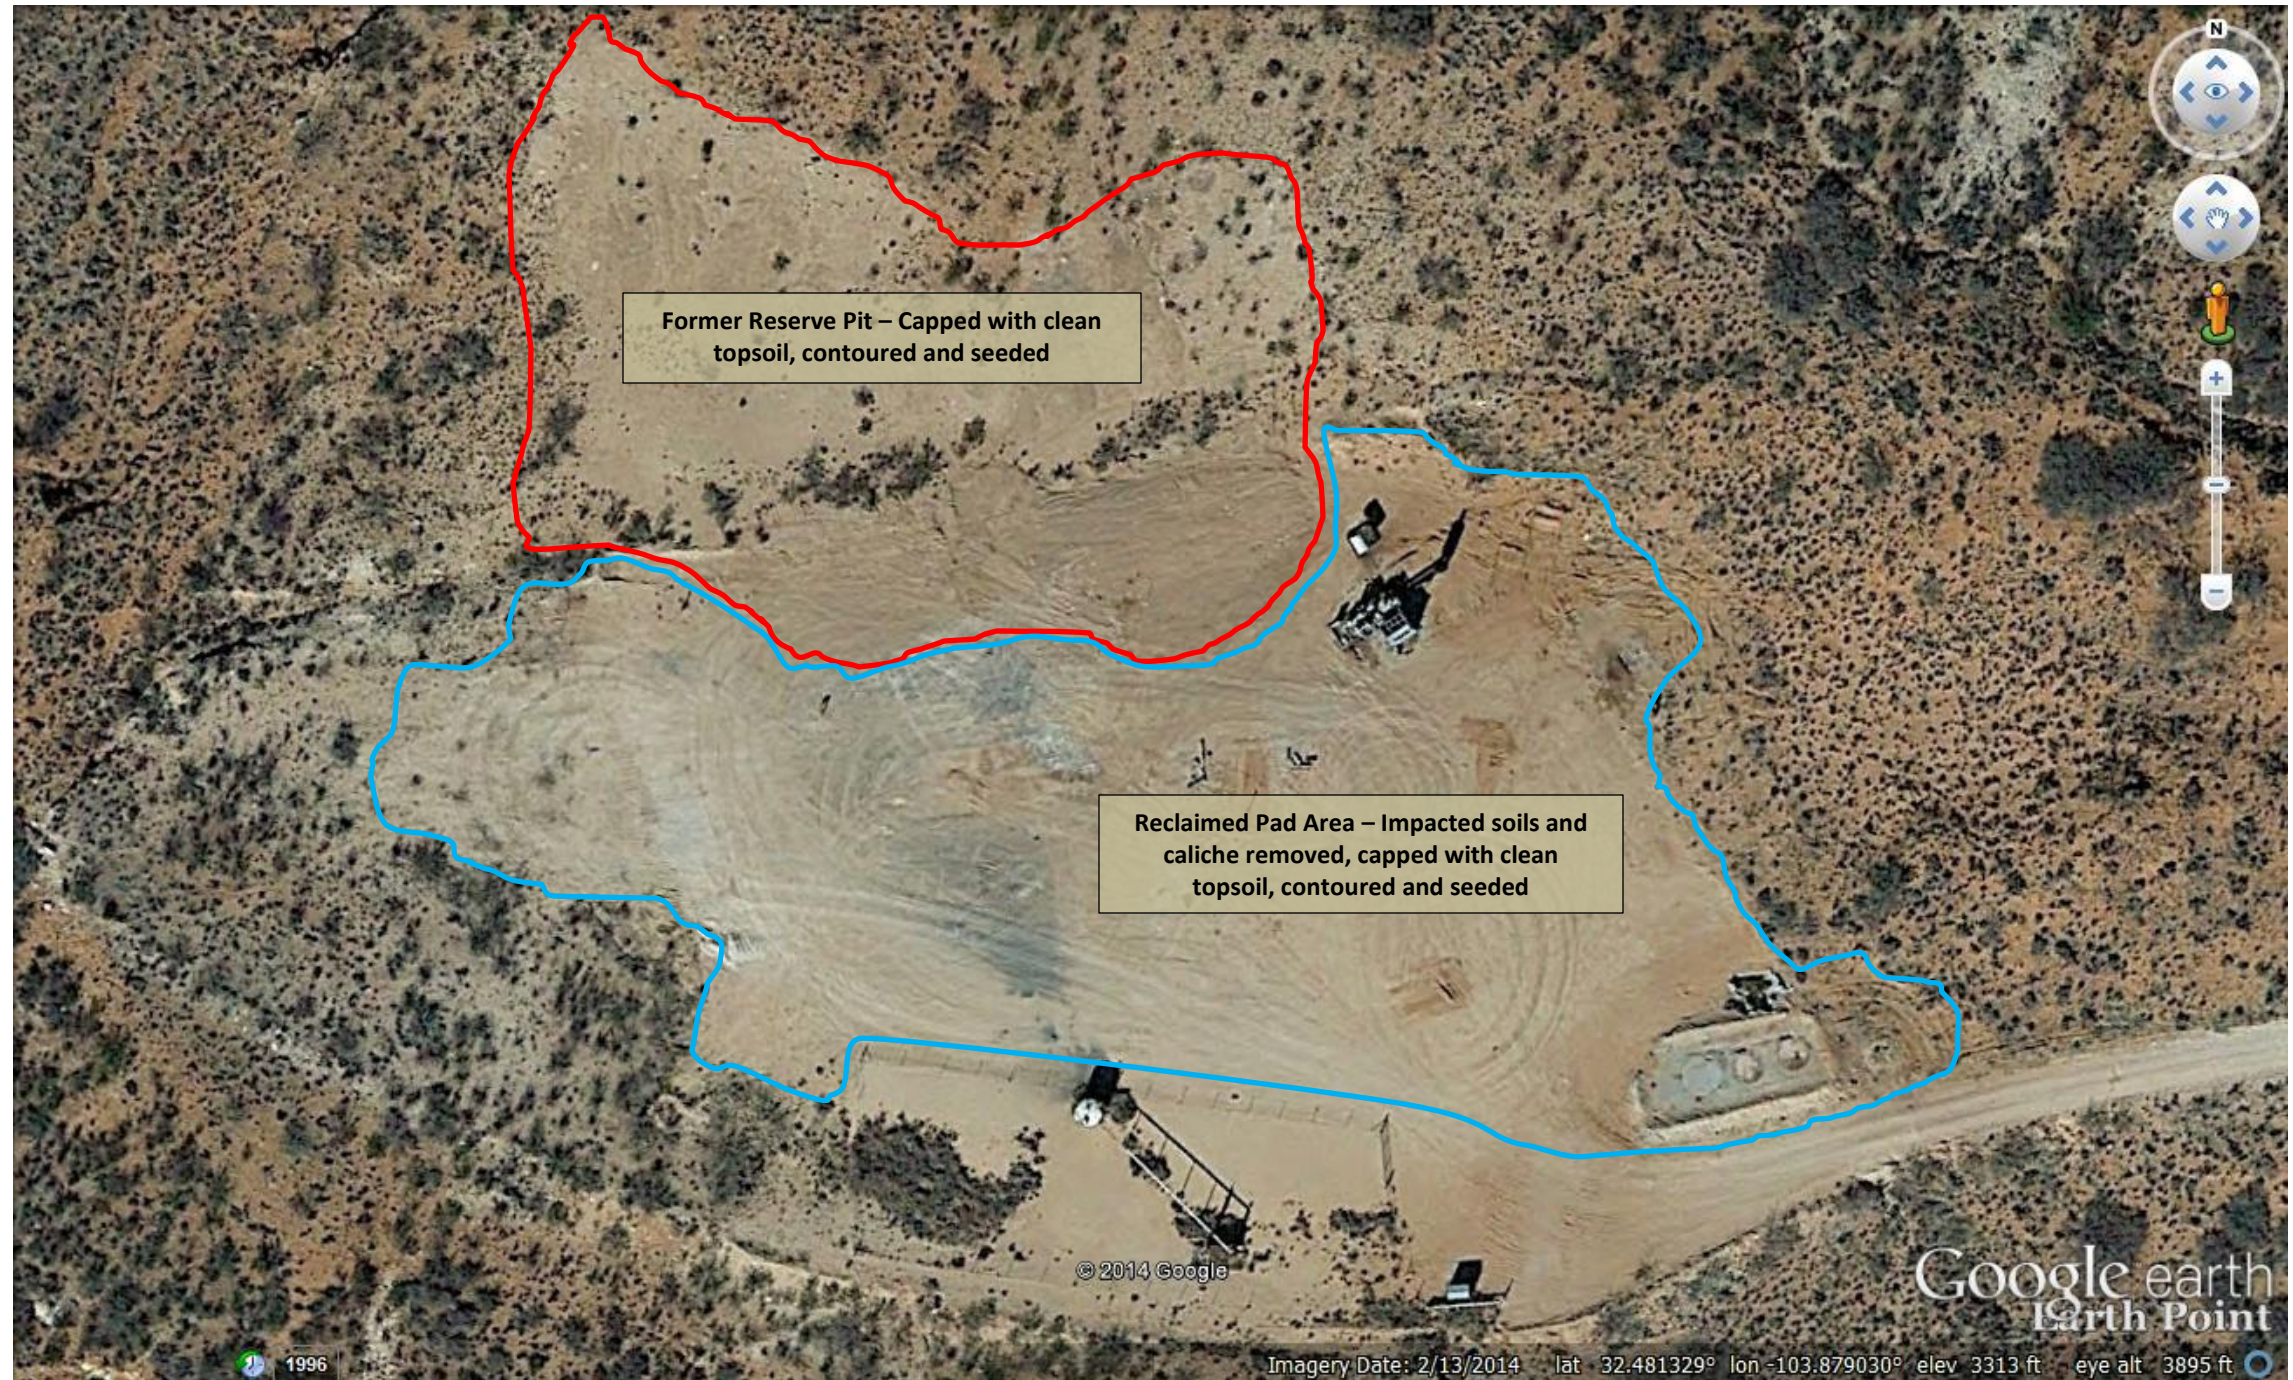
FIGURE 4: Big Eddy Unit 44 Battery #1 Overall Areas of Reclaim

The site was leveled and 18 inches of clean topsoil was imported and placed on the surface of the central and west areas of the site. A former reserve pit sloping upward at the north of the pad showed

signs of erosion on the surface as well as some exposed plastic at the east and west ends. The topsoil cap was extended to the north to include the reserve pit. The topsoil along the entire capped area of the former reserve pit and over the rest of the former well pad was contoured for erosion control and water diversion (Figure 4).

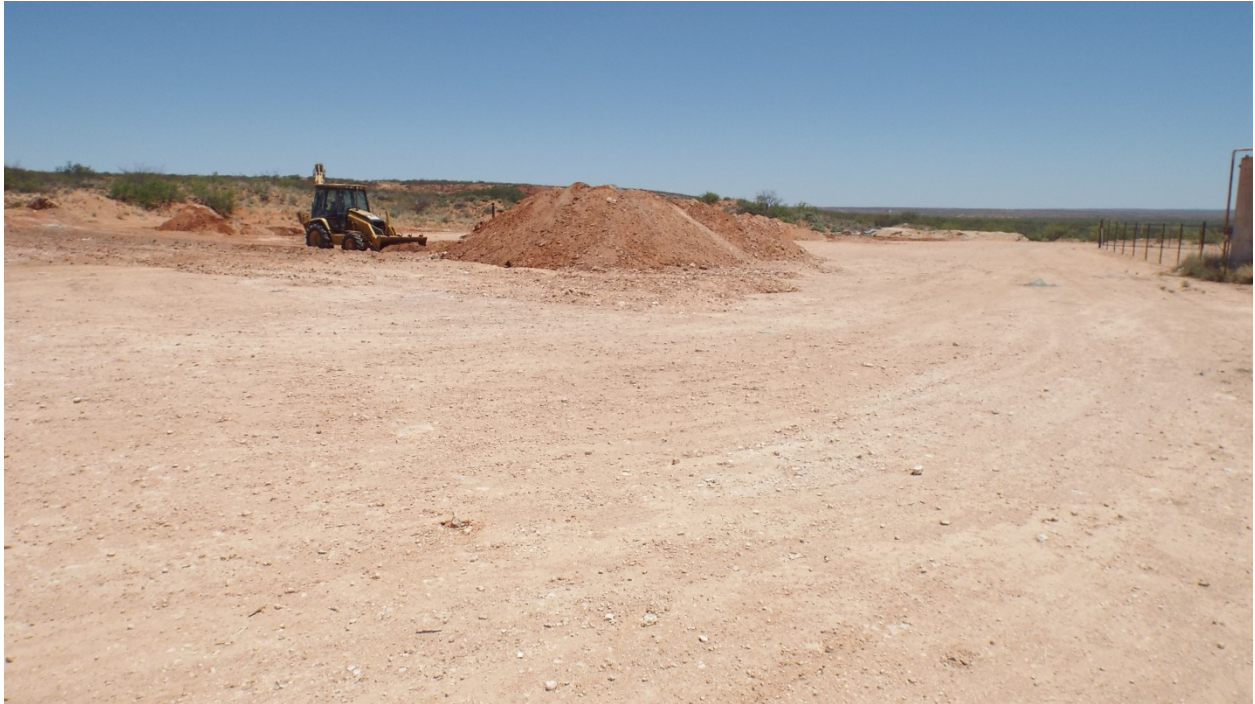
Stockpiling clean caliche on east pad, facing east 5/14/2014

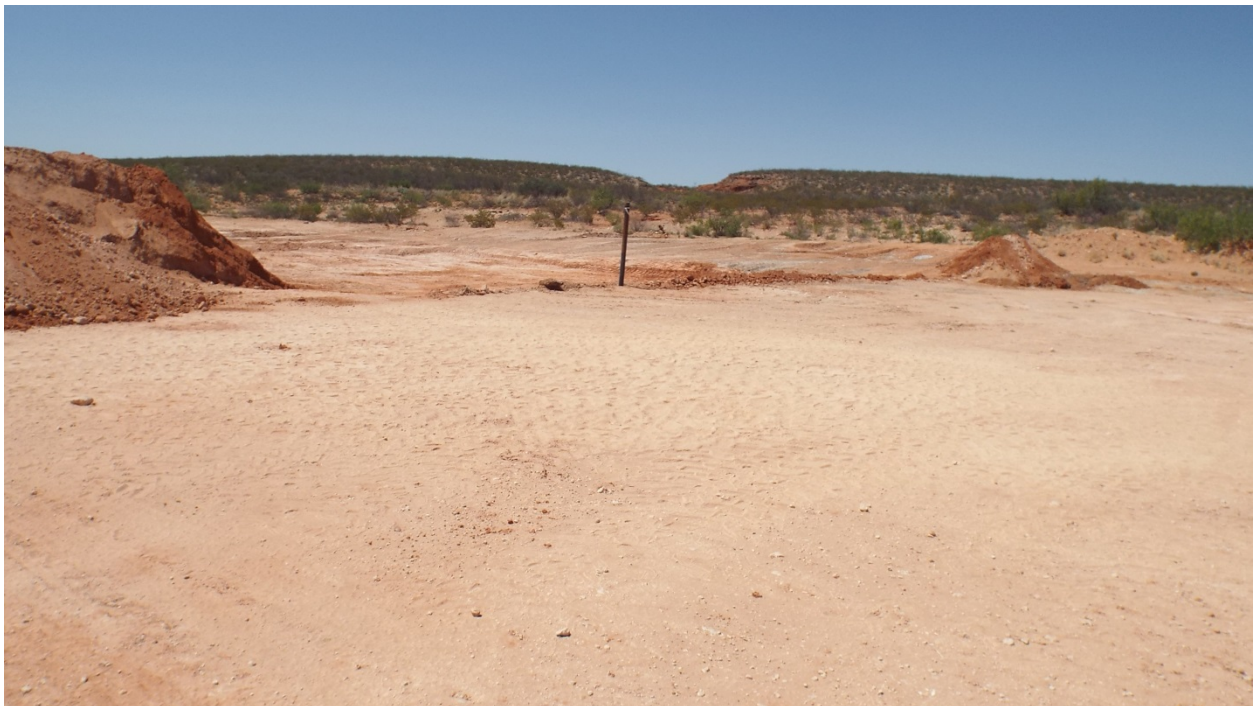
Excavating high chloride on west side of pad, facing NNW 5/15/2014

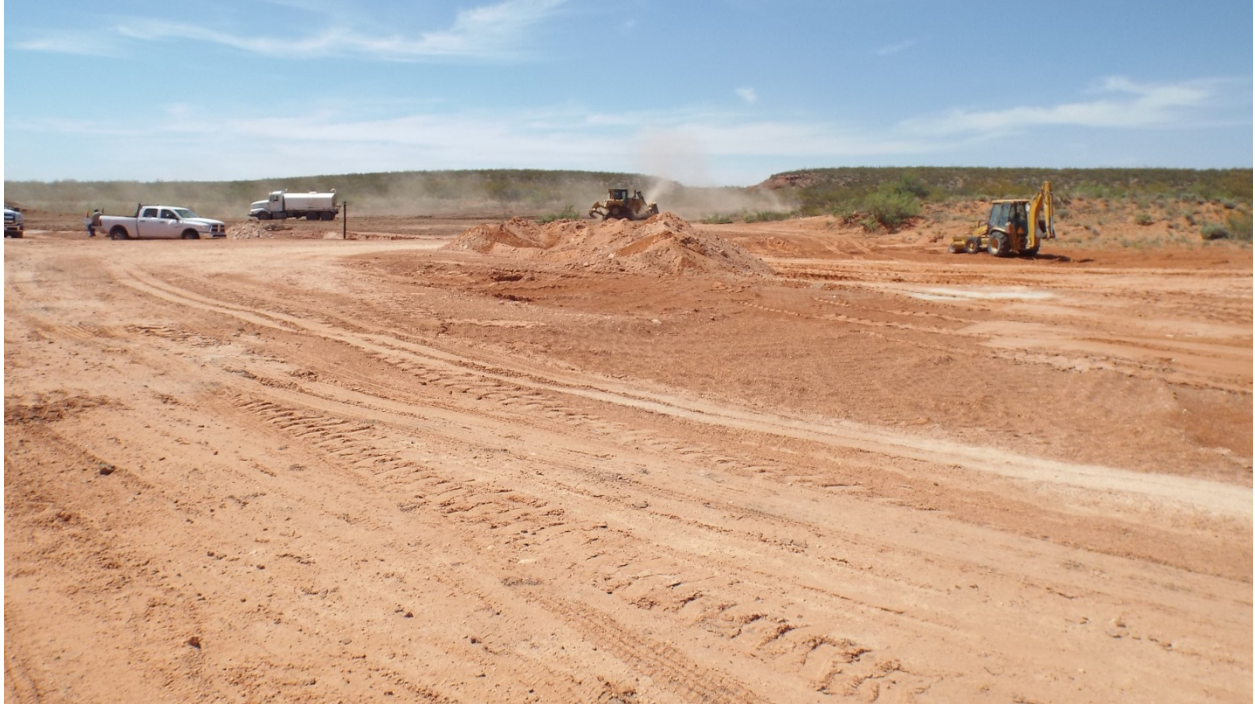
Capping former reserve pit with topsoil, compacting, top photo, facing NW 6/2/2014

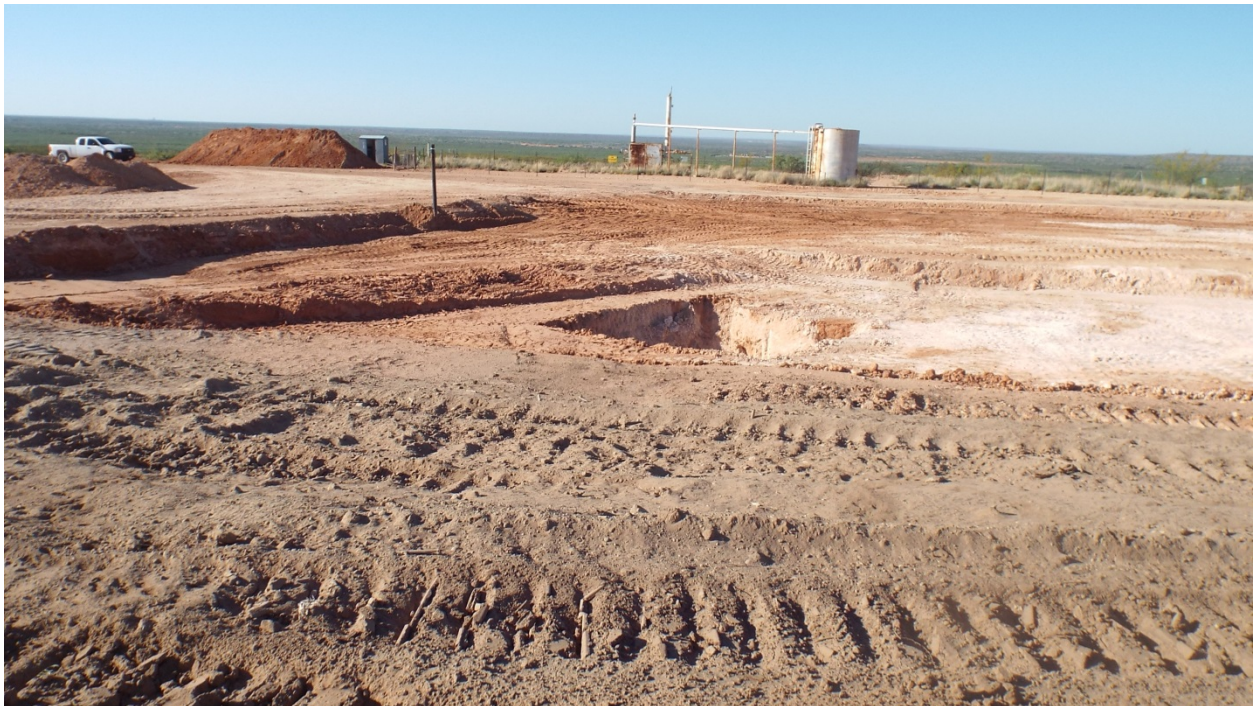
West central pad area of high chloride excavation, facing SE 6/4/2014

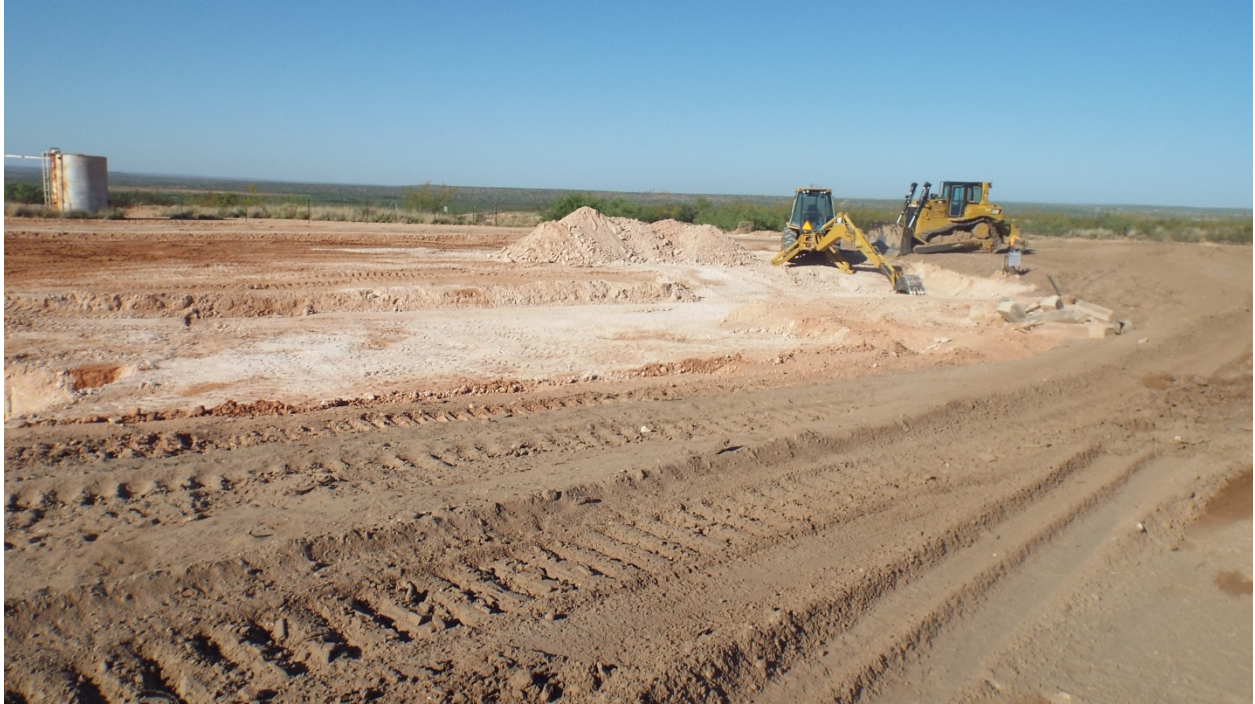
West pad area of high chloride excavation, facing SW, reserve pit recap – bottom/right 6/4/2014

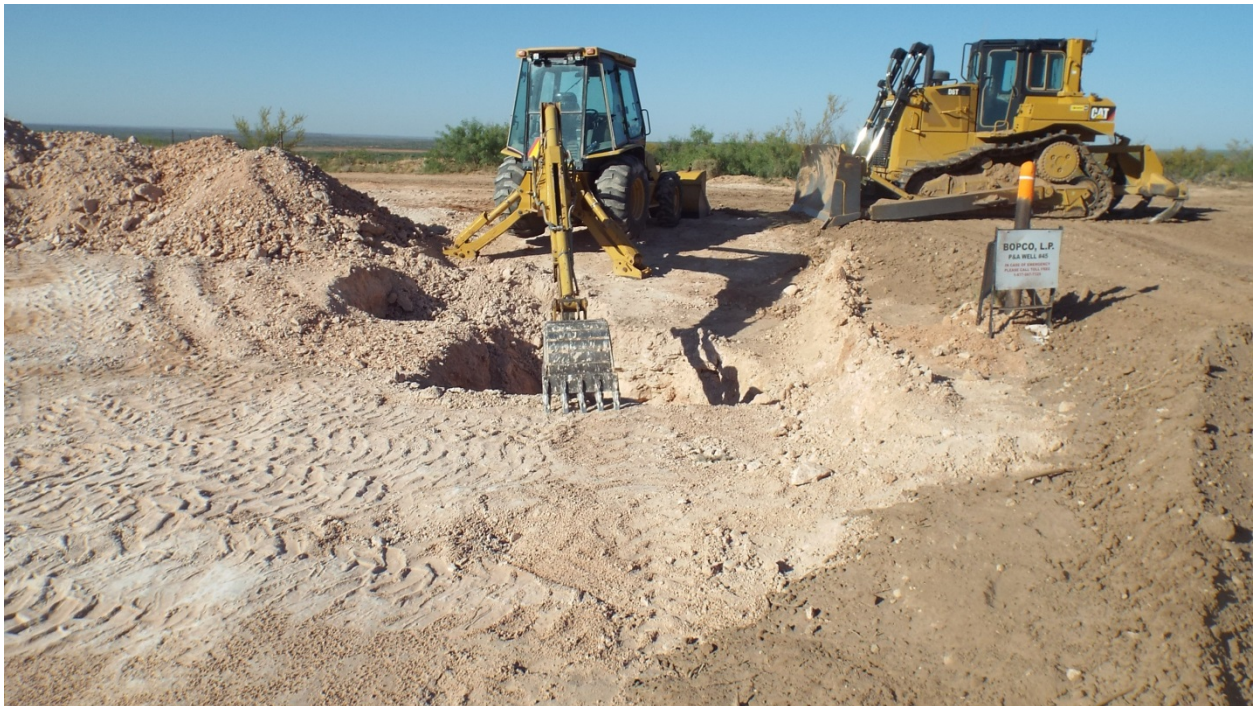
West pad area of high chloride excavation, facing south 6/4/2014

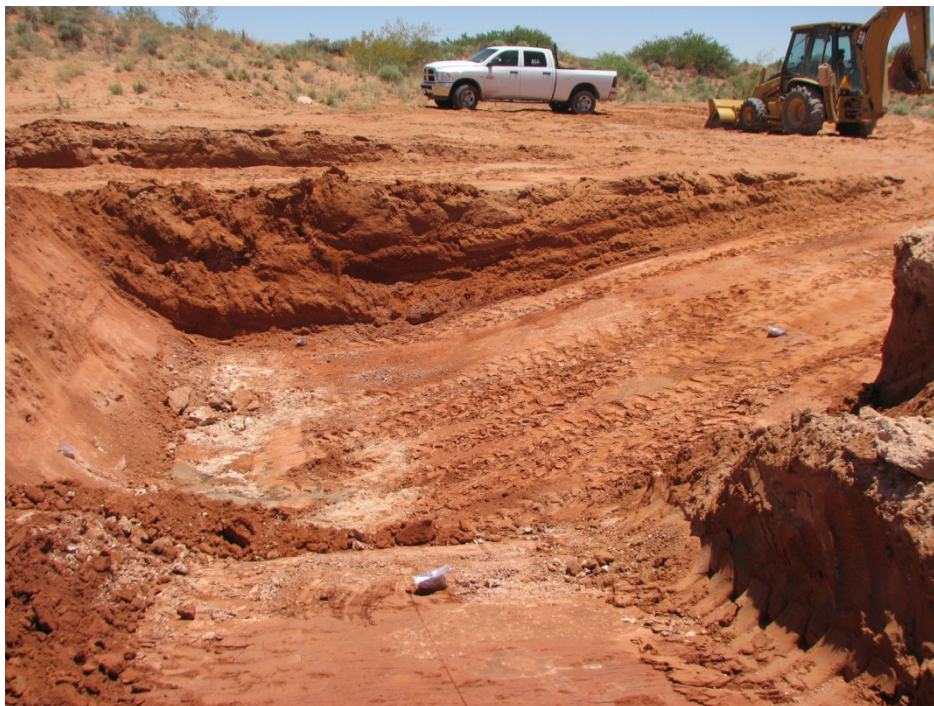
Compressor site excavation, facing north 6/5/2014

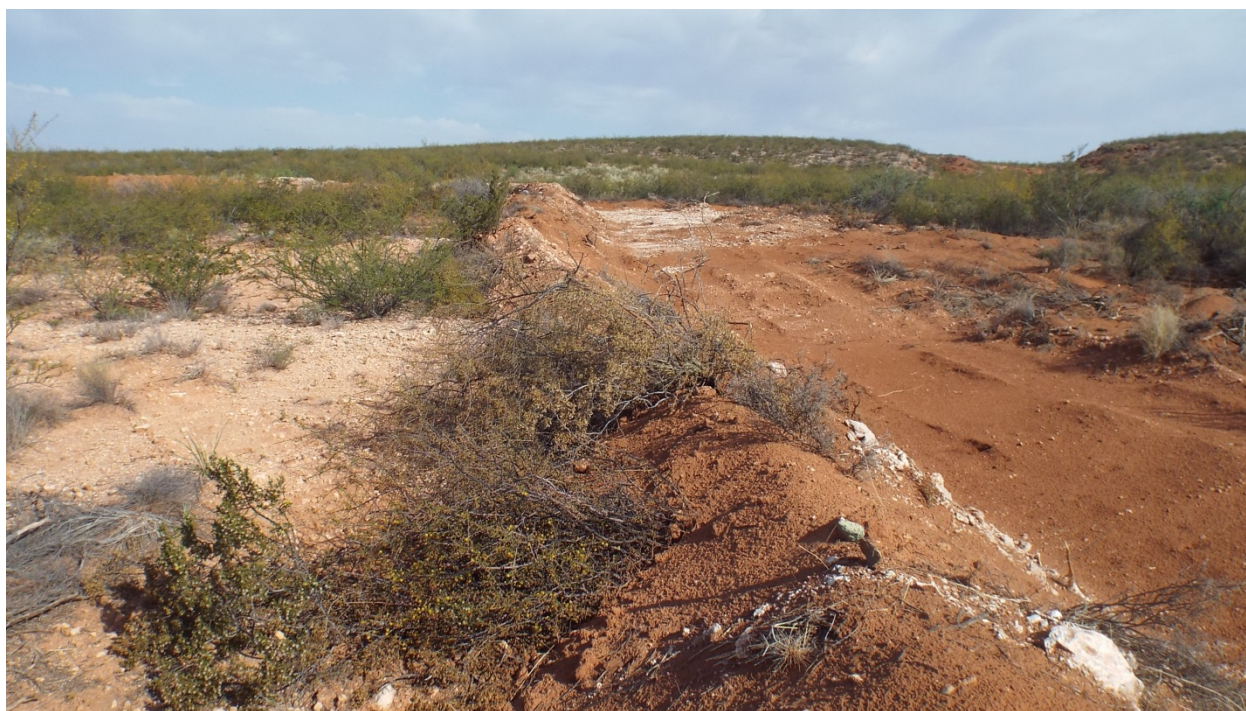
Renewed water diversion north of entire site, facing NW 6/11/2014

Existing trenches formerly positioned for water erosion control located north of the entire site were repaired. Photo documentation is included in the attachments. The entire site was reseeded with a Bureau of Land Management #2 seed mix, and the south east perimeter was fenced to prevent recreational traffic disturbance to the reclaimed area.

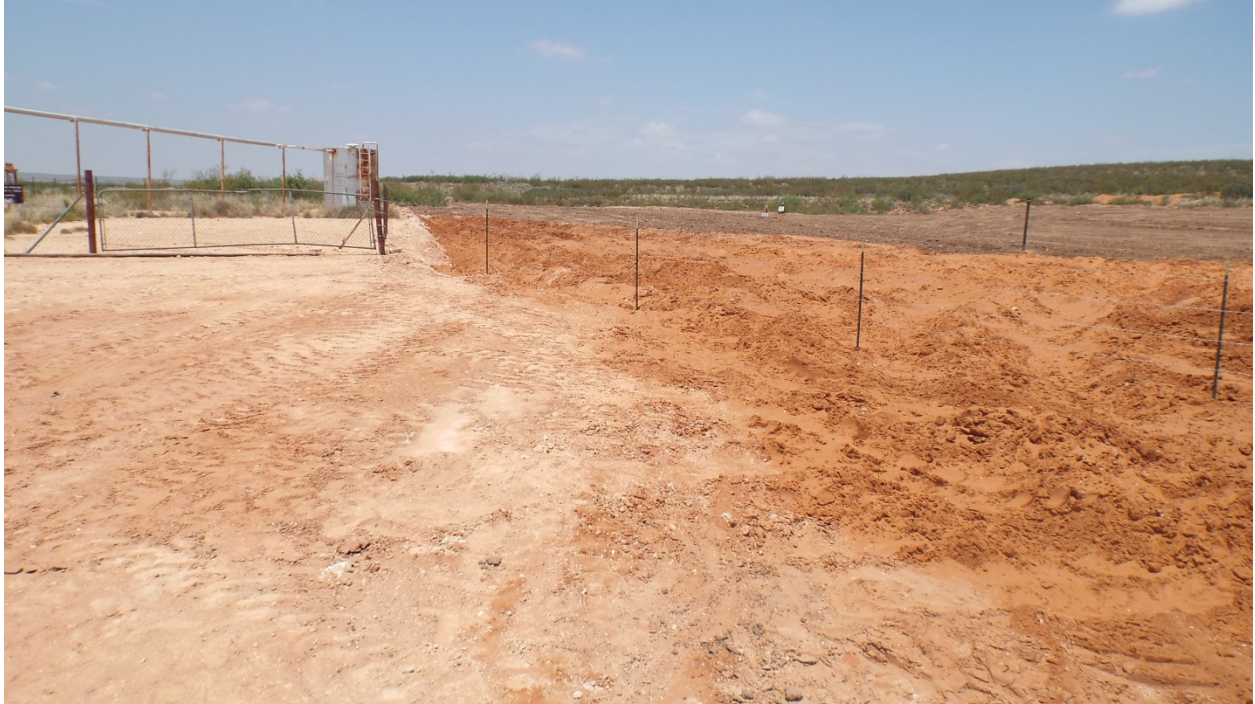
Post reclamation area with fencing, facing west from SE corner 6/13/2014

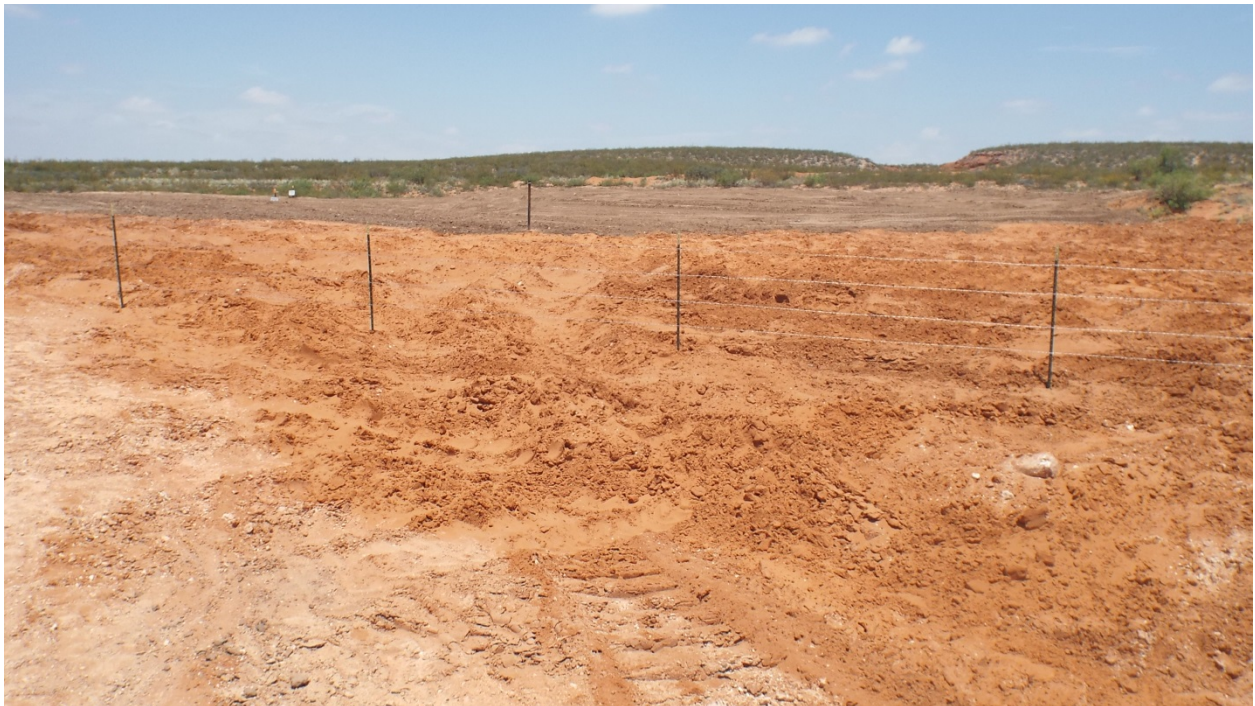
Post reclamation area with fencing, facing NNW from SE corner 6/13/2014
