Release Notification and Corrective Action

Name of Company	SDX Resources, Inc.	20451	Contact	Chuck Morgan
Address	PO Box 5061, Midland, TX 79704		Telephone No.	432/685-1761
Facility Name	AID 24 P State #1	30-015-22878	Facility Type	SWD
Surface Owner	State	Mineral Owner	State	Lease No. LG6340

Reference **AID 24 P State Com #1 24-17S-28E API # 30-015-22878 Eddy County, New Mexico**

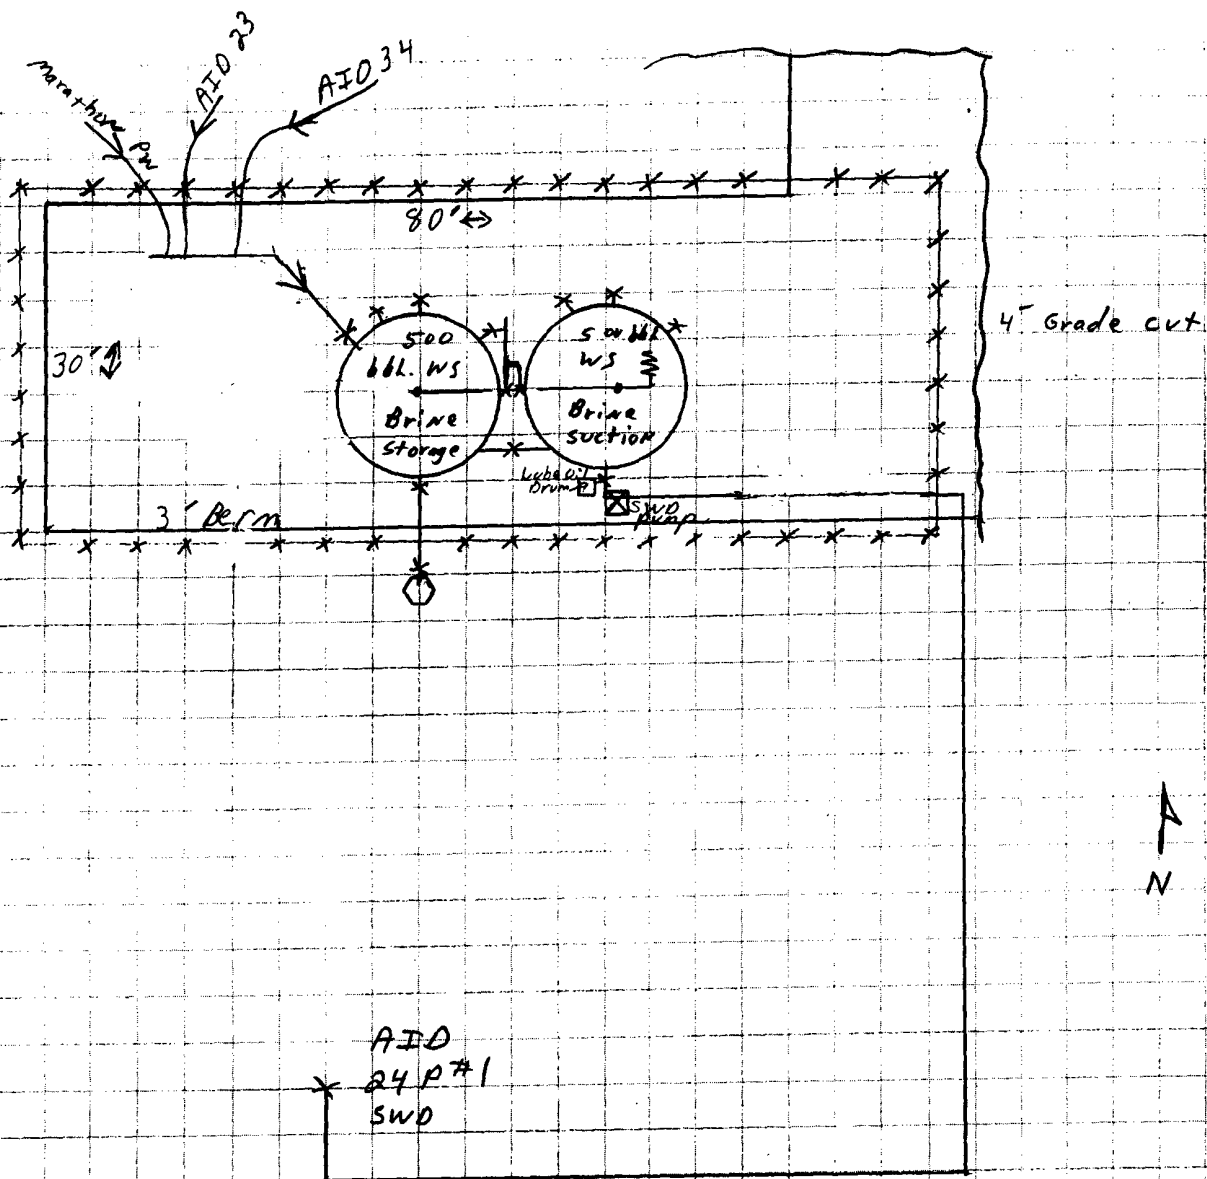
SDX Resources, Inc.
 AID State 24 P#1
 SWD Facility Diagram

Brine contacted small area around the base of tanks. Wells were shut down and a steam cleaning unit and a vacuum truck were called. Tanks were steamed off and the vacuum truck recovered 5 bbls of fluid. A backhoe attempted to remove any contaminated soil, but was unable to recover any saturated soil. (Site diagram attached)
