**Merit Energy  
State T Battery  
Site Investigation  
Unit K, Section 2, Township 15S, Range 37E  
Lea County, New Mexico**

**April 28, 2005**

**Merit Energy  
13727 Noel Road, Suite 500  
Dallas, Texas 75240**

**Safety & Environmental Solutions, Inc.  
703 E. Clinton Suite 102  
Hobbs, New Mexico 88240  
(505) 397-0510**

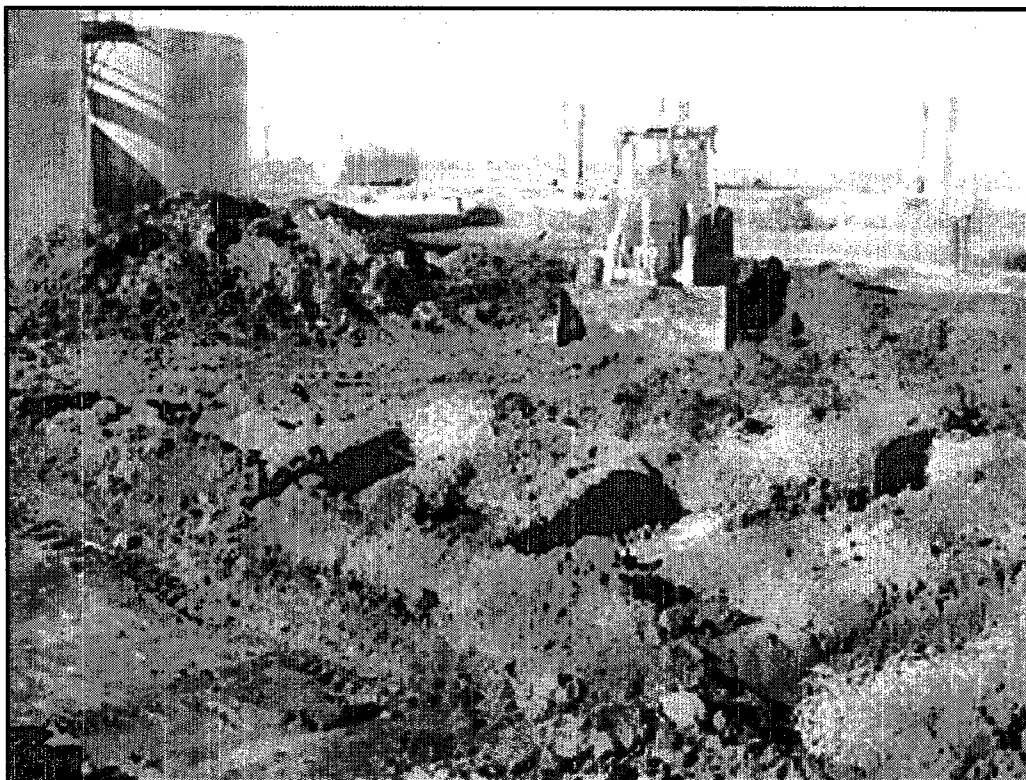
inside the bermed area at the site. Test Trenches 1 – 4 were installed on the north end to the battery site to the following depths:

| Test Trench # 1 | 7' |

Backhoe excavating trench #1

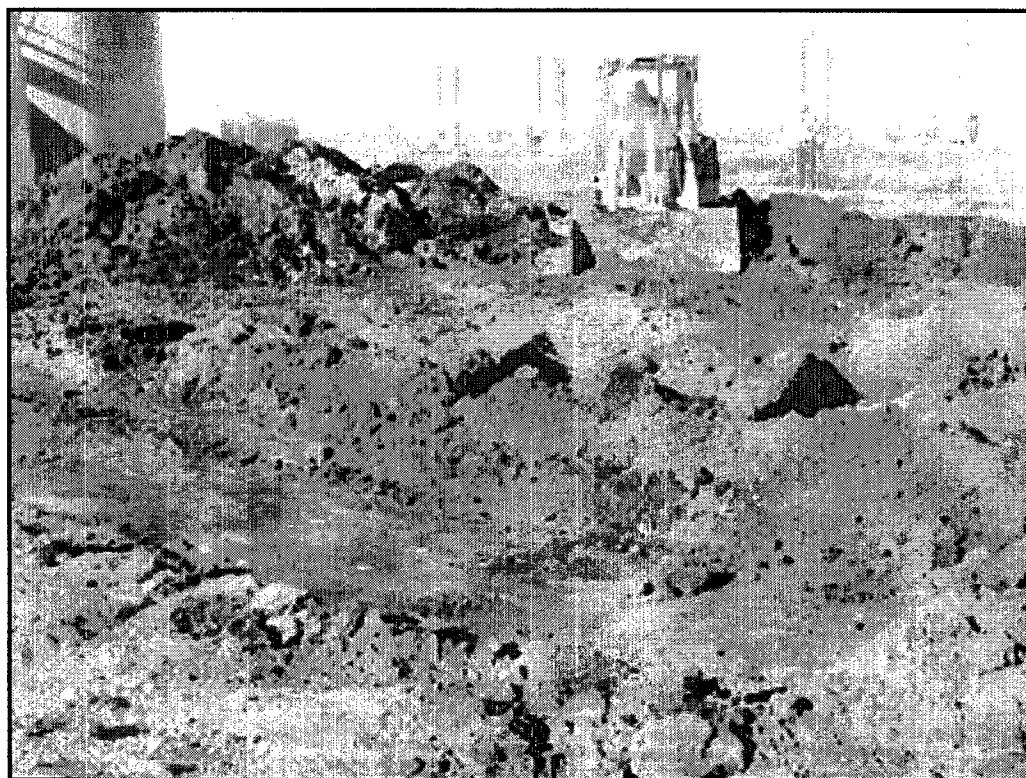
Backhoe excavating trench # 1 foreground typical material on N. side of battery

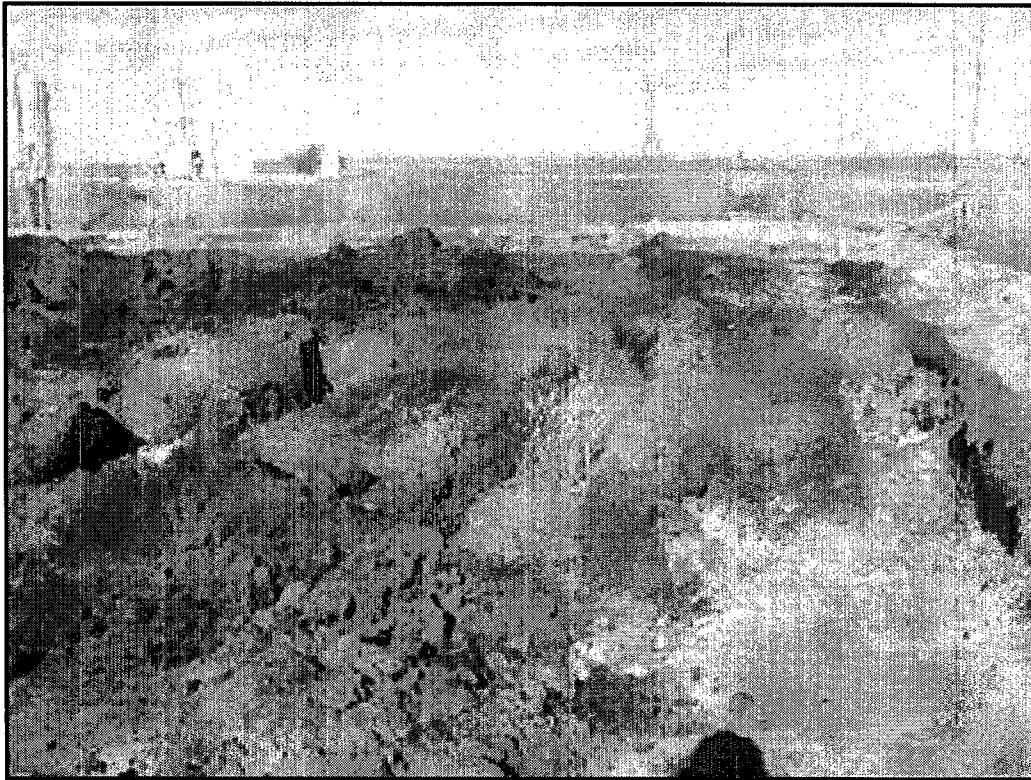
Undisturbed material on N. Side of battery

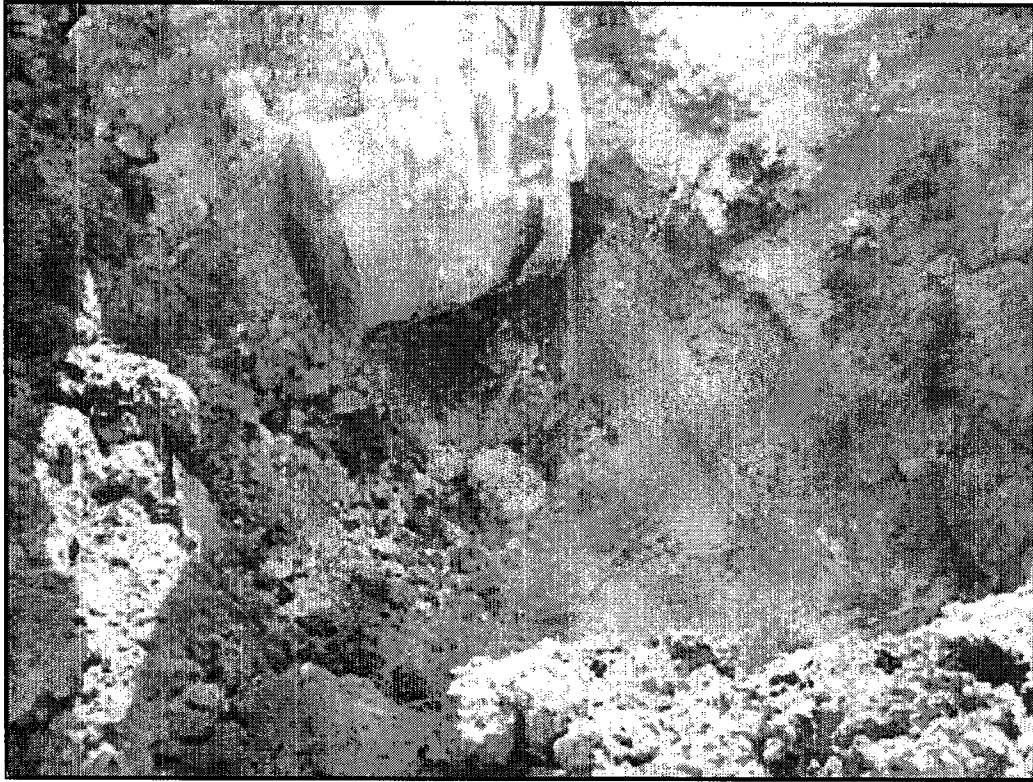
Test trench #1

| Date | Sample ID | TPH | Benzene | Toluene | Ethyl Benzene | Total Xylene |
|---|---|---|---|---|---|---|
| 4-27-05 | TT 1 @ 7' | 2040 | <0.005 | <0.005 | <0.005 | <0.015 |

The results of the analyses indicate the hydrocarbon contamination to be above the NMOCD guidelines in Test Trenches 1, 3, 4 and 6. The chloride concentrations are slightly elevated but should not present a threat to groundwater.

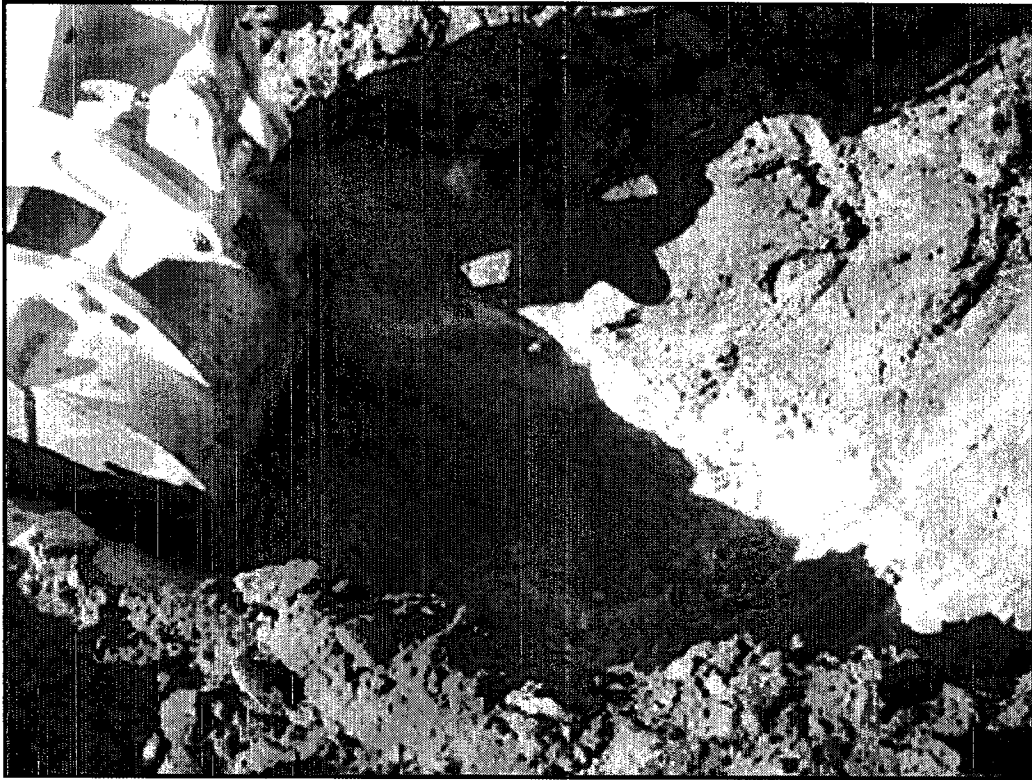
Test trench #2

| Date | Sample ID | TPH | Benzene | Toluene | Ethyl Benzene | Total Xylene |
|---|---|---|---|---|---|---|
| 4-27-05 | TT 2 @ 5' | 98.2 | <0.005 | <0.005 | <0.005 | <0.015 |

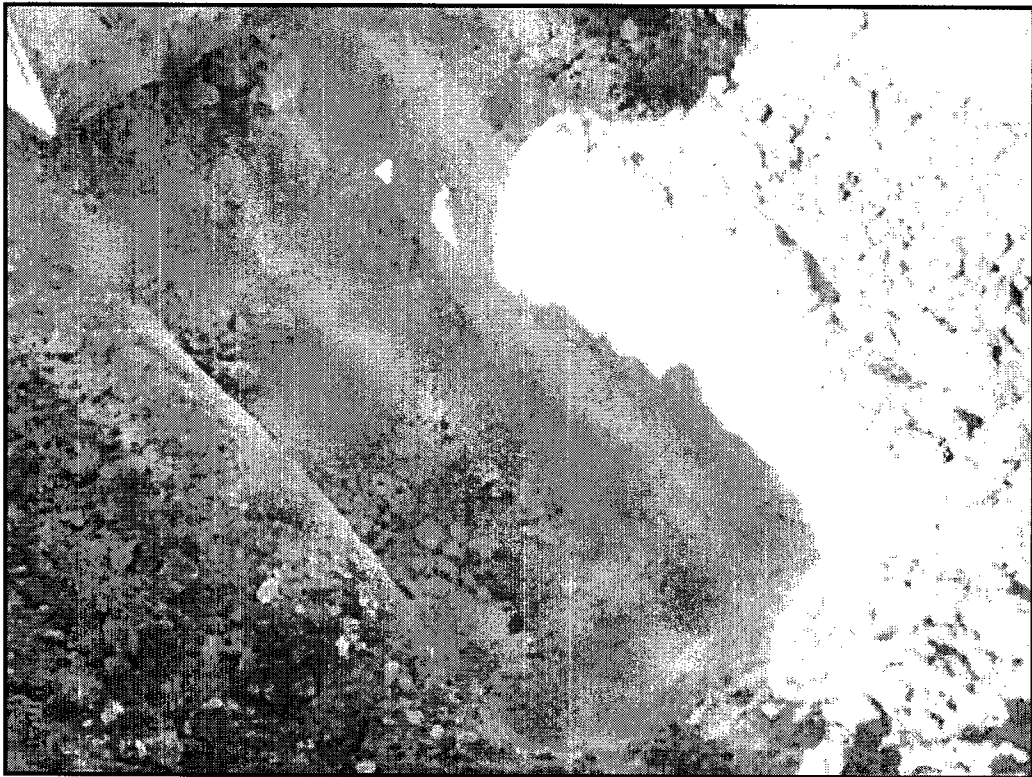
Test trench #3

| Date | Sample ID | TPH | Benzene | Toluene | Ethyl Benzene | Total Xylene |
|---|---|---|---|---|---|---|
| 4-27-05 | TT 3 @ 5' | 1610 | <0.005 | <0.005 | <0.005 | <0.015 |

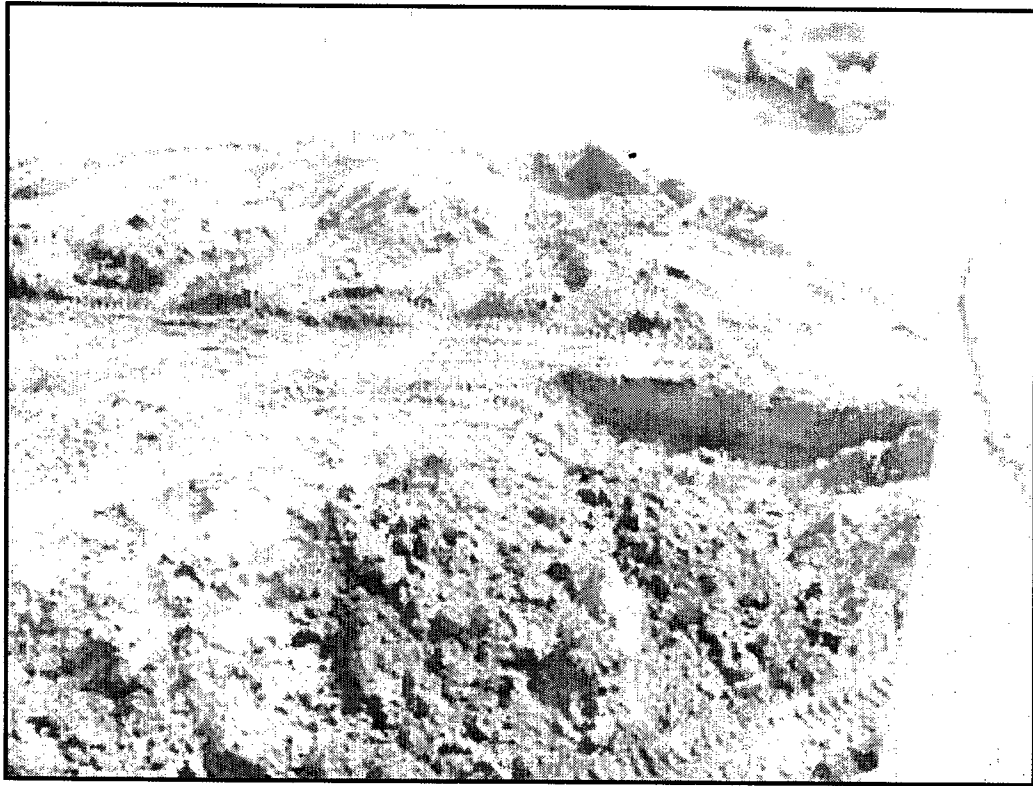
Test trench # 4

| Date | Sample ID | TPH | Benzene | Toluene | Ethyl Benzene | Total Xylene |
|---|---|---|---|---|---|---|
| 4-27-05 | TT 4 @ 4' | 10900 | <0.005 | <0.005 | 0.524 | 3.16 |

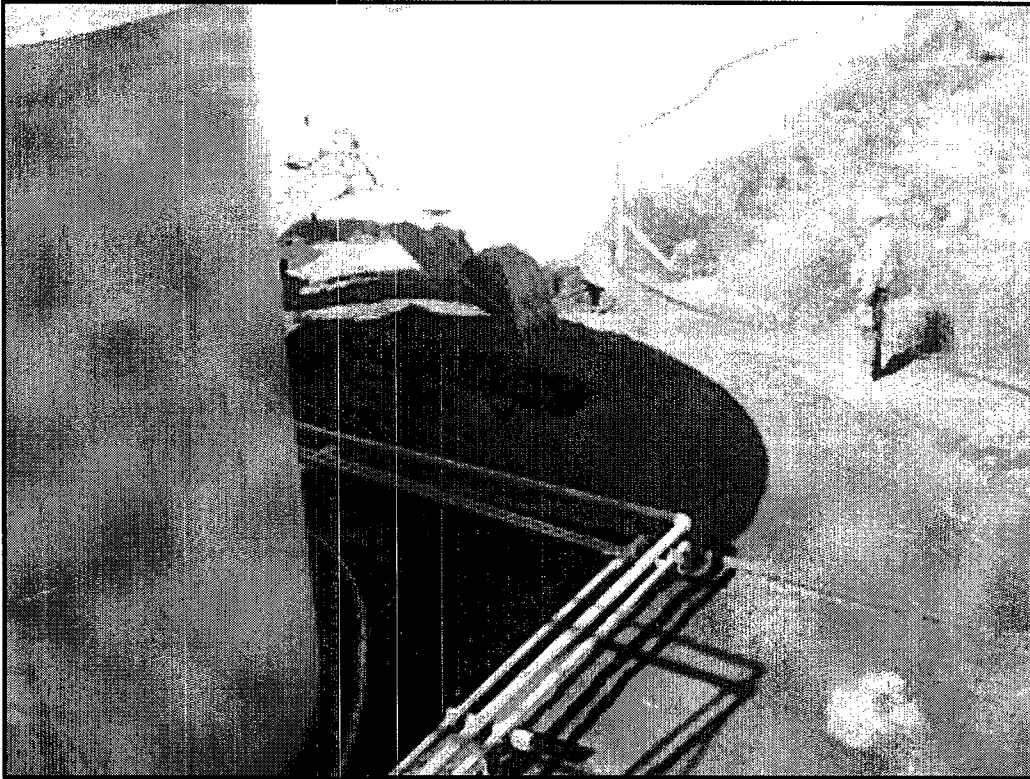
Test Trench # 5 was installed on the west side of the battery and excavated to a depth of 1' where an electric line was cut. This trench was abandoned at that time.

Backhoe digging trench #2 (hit electric line here)

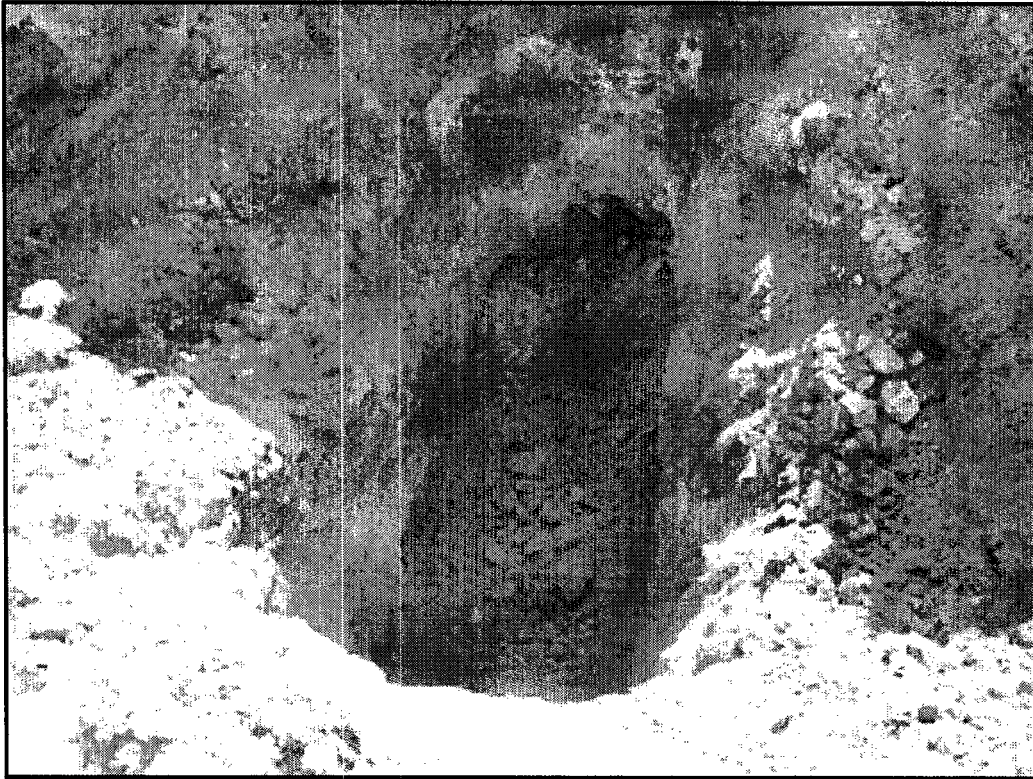
Test trench #6

Test Trench # 6 was installed on the east side of the battery near the center and excavated to a depth of 8'.

| Date | Sample ID | TPH | Benzene | Toluene | Ethyl Benzene | Total Xylene |
|---|---|---|---|---|---|---|
| 4-27-05 | TT 6 @ 8' | 3930 | <0.005 | <0.005 | 0.715 | 0.016 |

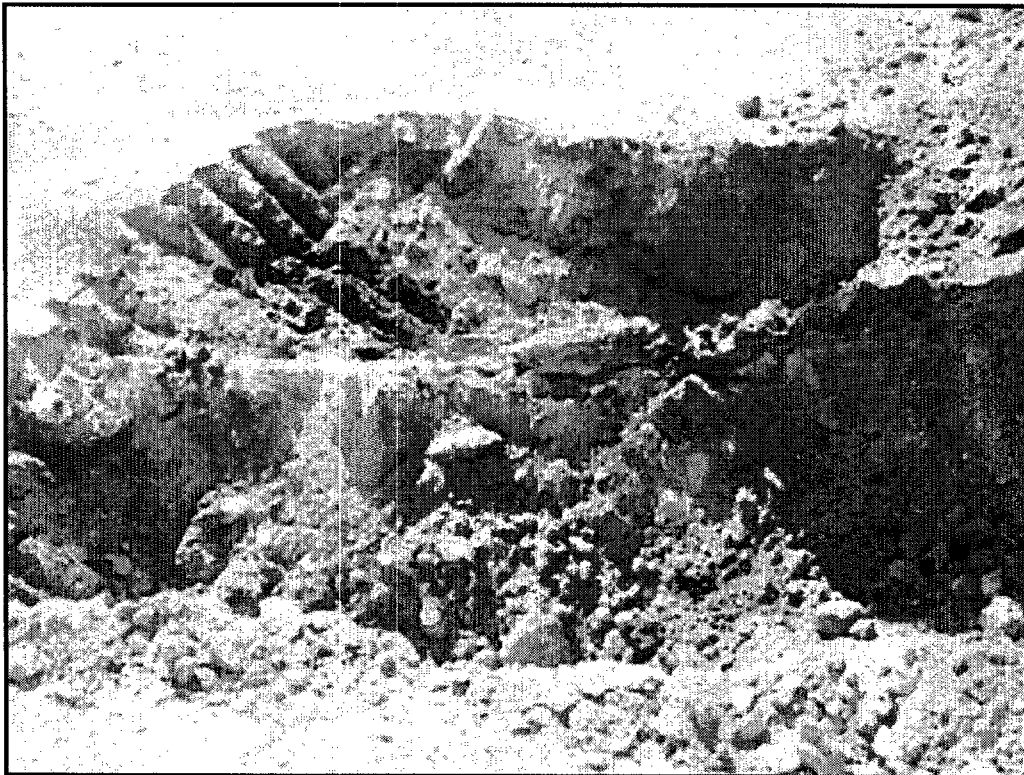
Test trench #7

Test Trench # 7 was installed on the southeast end of the battery and excavated to a depth of 3'. No sample was retrieved from this trench. White caliche was encountered at a depth of 3'.
