August 28, 2014

Subject: **Remediation and Closure Report**  
Devon Energy  
Harrod No. 1  
API #: 30-025-34535  
**1RP-7-4-3185**

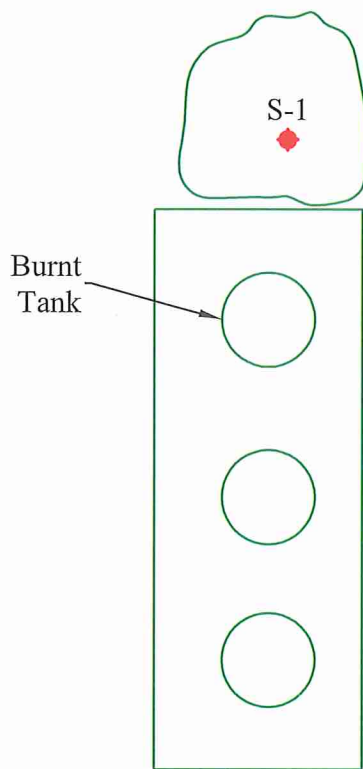
Harrod #001  
Devon Energy Corporation  
Lea County, New Mexico  
Figure 1 - Site Plan

Housekeeping activities were initiated at the historical stain just to the north of the tank battery. The impacted area measured approximately 20x20 feet. Sampling activities at S-1 were completed and a work plan was approved by the NMOCD.

The impacted area was subsequently excavated to a depth of 0.75-feet deep. The contaminated soil was disposed of at Lea Land, LLC.

The excavated area was backfilled with new caliche and re-contoured to match the surround location.
